Architectural Feasibility Report
For
Upton Town Library
2 Main Street
Upton, Massachusetts

April 11, 2016

Tecton Architects
One Hartford Square West
Hartford, CT 06106

Architectural Feasibility Report
Upton Library
Town of Upton, Massachusetts
April 11, 2016

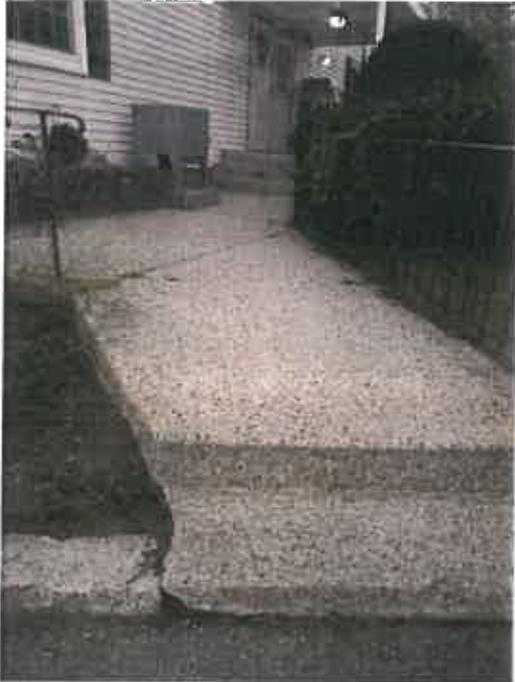
1. Exterior Sidewalk and Stairs

- Does not meet, nor attempt to comply with, any state or federal ADA regulations.
- The site is restricted and no ADA access into the building exists.
- ADA parking is on a slope greater than that allowed by the regulations.
- Stair are absent of any type of HC lift aids and the handrails do not meet code in several locations as they do not extend beyond the bottom step or upper landings.

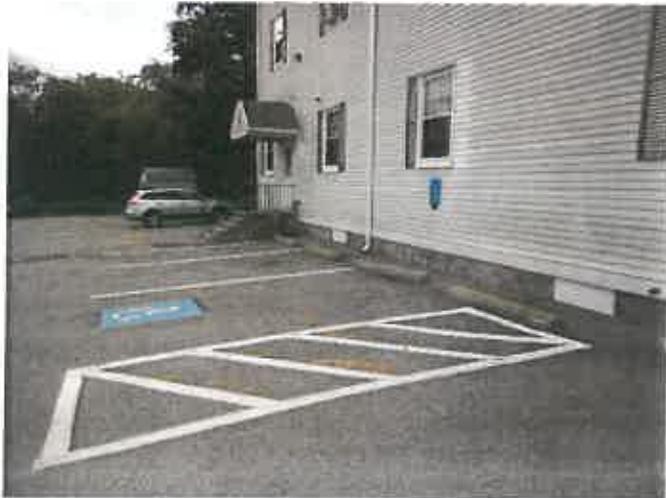
2. Exterior HC Parking and Stair

- Does not have any dedicated parking spaces for library patrons or staff, sharing off-street parking and a lot for 9 vehicles with other municipal departments and their patrons.

- The gutter currently purges rain water onto the asphalt parking lot at the HC parking spot and entrance door. This is cause of a hazardous event when the water freezes on the pavement.

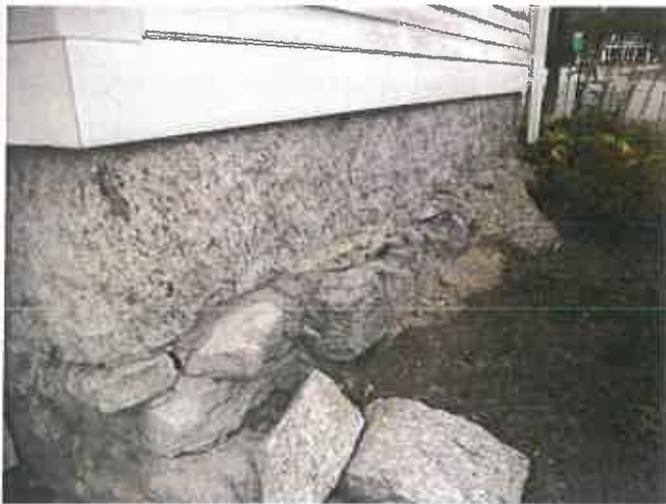
4. Exterior Foundation

- The existing stone foundation wall is suspect and appears to have repair attempts.
- Interior of stone foundation walls are exposed and uninsulated.
- Has a chronic problem with elevated mold spore levels and water entering through the fieldstone foundation to pool in the crawl space of the dirt-floored basement. It appears that a poly sheet has been loose laid to reduce the migration of water vapor into the facility.

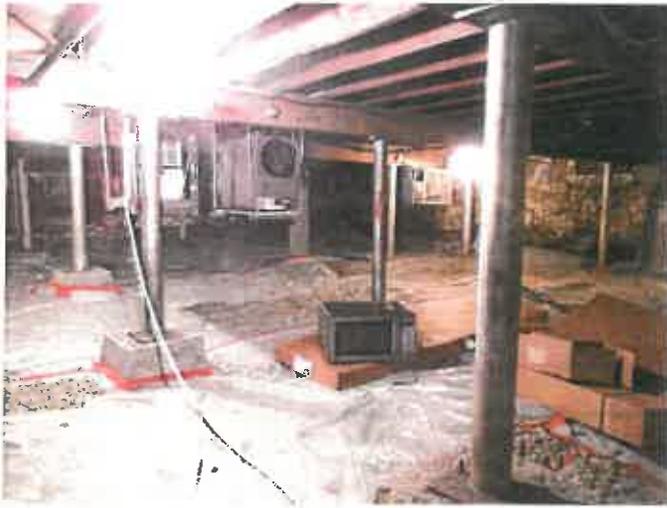
5. Interior Foundation Moisture & Insulation

- Exhibits excessive levels of humidity and temperature fluctuations.
- The First floor is above an unconditioned moist basement and is uninsulated at the floor line.

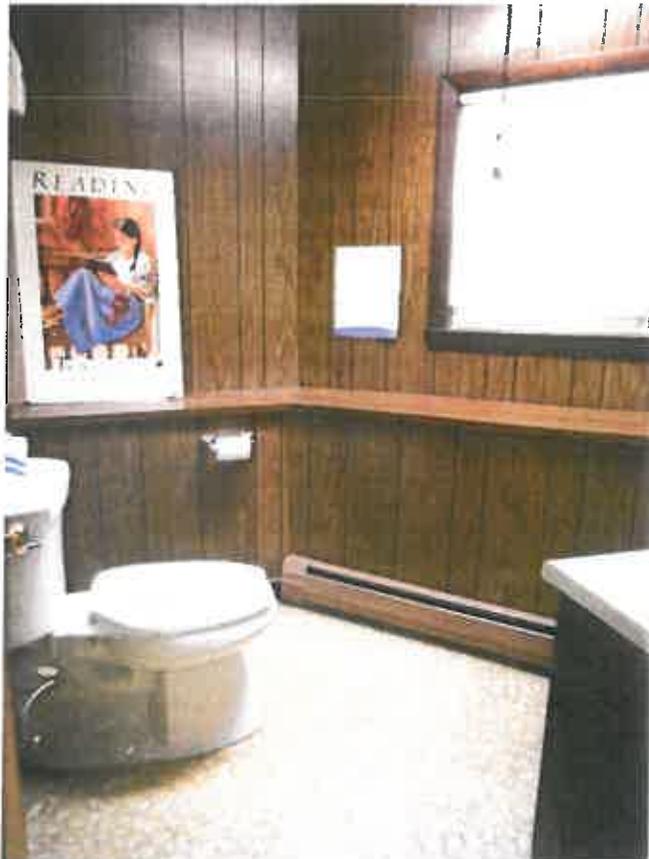
6. Toilet, Fixtures & Accessories

- The toilet does not meet ADA requirements for clearances and fixture type. Additionally the accessories typically found are absent. Grab bars, call for aid and other are required.

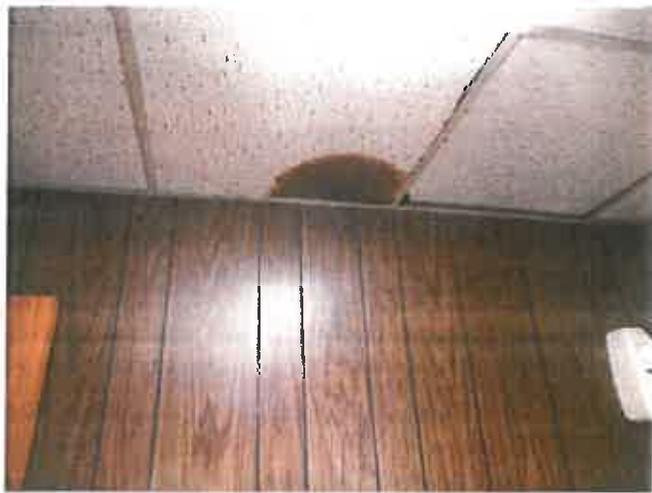
7. Above Ceiling Leaks

- Multiple ceiling leaks are evident throughout the facility suggesting water damage and the potential for mold growth.
- An attempt is made to provide access to the upper level via a chair/stair lift; however, the lift is mounted to the staircase one step above the ground floor. No ramp or other is provided. This lift is secondary to the lack of ability to actually enter the Library as the exterior stair is absent of a lift function.

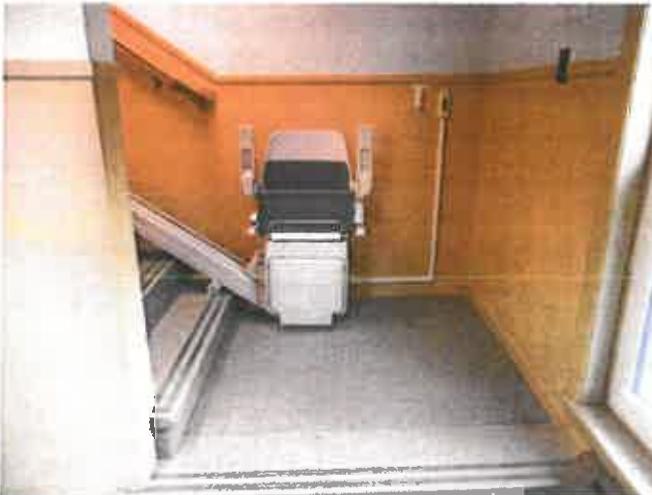
8. Stair Chair Left

8	Stair Chair Lift	The stir lift allows access to the upper level if one can navigate the single step at the lower landing. Handrail does not meet code (typical).
9	Inaccessible Stairs	Multiple locations demonstrate the lack of accessibility throughout the facility. Railings do not meet code. Handrail does not meet code (typical).
10	Millwork and Fixtures	Millwork and fixtures does not meet ADA for height, reach and clearance access
11	Attic Insulation	The below roof deck requires insulation. Wall insulation is unknown.
12	Condensers, Mold, Window Units	Condensers appear new, window units suggest inadequate cooling, mold on exterior wall

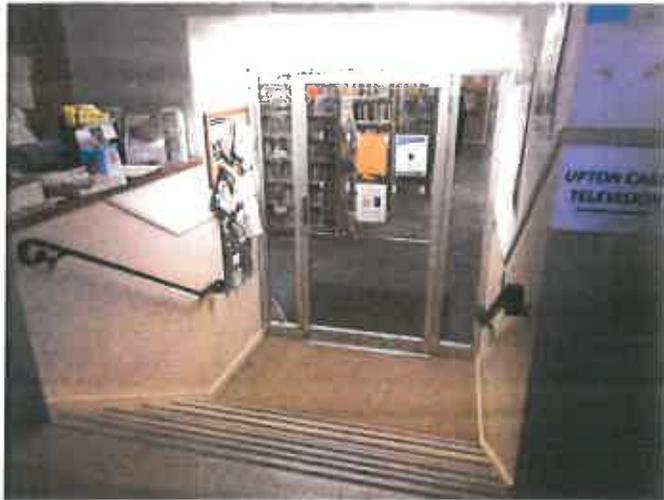
9. Inaccessible Stairs

- Multiple locations of interior stair provide no ADA access.
- Multiple examples are found where the millwork and plumbing fixtures are not ADA accessible.

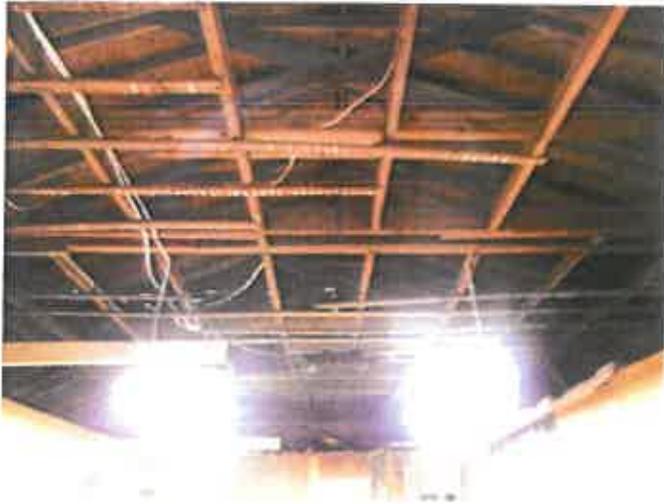
11. Attic Insulation

- The roof deck is un-insulated and does not meet the current energy code.

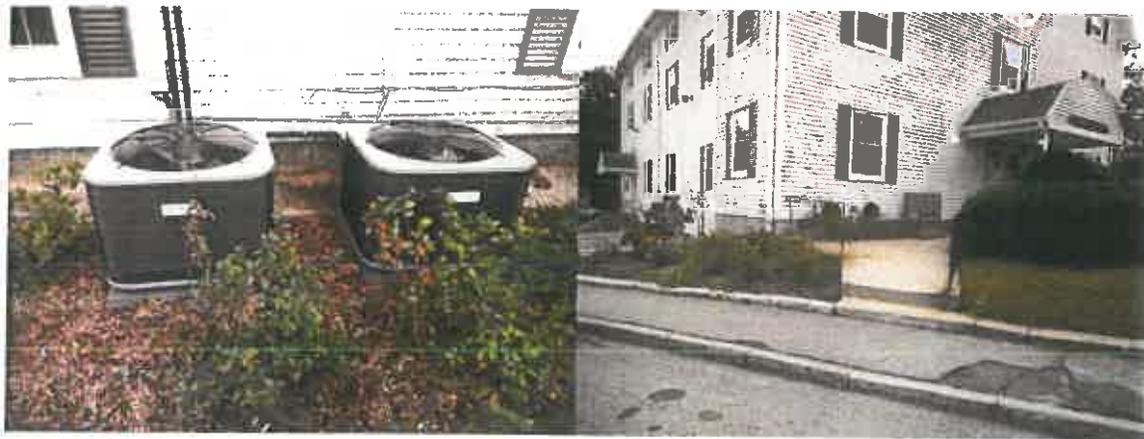
12. Condensers, Mold, Window Units

- Based on age of the structure it is assumed that minimal if no insulation exists in the exterior walls (verification by destructive observation would be required).
- Two newer condensers are on site; however, the addition of window units suggests the cooling is inadequate for the facility. Possible the age of the structure is systemic of the amount of, or lack thereof, wall insulation.
