Upton, MA

Post Construction Stormwater Management

BMP RETROFIT SITE INVESTIGATIONS

Prepared by: **BETA GROUP, INC.**

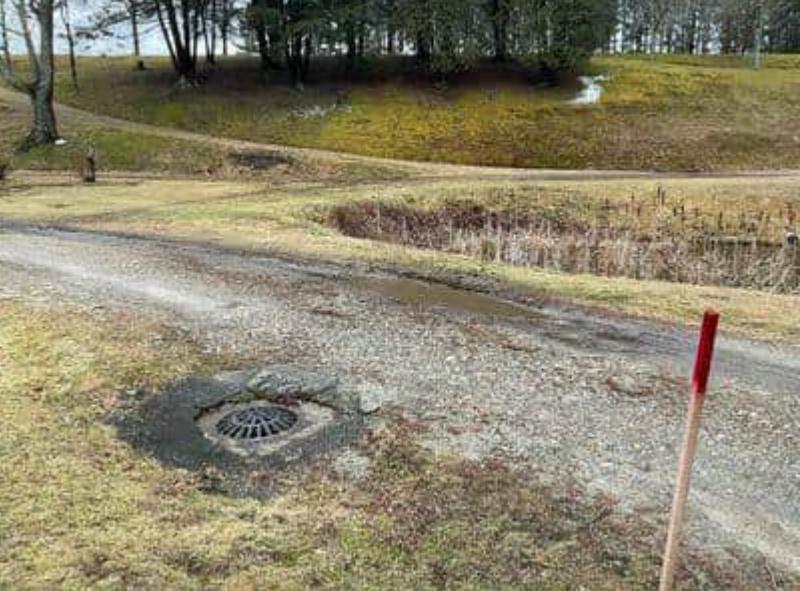
Existing catch basins drain into ponds in center of cemetery, facing southwest.

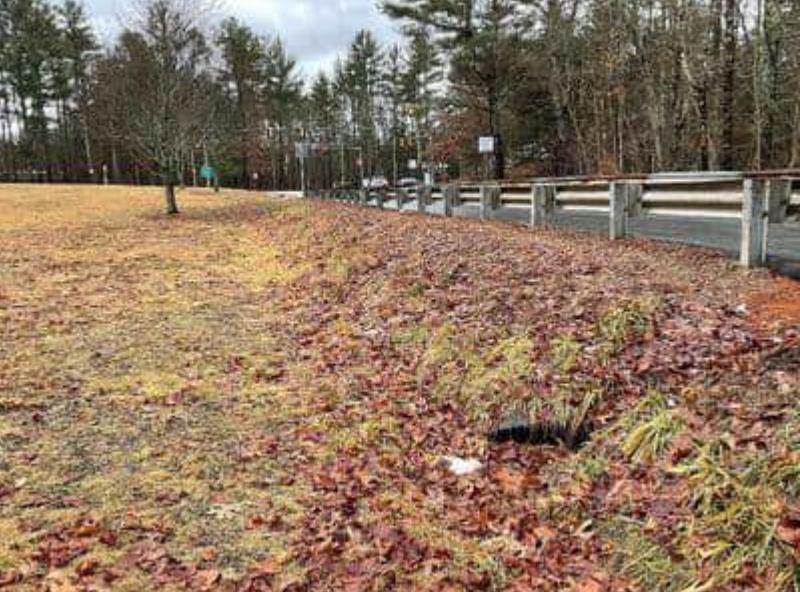
Existing inlet structure facing south along Maple Avenue towards intersection of Maple Avenue and Pleasant Street.

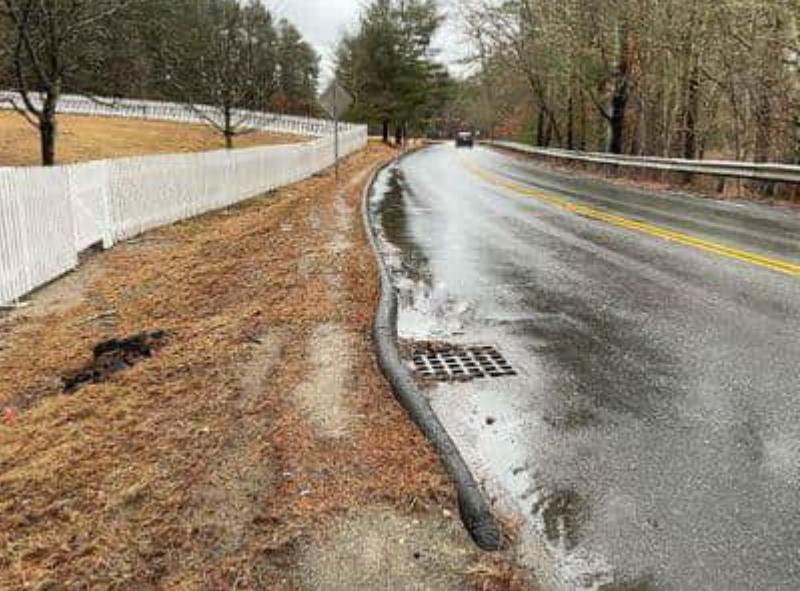
An additional inlet and catch basin structure (86-2) was observed north of this area along the cemetery fence line. Opportunities for BMP retrofits are limited in this area due to the cemetery fence and existing grading.

Existing catch basin 86-2 and inlet structure facing south along Maple Ave.

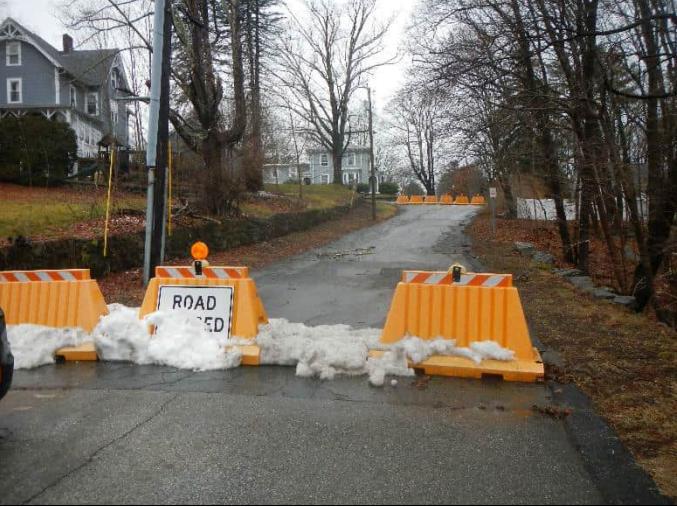
Roadway leading west from parking lot – opportunities for swales are limited given steep slopes and existing retaining walls.

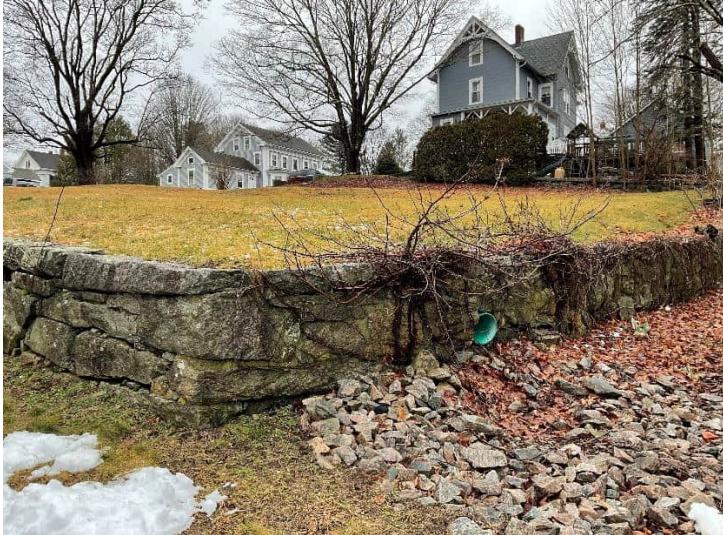
Existing discharge through retaining wall into riprap.

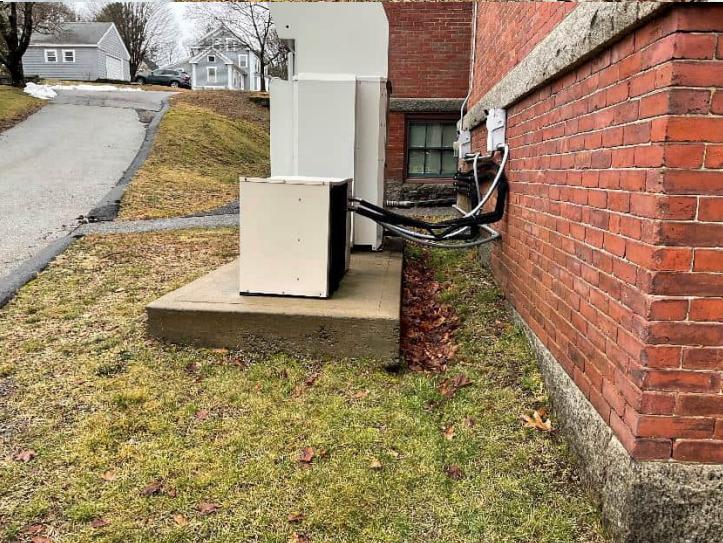
Eroded soil beneath drip edge is beginning to scour existing concrete pad – opportunity to reroute to leaching basin. Equipment presents challenge to installing drip edge.

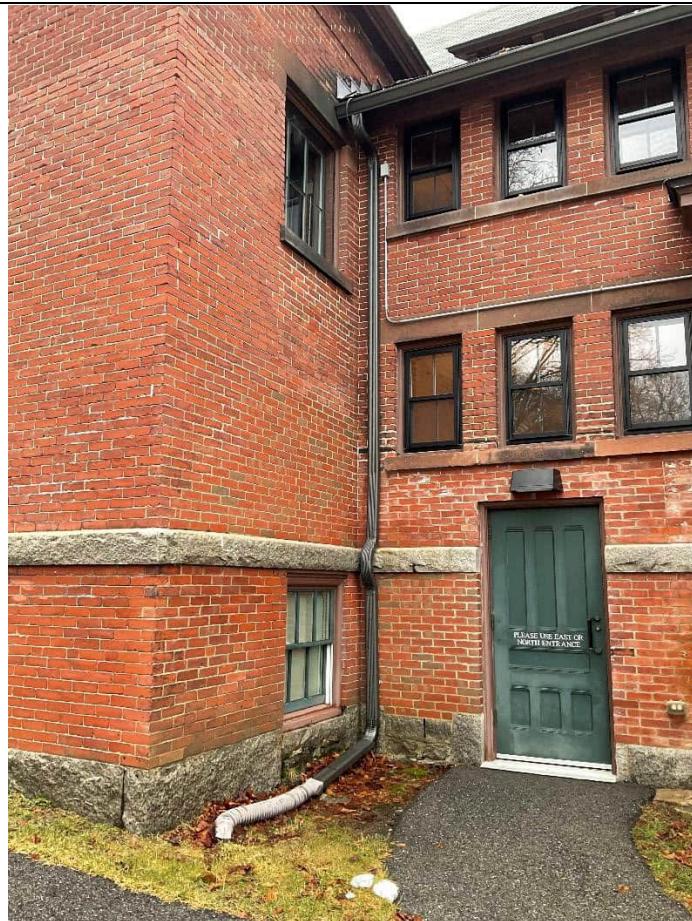
Existing downspout discharges to ground – opportunity to discharge to leaching basin, would require cutting and restoration of existing HMA path.

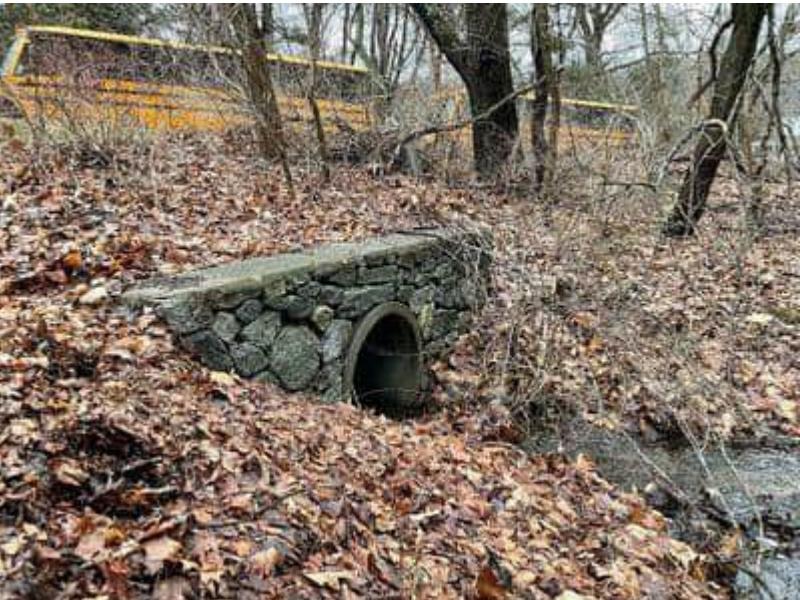
Existing conditions on this undeveloped parcel include two outfalls, one (78-6) that discharges stormwater flow in the north corner to a wet area in the west corner that is retained by an outlet control structure and one (78-5) that was buried under leaves in the east corner of the parcel on the day of the site visit. It is unclear if the existing wet area was designed as a pond or is a natural wetland, although the wet area does appear in the 2005 Wetlands GIS layer published by MassDEP.

A photograph of a concrete pipe (outfall) embedded in a stone wall, situated in a wooded area with fallen leaves on the ground. A yellow caution tape is visible in the background.	Outfall 78-6, viewed facing E.

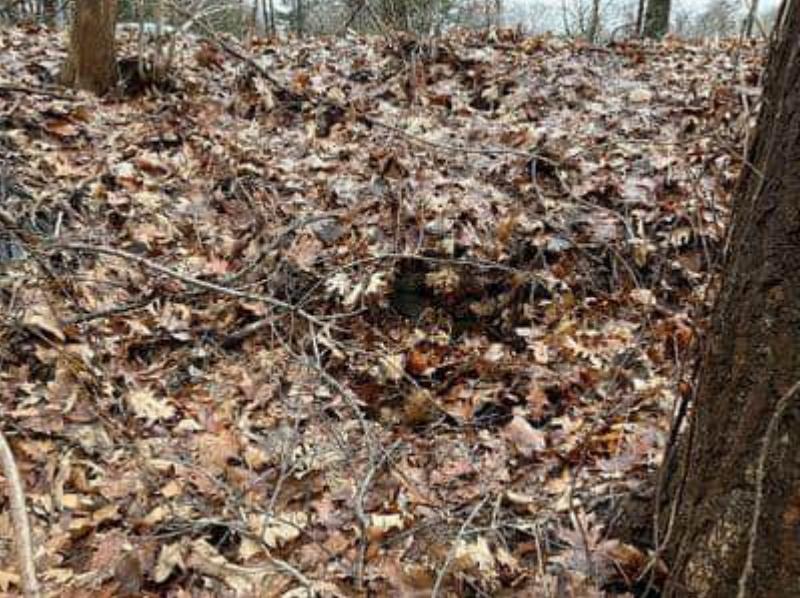
Outfall 78-5, viewed facing E.

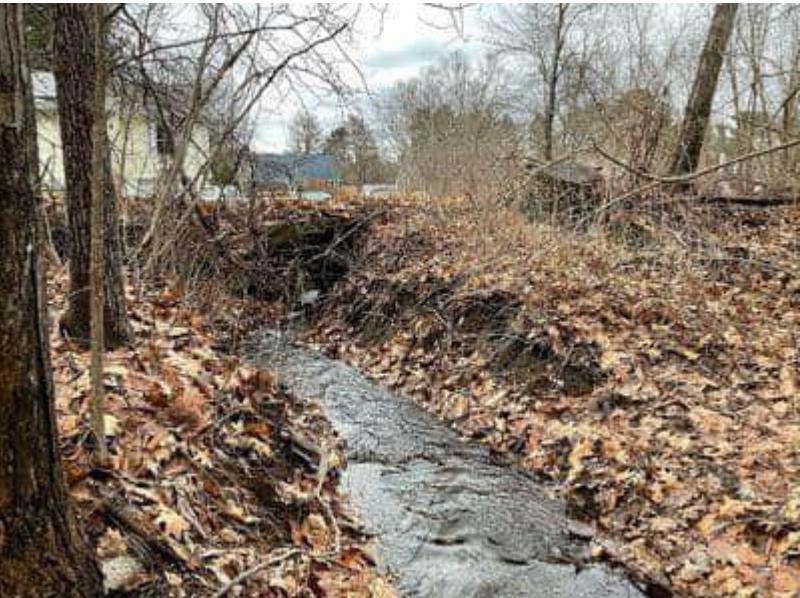
Existing outlet; opportunity for installation of inlet control structure and wet basin.

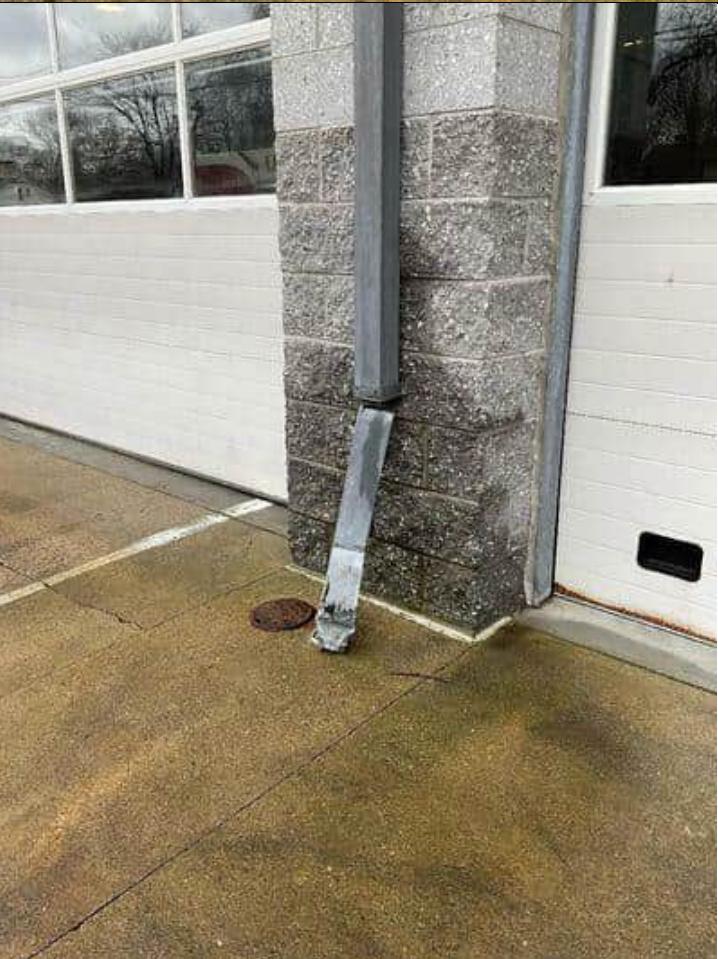
<p>Disconnected downspout along fire department vehicle bay.</p>

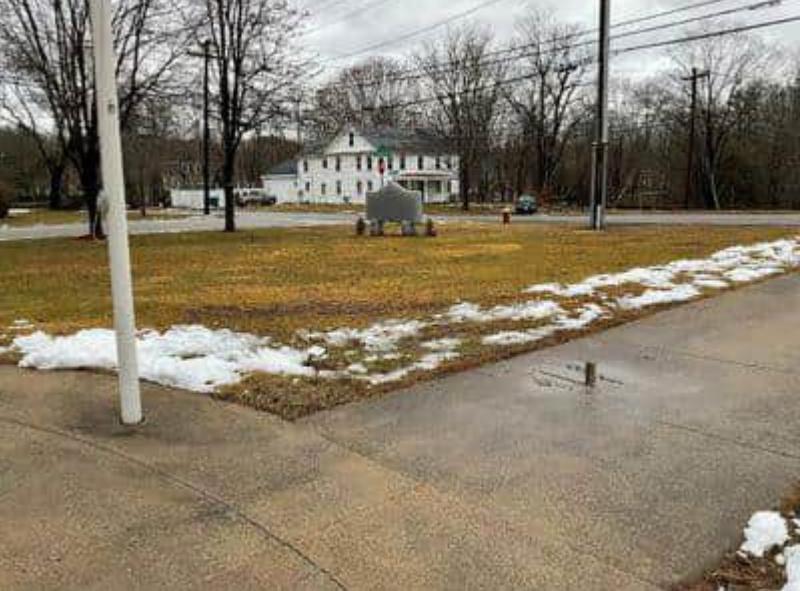
<p>Saturated low spot along walkway to main fire department building entrance from School Street.</p>

Stone infiltration trenches could be installed adjacent to walkways.

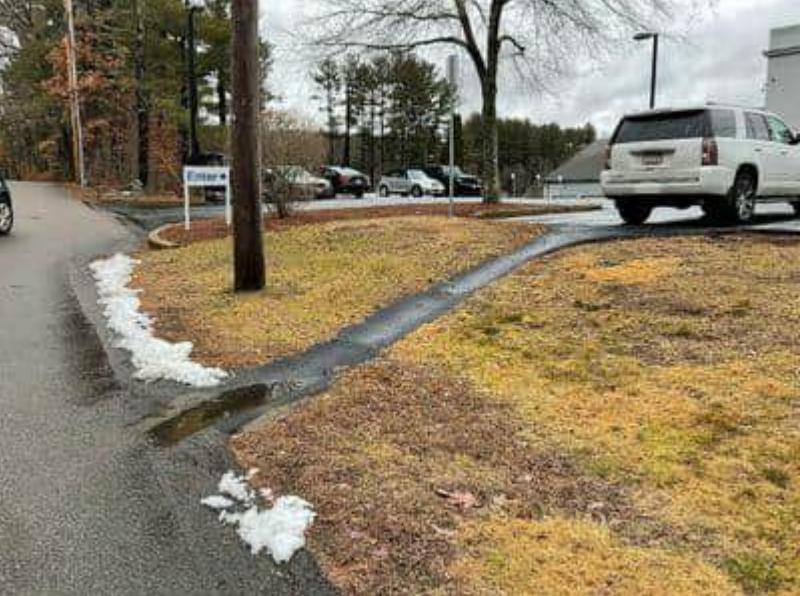
Existing paved waterway from south edge of police station front parking lot along Warren St.

Can redirect flows from paved waterway to water quality swale. There is also room to provide a small infiltration area (either a shallow pond or adding a leaching basin or combo) near the corner. Overflow would need to be between HMA berm and sidewalk, which is essentially where the flow from the Warren Street goes anyway.

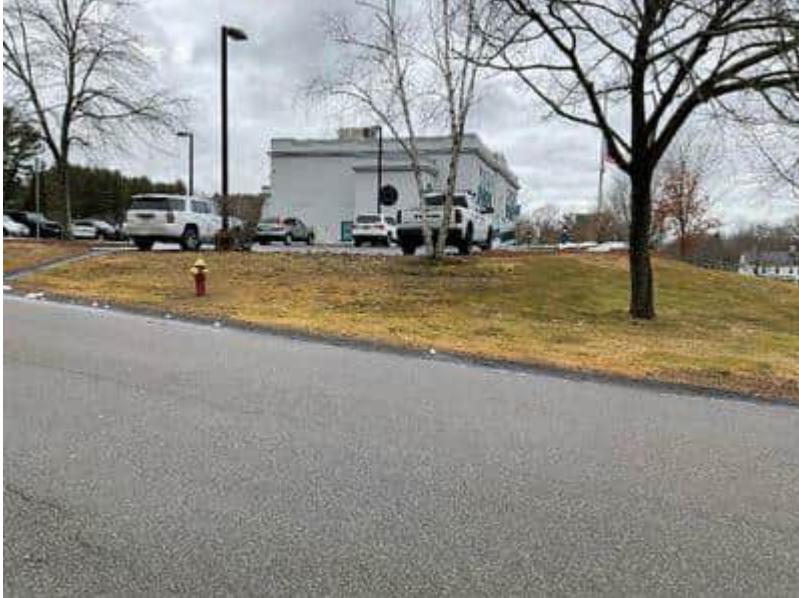
Flow path of existing paved waterway along north Warren St curb.

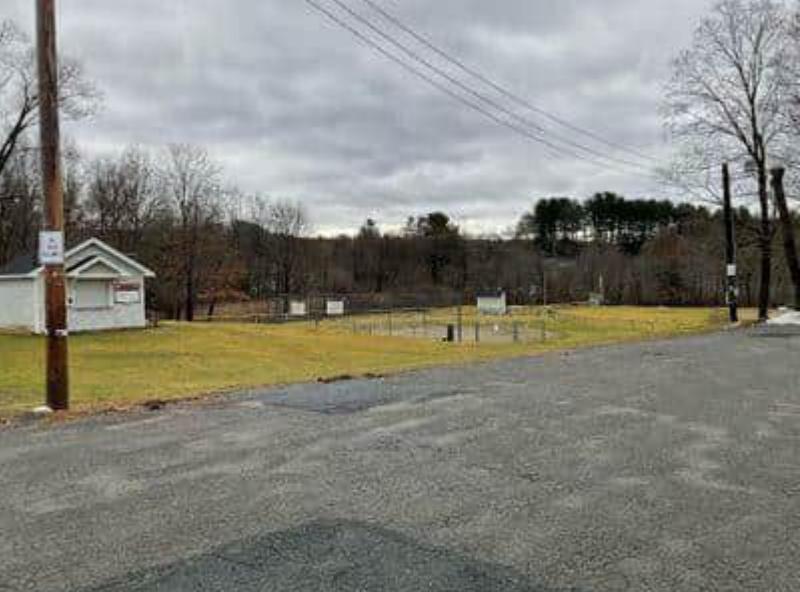
Facing southeast from VFW parking lot to sloping area that leads to ballfields - opportunity for WQS along existing channelized area.

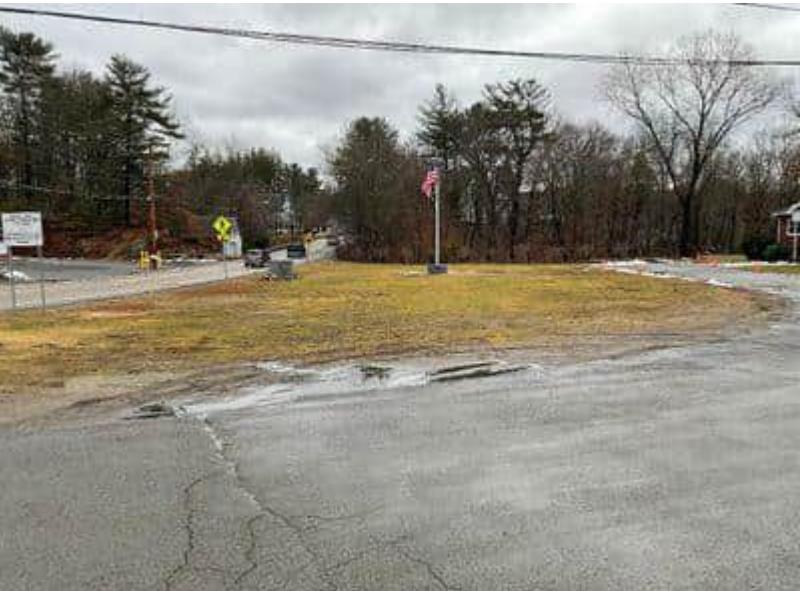
Facing east from VFW parking lot to area near flagpole - opportunity for shallow infiltration area with sediment forebay.

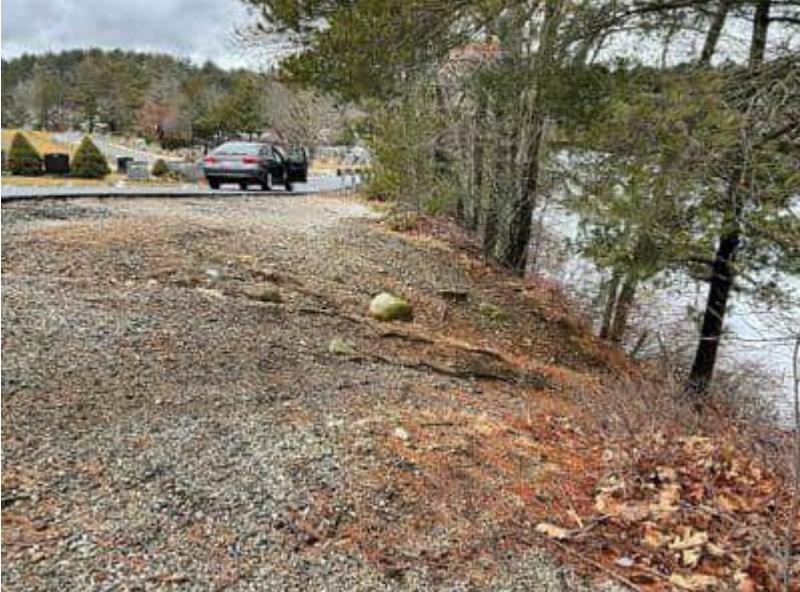
A photograph showing an eroded area along a perimeter roadway leading to Pratt Pond. The ground is exposed and rocky, with fallen leaves scattered around. A car is parked on the road in the background.	Eroded area along perimeter roadway leading to Pratt Pond.

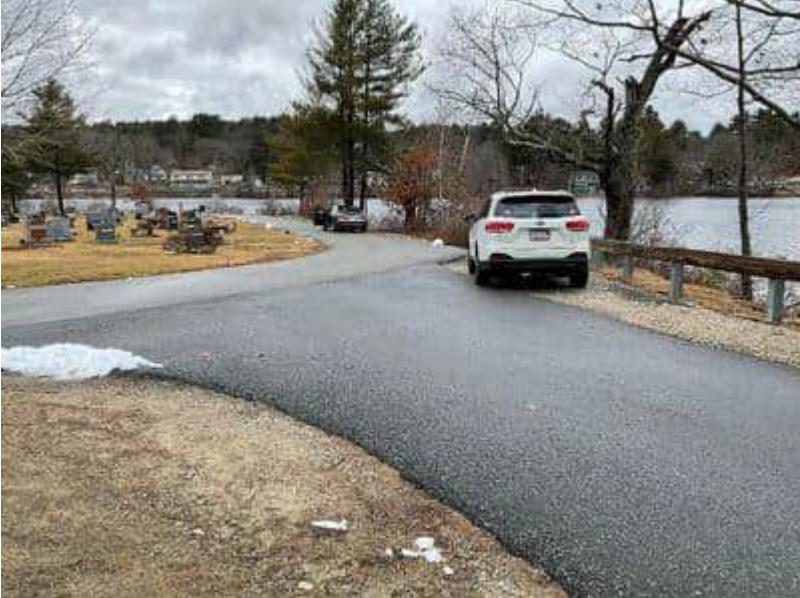
White car is parked in area where opportunities exist for WQS ending in vegetated basin.

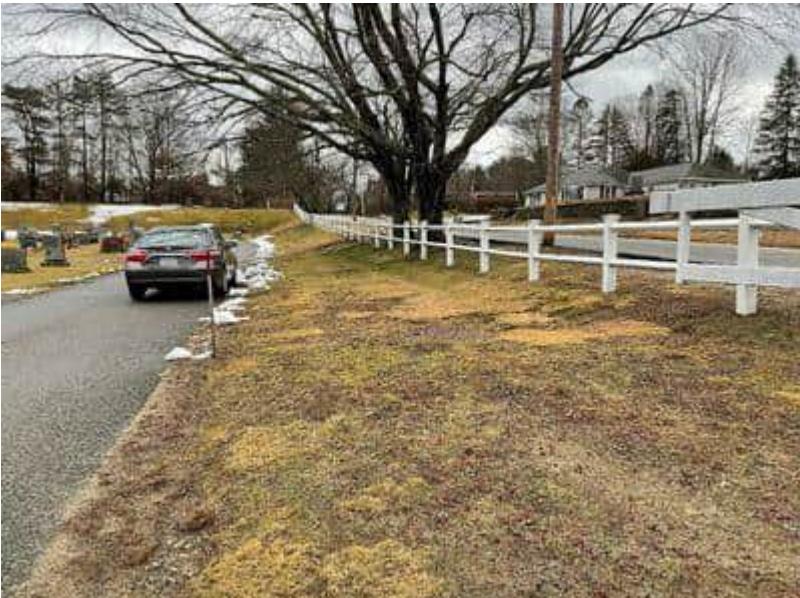
Steep slope along North Main Street, looking south.

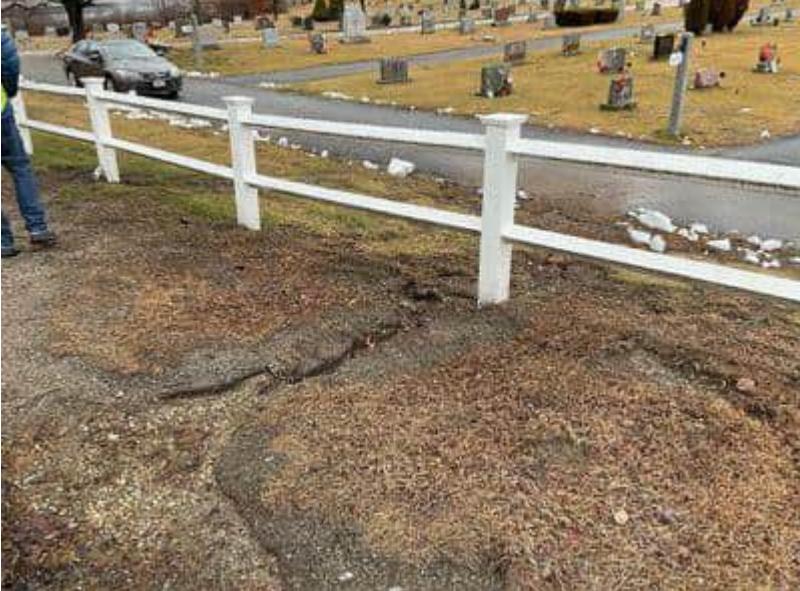
Land use at this cemetery is primarily devoted to gravesites; resultingly, limited opportunities exist for stormwater treatment. A naturalized swale collects roadway runoff along North Main Street and discharges onto the cemetery property – there is evidence of erosion and sedimentation in several locations. Inside the cemetery, erosion was observed along the shoreline of Pratt Pond, particularly in areas with steep slopes. The area between the shoreline roadway and the pond presents many opportunities for vegetation with a restoration seed mixture and stabilization. Additional opportunities for BMP retrofit installation include:

Channelized erosion entering site along North Main Street, with deposited sediment visible in background.

1. Formalizing the naturalized swale along North Main Street could provide treatment for the roadway runoff currently entering the cemetery. However, this may not be viable due to the existing mature trees, the utility pole, and the existing slope adjacent to the roadway. A linear infiltration practice could be installed along the west edge of the cemetery roads, but a small culvert would be needed to cross the main driveway. Erosion protection would be needed for any discharge into Pratt Pond.
2. The north driveway into the current brush stockpile area could be converted into an infiltration basin with a sediment forebay and vegetated filter strip. This would restrict access to the southern, east-west aligned driveway. The brush area, particularly the north driveway, currently receives stormwater runoff from the paved internal roadways north and northwest of the brush area.

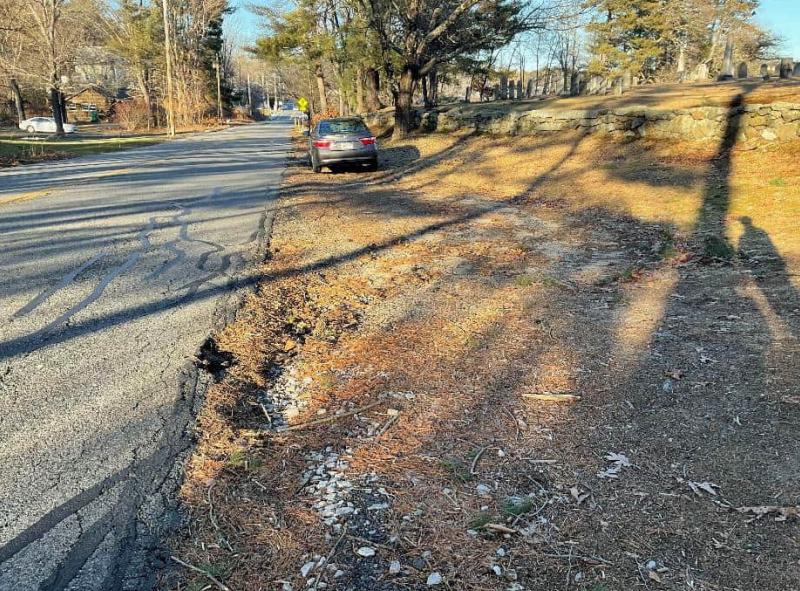
Existing channelized erosion along School St, facing north.

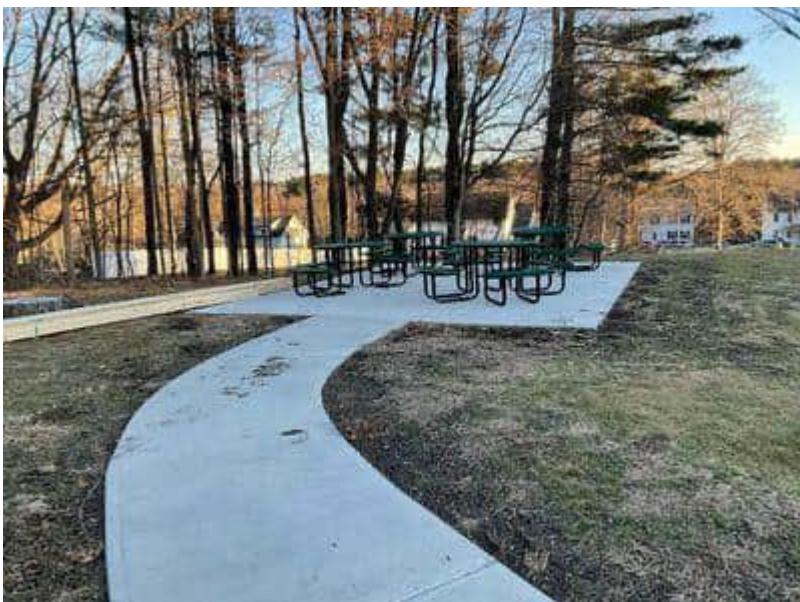
Newly constructed concrete patio and walkway, facing southeast.

4. The newly constructed concrete patio and walkway present another opportunity for the installation of a stone infiltration trench. The presence of lumber indicates construction is ongoing; if a picnic shelter or other roof structure was constructed, a stone drip edge along the perimeter could also be installed.

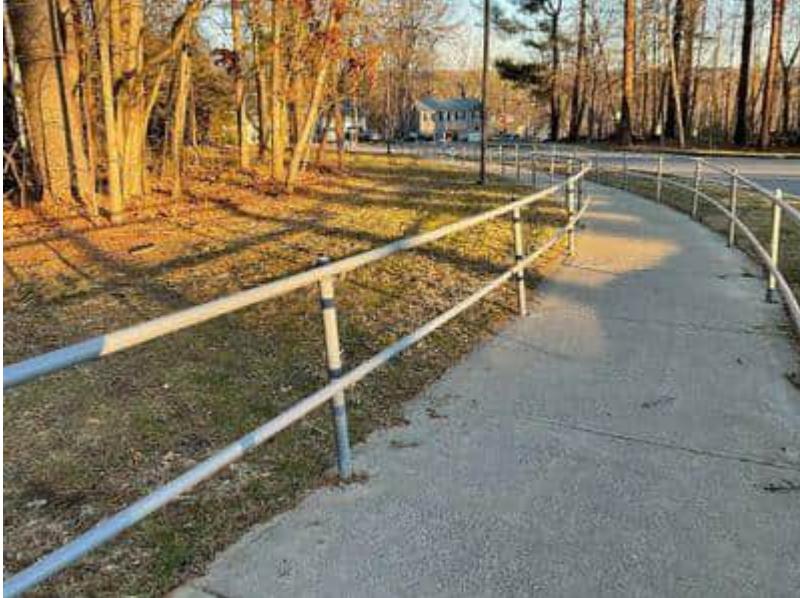
Sidewalk to Fiske Ave, facing east.

5. The sidewalk leading from the school to Fiske Avenue has a slight pitch (0.5%) north and drains downhill towards the street. Existing vegetation along both edges of the sidewalk may be channeling stormwater along the sidewalk itself; there is an opportunity for installation of a water quality swale with check dams along the north edge of this sidewalk to reroute and infiltrate stormwater.

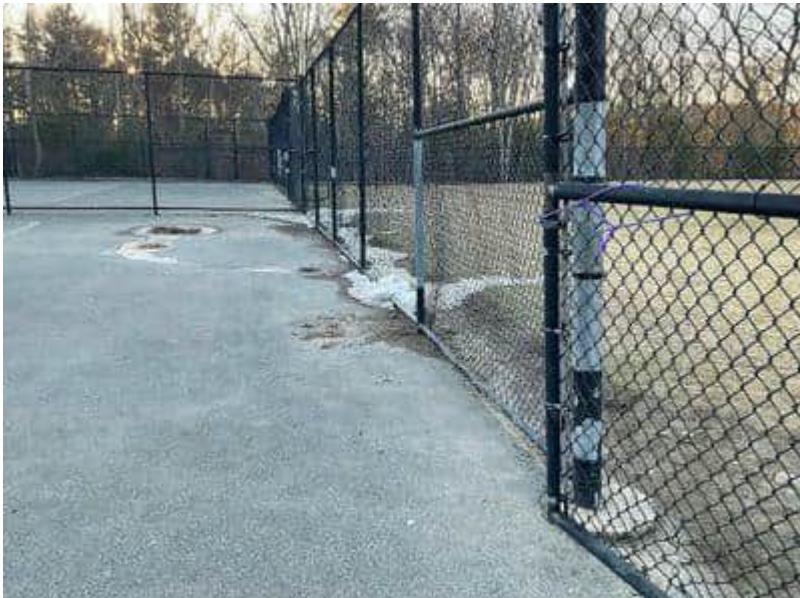
Evidence of ponding along back of basketball courts, facing west.

1. There is an opportunity to install a stone infiltration trench with a subdrain connected to the existing catch basin north of the school basketball courts. Ponding was observed on the court playing surface – installation of an infiltration trench along the north edge of the court would capture this water and allow it to infiltrate naturally. Any overflow would outlet to the connected catch basin.

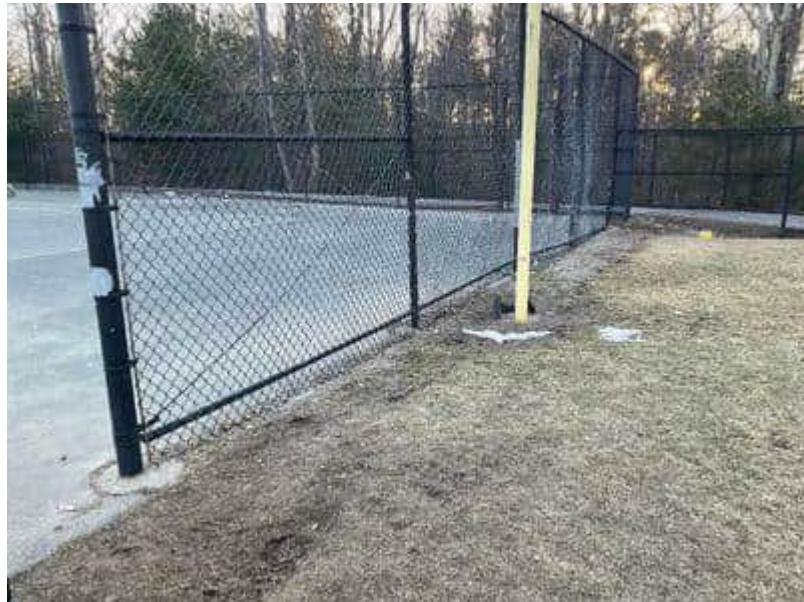
Grade change and soil accumulation at north end of basketball court, facing west.

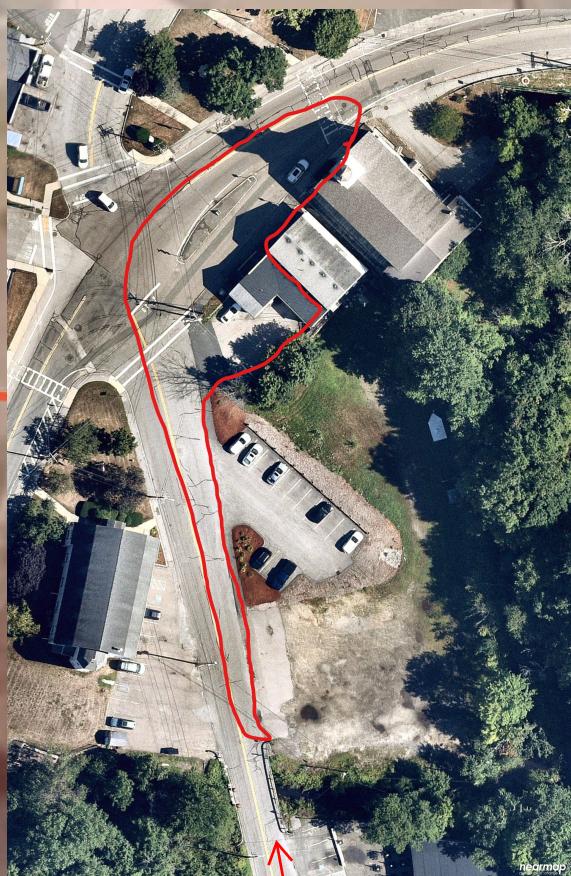
Flow from street follows gutter and discharges directly to brook from a paved waterway. Watershed to this point includes half of the roadway and is depicted in aerial photo.

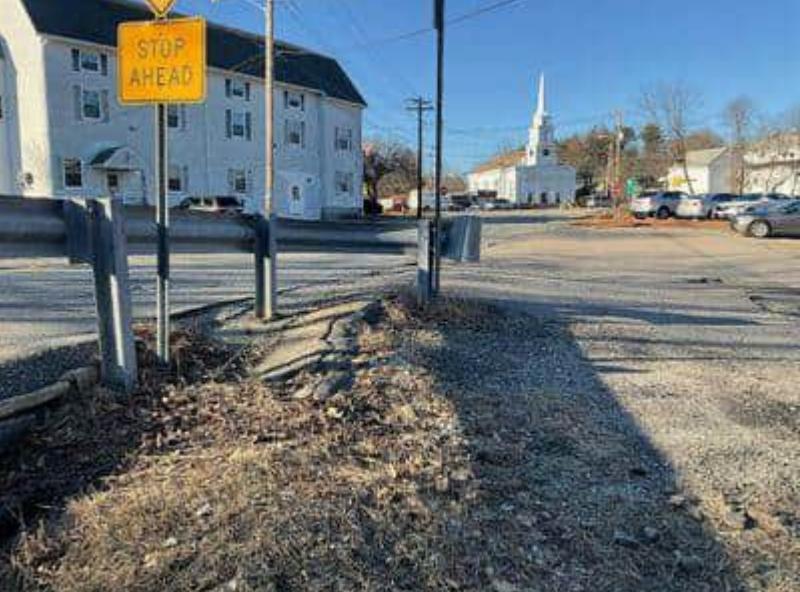
Existing conditions on this parcel include a paved waterway flowing from Grove Street directly to Center Brook, capturing a large impervious catchment from Main Street and the eastern half of Grove St (see Attachment 1 for detail on catchment). Multiple low areas with shallow mud were observed near the east edge of the lot along Center Brook. Most of the surface of this parcel is compacted gravel.

A photograph of a paved waterway or drainage channel. A yellow "STOP AHEAD" sign is visible on the left. In the background, there are buildings, trees, and a parking lot under a clear blue sky.	Existing paved waterway from Grove Ave, facing north.

Rerouting the existing paved waterway to a water quality swale with check dams along the south edge of the parcel would provide significant treatment of impervious stormwater runoff. The swale would then outlet to Center Brook with riprap outlet protection. Along the east edge of the parcel, an opportunity exists to install a shallow infiltration basin with a sediment forebay for pretreatment; overflow would flow to Center Brook through a stone spillway.
