Holy Angels Church

CRITERIUM-DUDKA ENGINEERS

Status

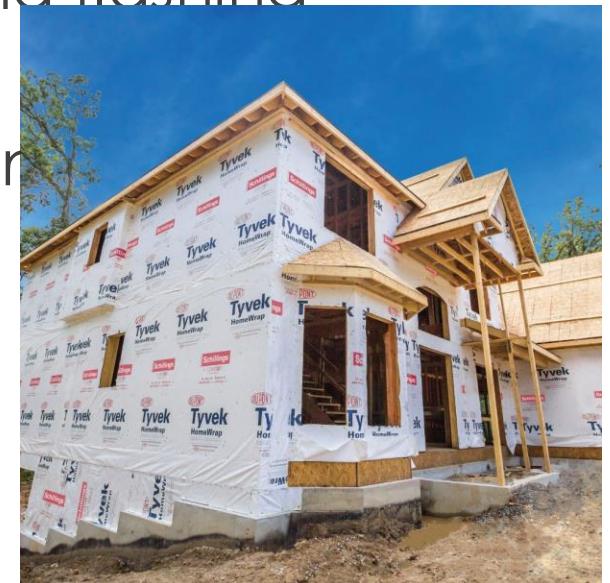
- Siding consists of board sheathing, shiplap, clapboards/trim, & paint.
- It is missing industry standard weather barrier and flashing between sheathing and Clapboards
- Water Intrusion will continue with paint as the long term protection

- Before Painting, within the year;
 - Replace rotted siding, wall studs, sill plates
 - Replace basement windows & doors with new construction windows and doors, repair rough openings and add flashing.
 - Replace the roof with emphasis on flashing around the steeple
 - Weatherproof the steeple
 - Mold Remediation
 - Foam insulation (closed cell or batt with vapor barrier)
 - Consider replacing clapboards and add weather barrier

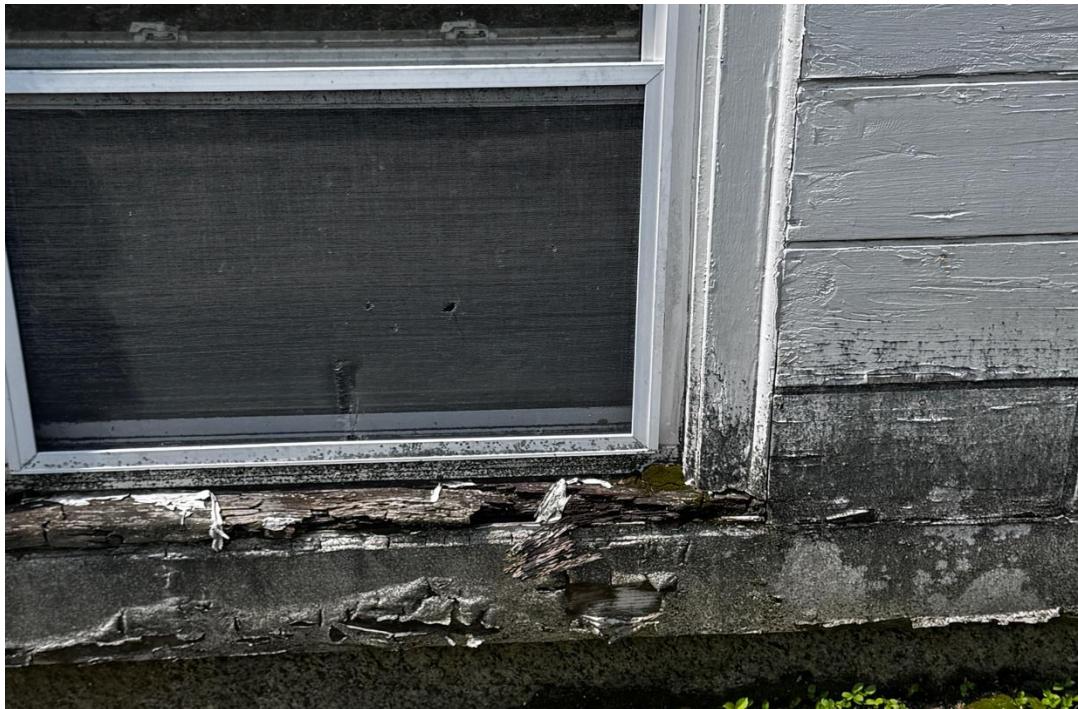
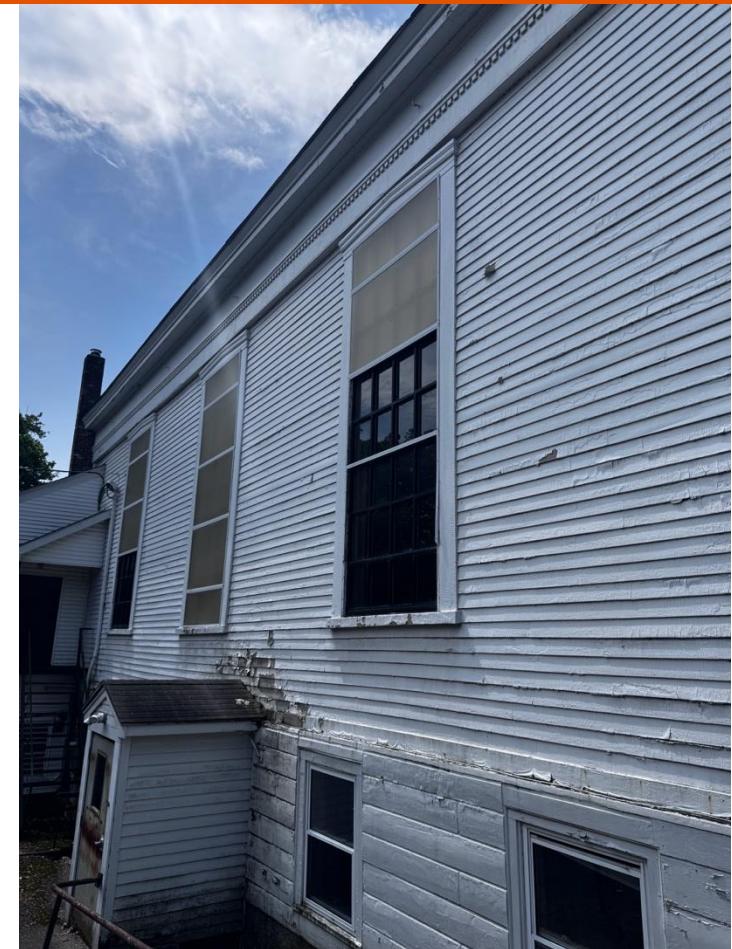
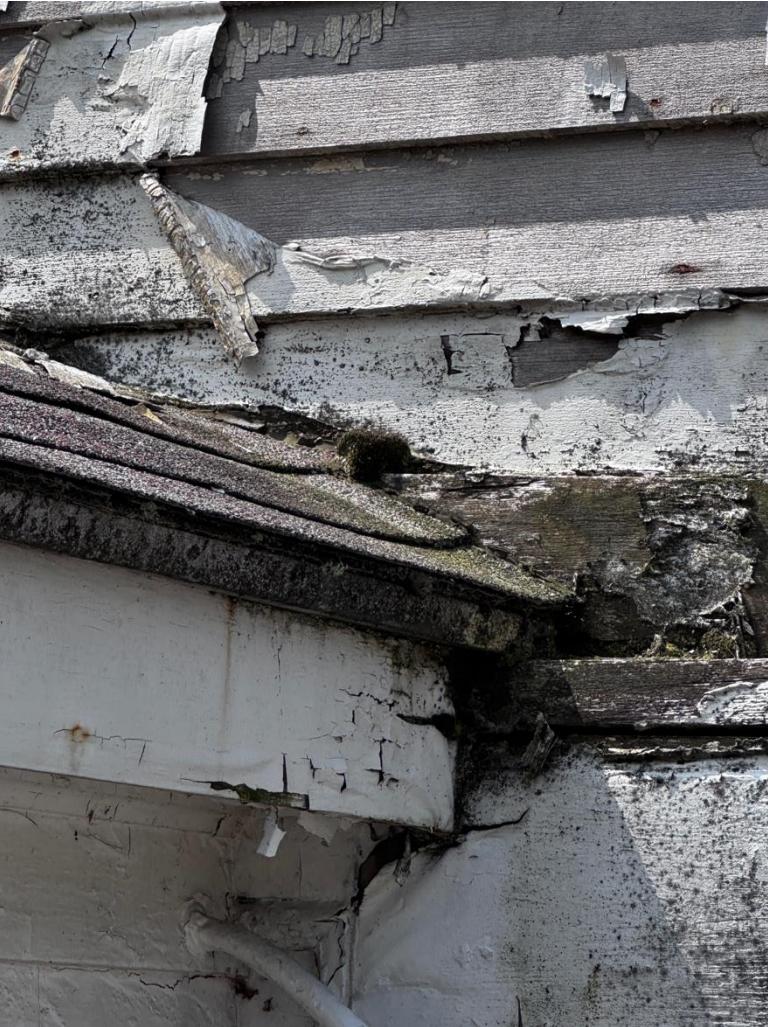
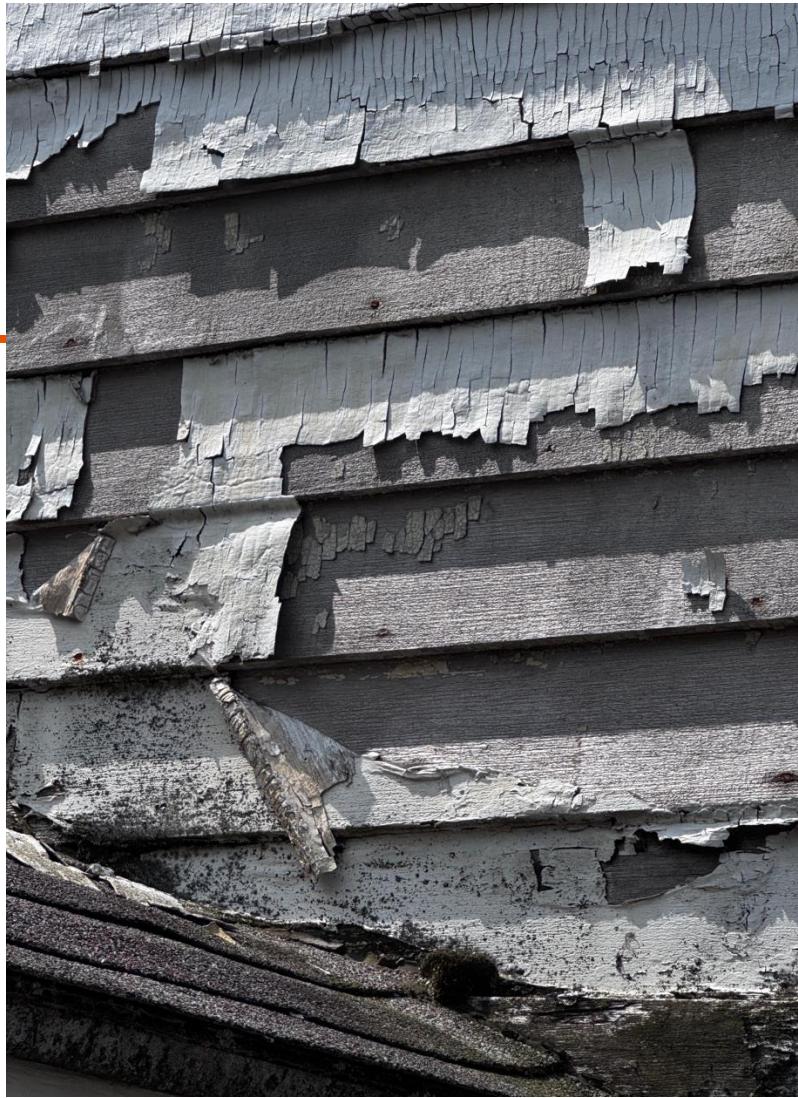
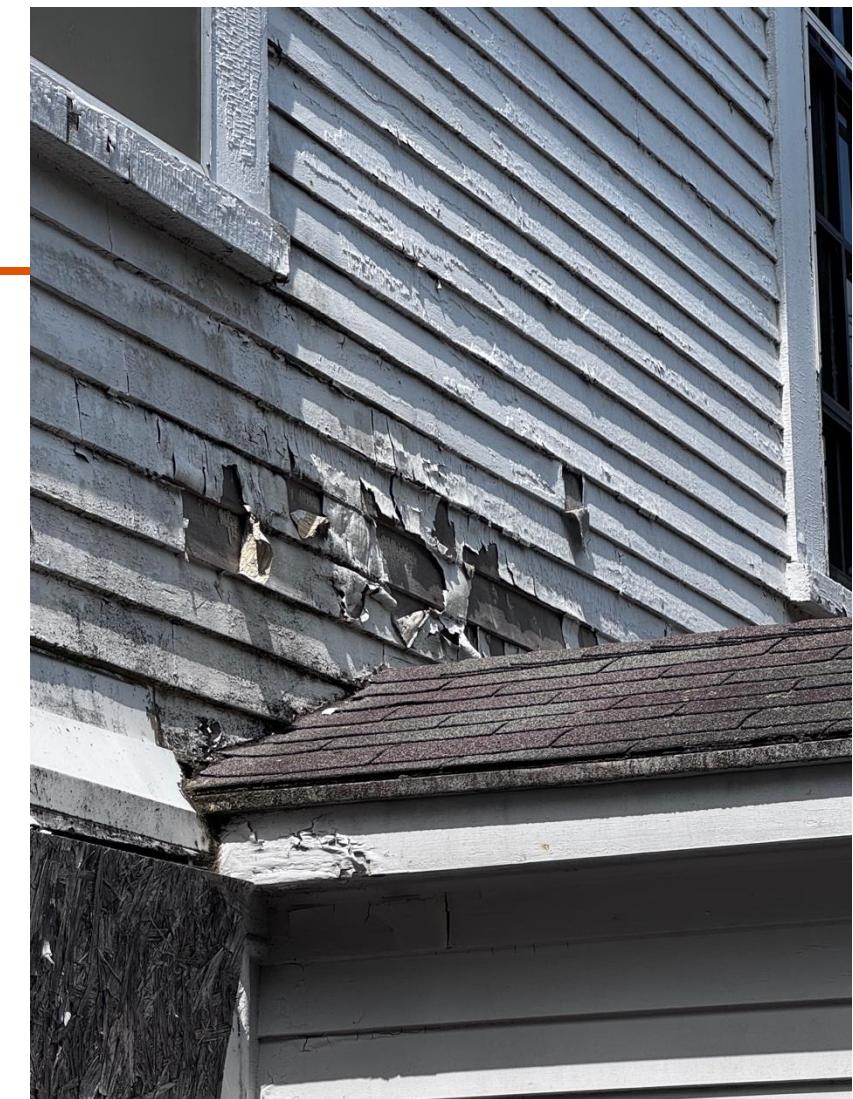
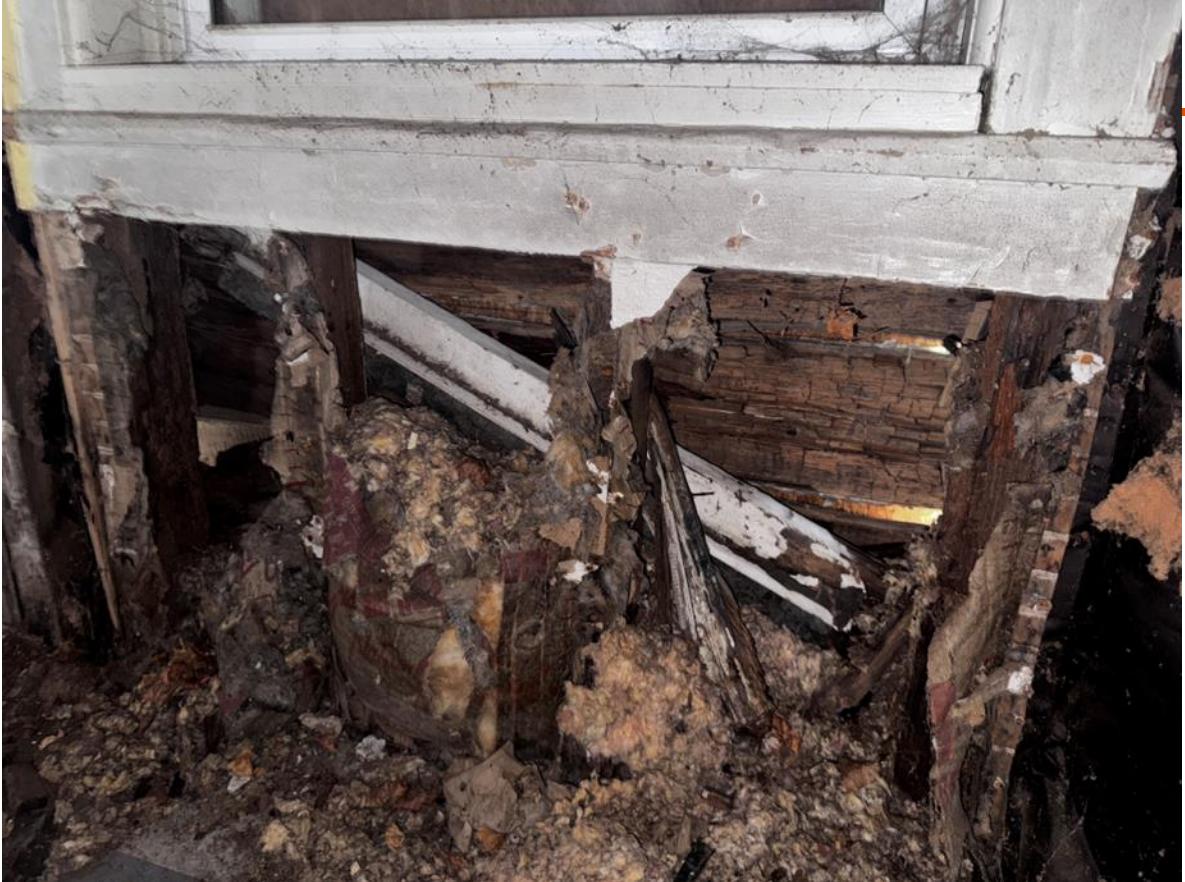
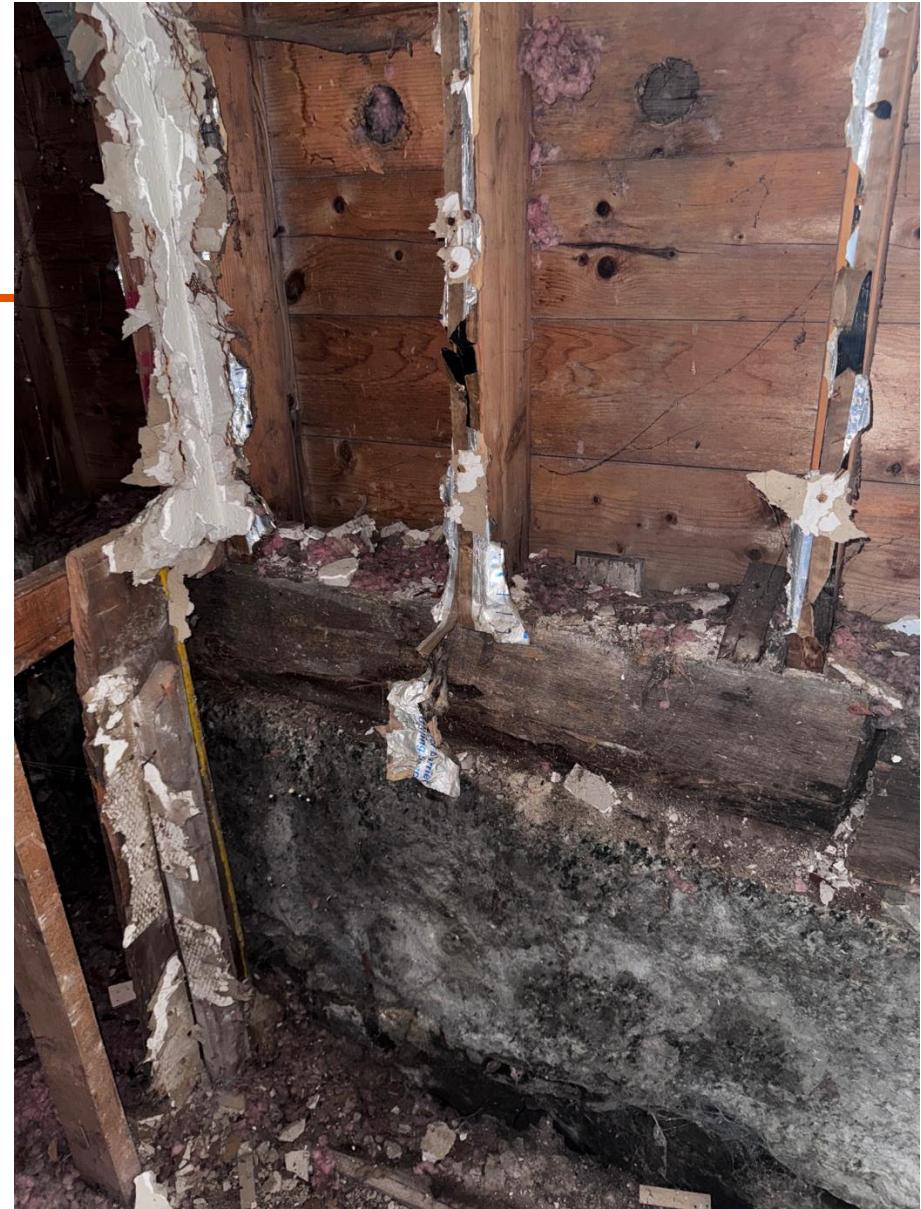
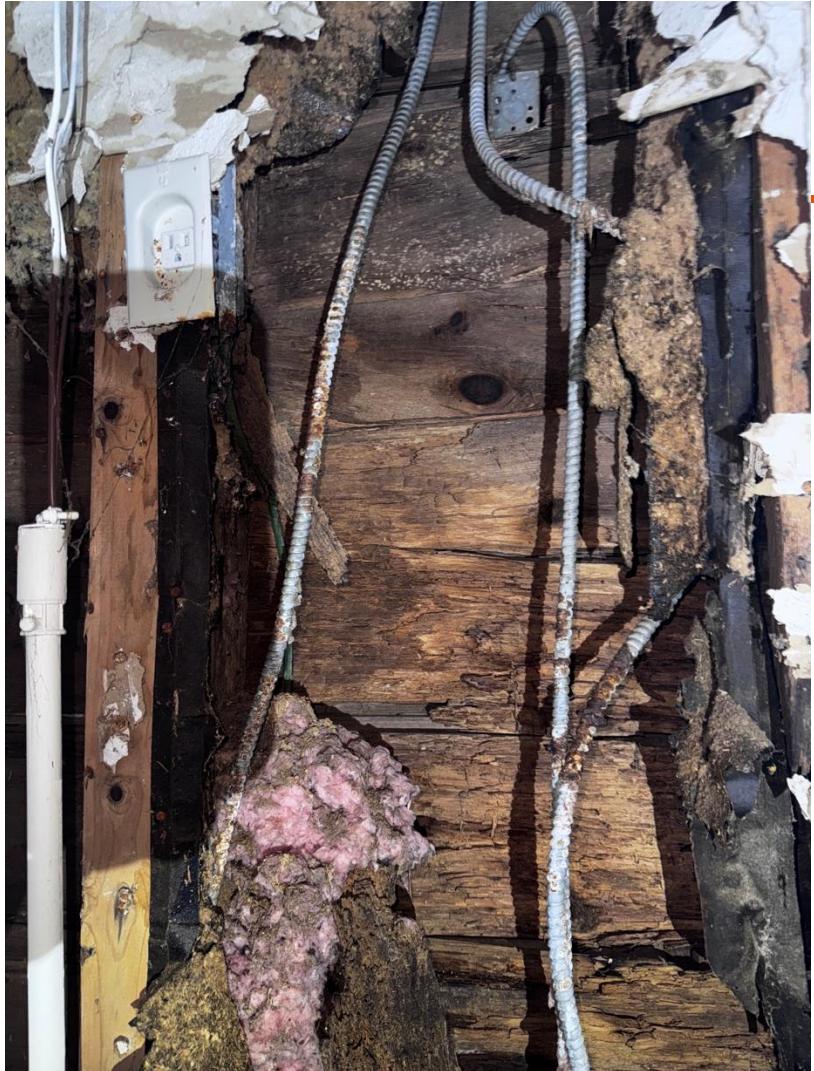
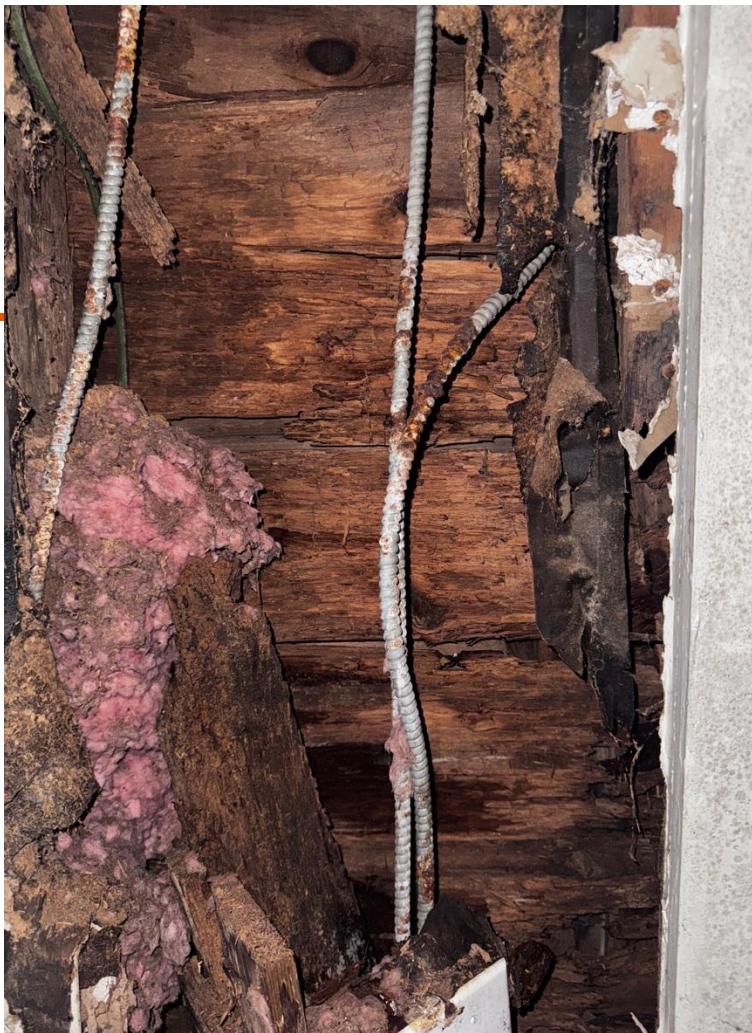
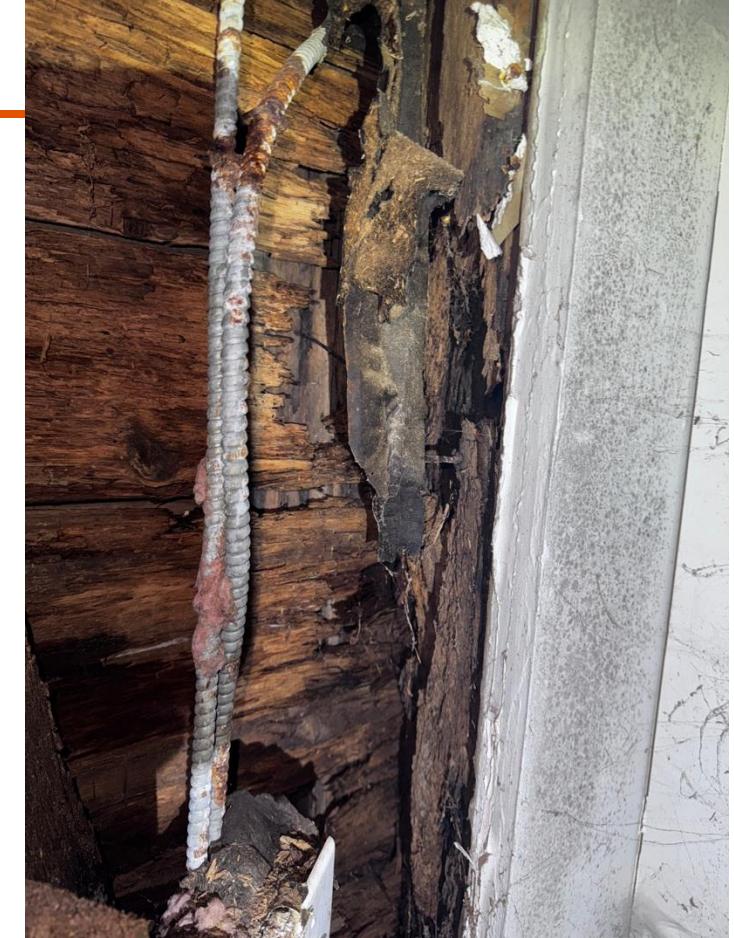
- Exterior Walls have considerable rot of the studs, siding, an some of the structural elements.
