Property: **Holy Angels Church**

Service: **Asbestos, Lead Paint, Mold, and Radon Sampling Report**

ACM, LEAD PAINT, MOLD, AND RADON SAMPLING REPORT

**Holy Angels Church
3 Milford St
Upton, MA, 01568**

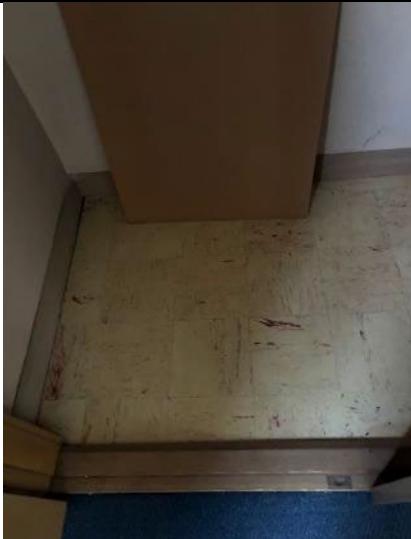
Asbestos containing tan 9" x 9" flooring in the first floor

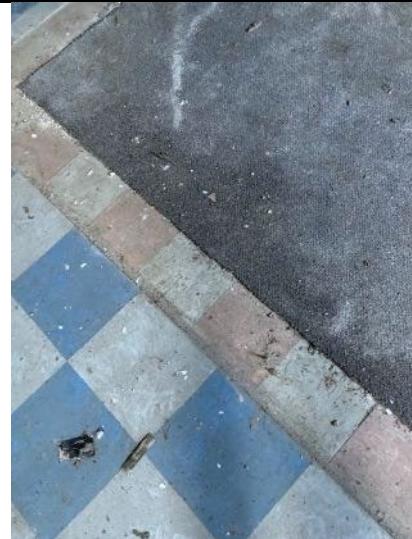
Asbestos containing pink and white 9" x 9" floor and black mastic is throughout basement

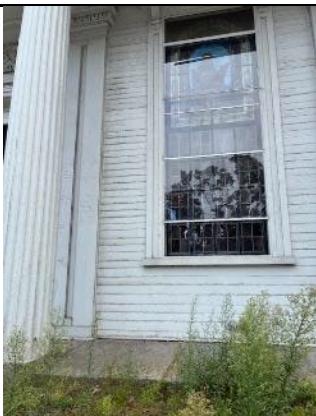
Asbestos containing tan caulking is present under exterior wood siding

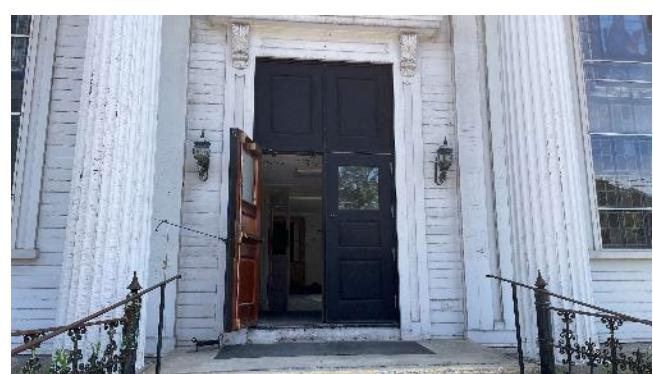
Lead-based paint on metal railings and front columns

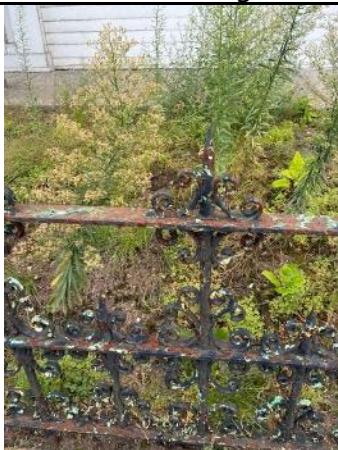
Lead-based black paint on metal railing

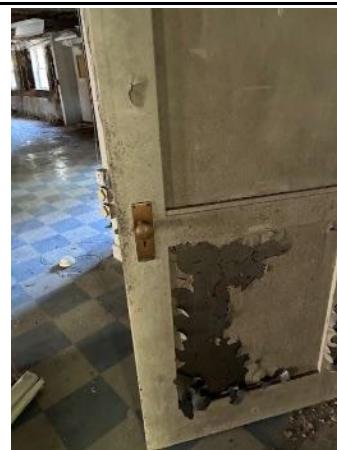
Lead-based white paint on metal door in basement

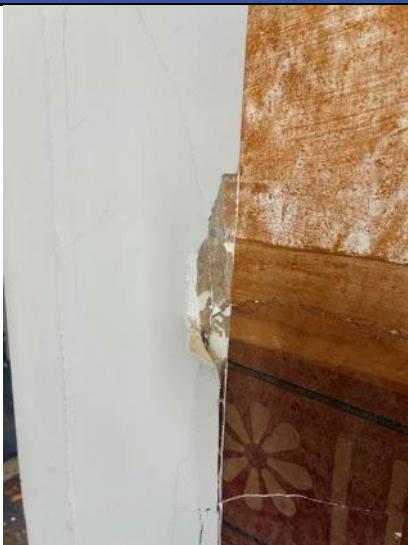
Lead-based red paint on plaster

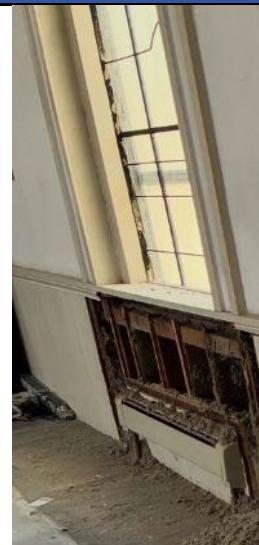
Lead-based black paint on stone around window sill

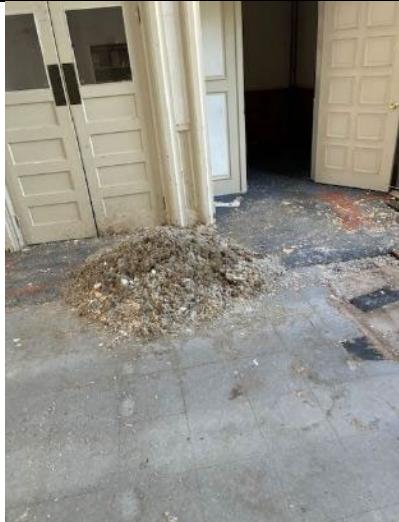
Overview of 1st floor – asbestos containing tan 9" x 9"
Floor tile extends beneath gray tile and carpeting

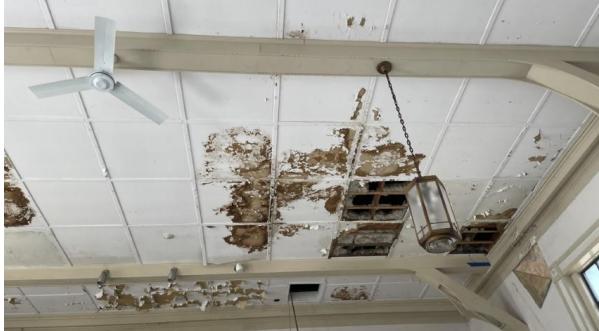
Overview of the main floor	View of the affected ceiling on the main floor

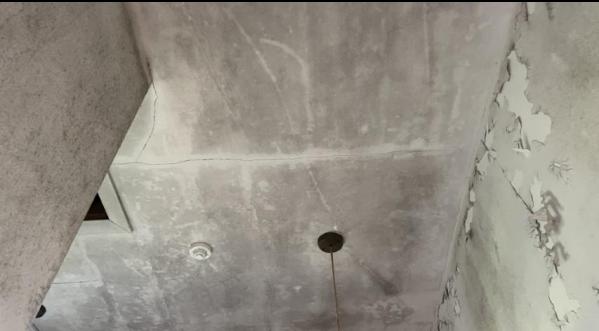
View of visible microbial growth on walls and ceilings in the basement	Overview of the basement

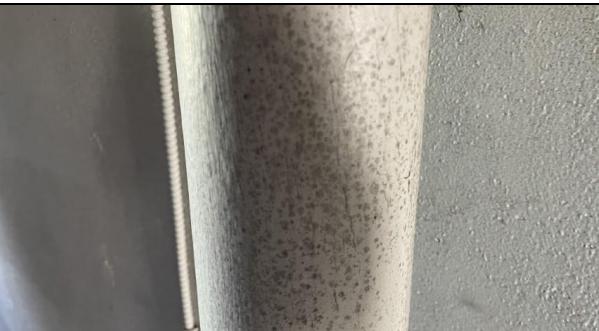
Detail of visible microbial growth on a wall in the basement	View of thermal abnormalities observed

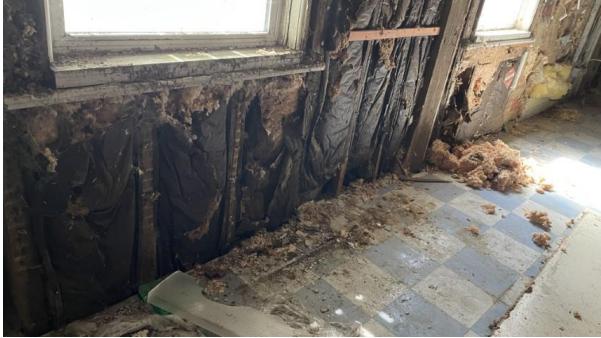
Overview of the main floor entrance	Detail of damaged basement insulation

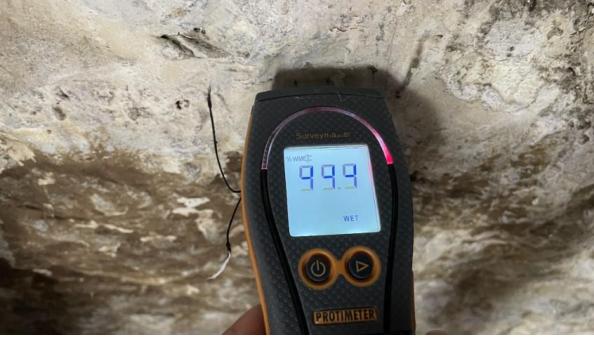
Detail of elevated moisture on the basement stone foundation	View of the basement subfloor

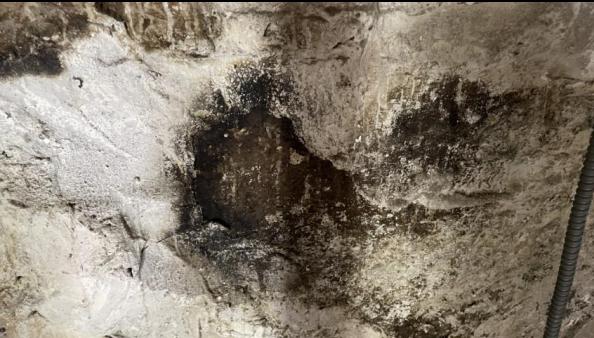
View of heavy microbial growth on the basement foundation	View of the basement bathroom
