STRUCTURAL EVALUATION

Holy Angels Church
3 Milford Street
Upton, MA

April 26, 2019

Project Number: 19-0104-MA
Date of Inspection: April 4, 2019
Engineers: H. Alan Mooney, P.E.
Nate Powelson, P.E.

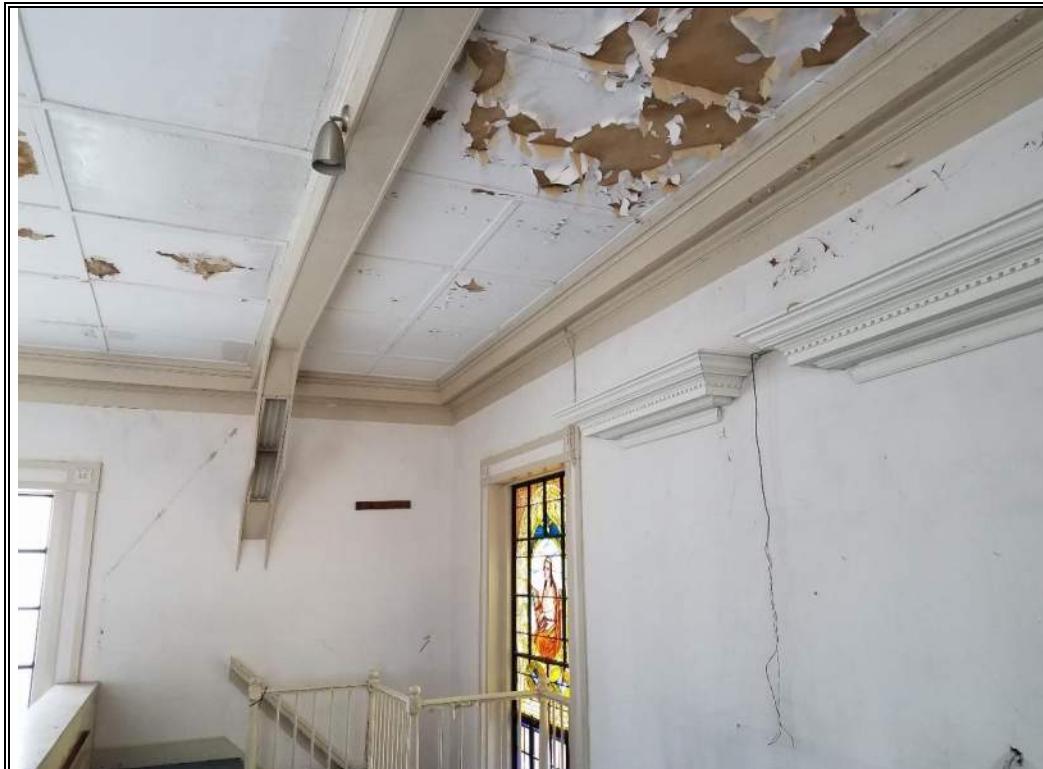
The most significant area of water intrusion is around the bell tower. There are water stains on the ceiling of the balcony, most likely the result of wind-driven rain entering the bell tower. That structure is not weather tight. It would be necessary, if the building is to be renovated, to enclose that bell tower in some way to assure weather-tightness.

Upper level
balcony showing
water intrusion
from bell tower
above

At this point, if the building is to remain unused for the foreseeable future, some effort to make the bell tower weather tight, at least temporarily, is recommended. Given the accessibility (height, steep roof, attic access), we suggest an allowance of \$7,000 to do that, and that would only provide a temporary solution, not a permanent one.

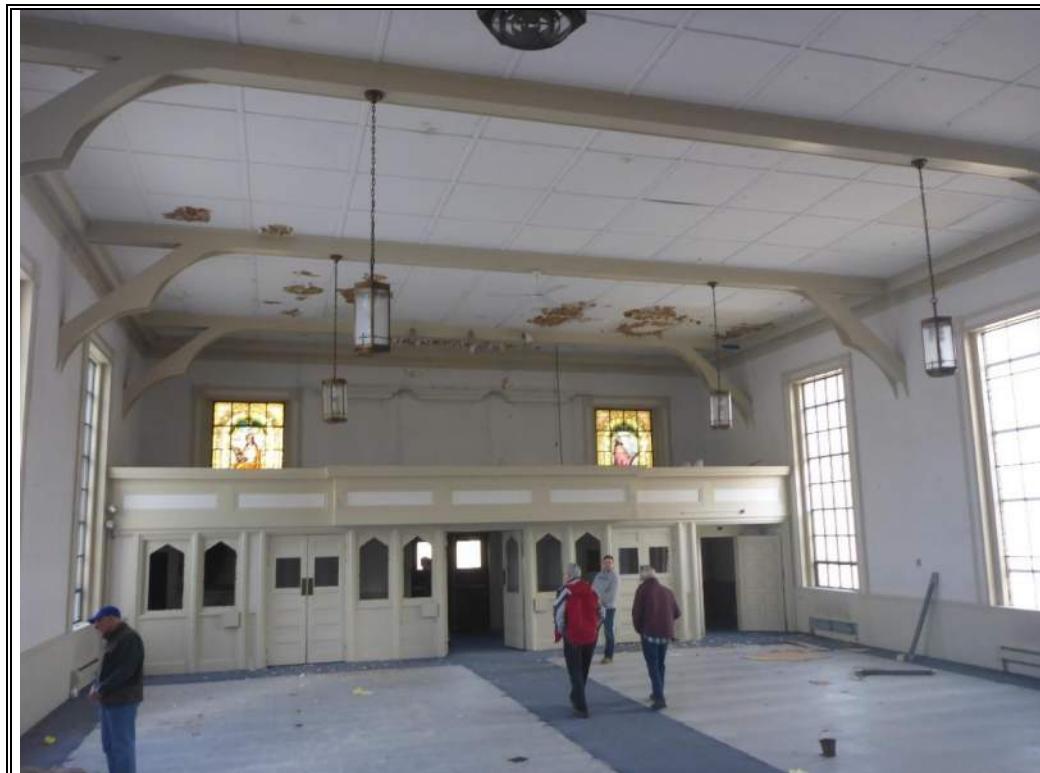
Upper level,
looking toward
balcony, showing
water intrusion
from bell tower
above

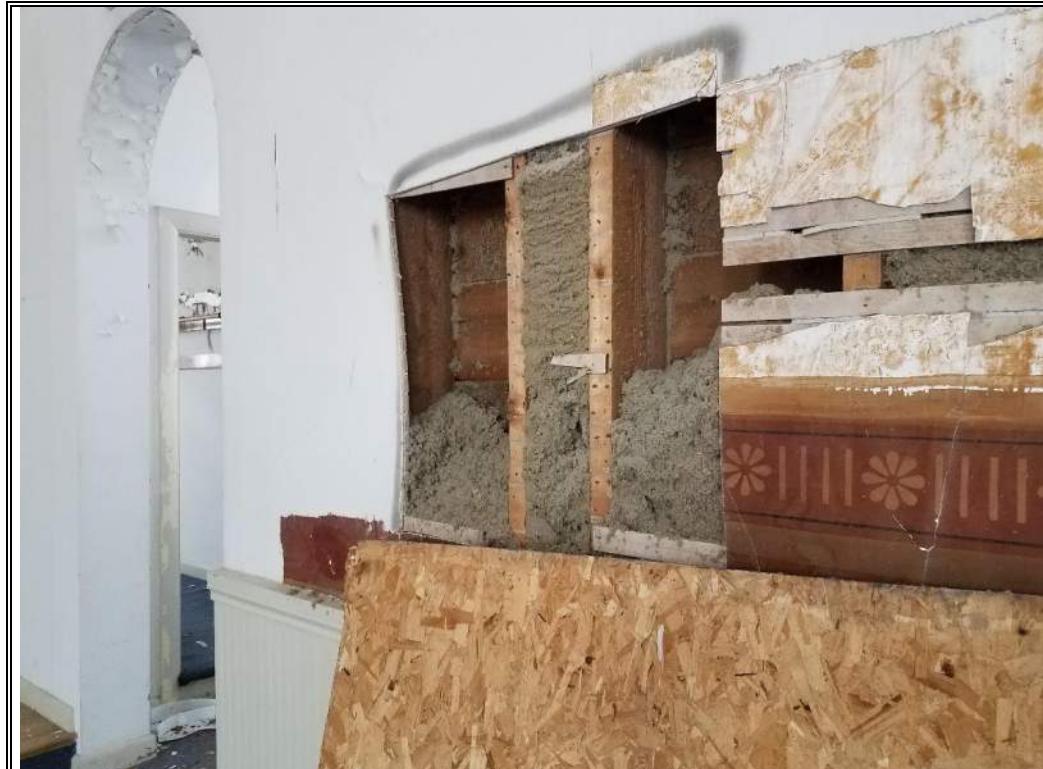
Photo Number
15

The interior finishes are what would be expected of a building of this age and construction type, and they are generally in fair condition at this time. The lower level finishes have been removed almost entirely. The main level finishes are still in place, but would need to be renovated for any future use. As noted, as the main level finishes are removed, there appears to be loose insulation in the wall cavity which should be tested for asbestos.

Upper level –
open wall, loose
insulation,
possible ACM

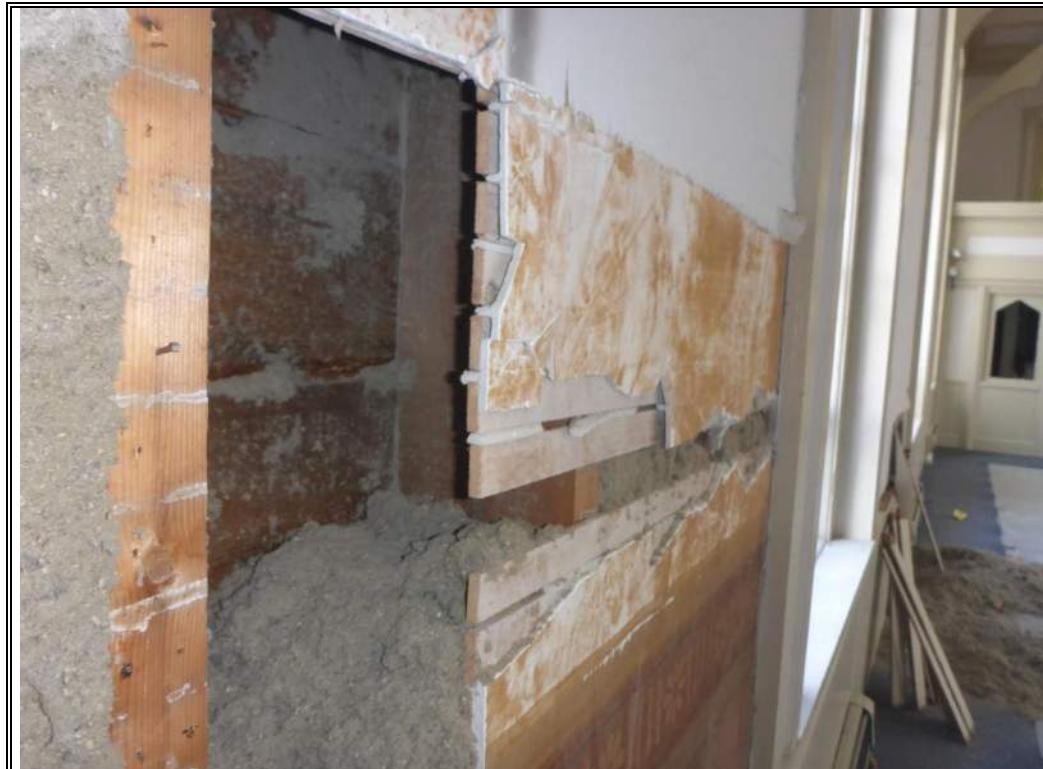
Upper level –
open wall, loose
insulation,
possible ACM,
plaster and lath
wall finish

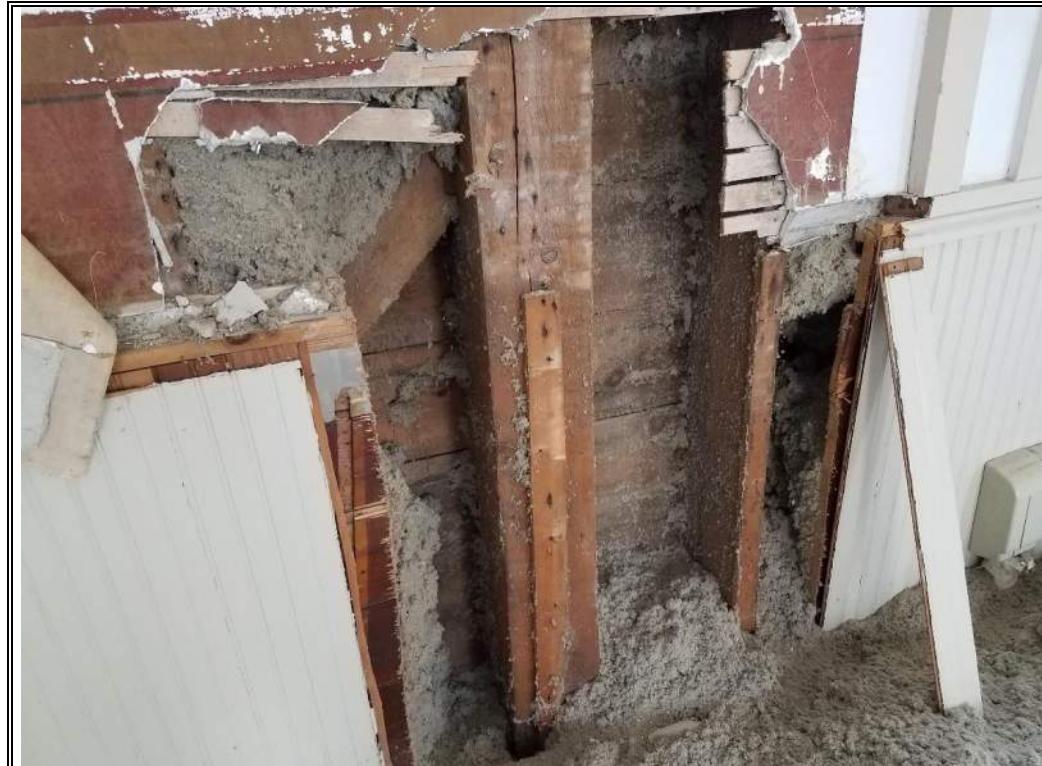
Photo Number
17

Upper level –
open wall, loose
insulation,
possible ACM,
wainscoting

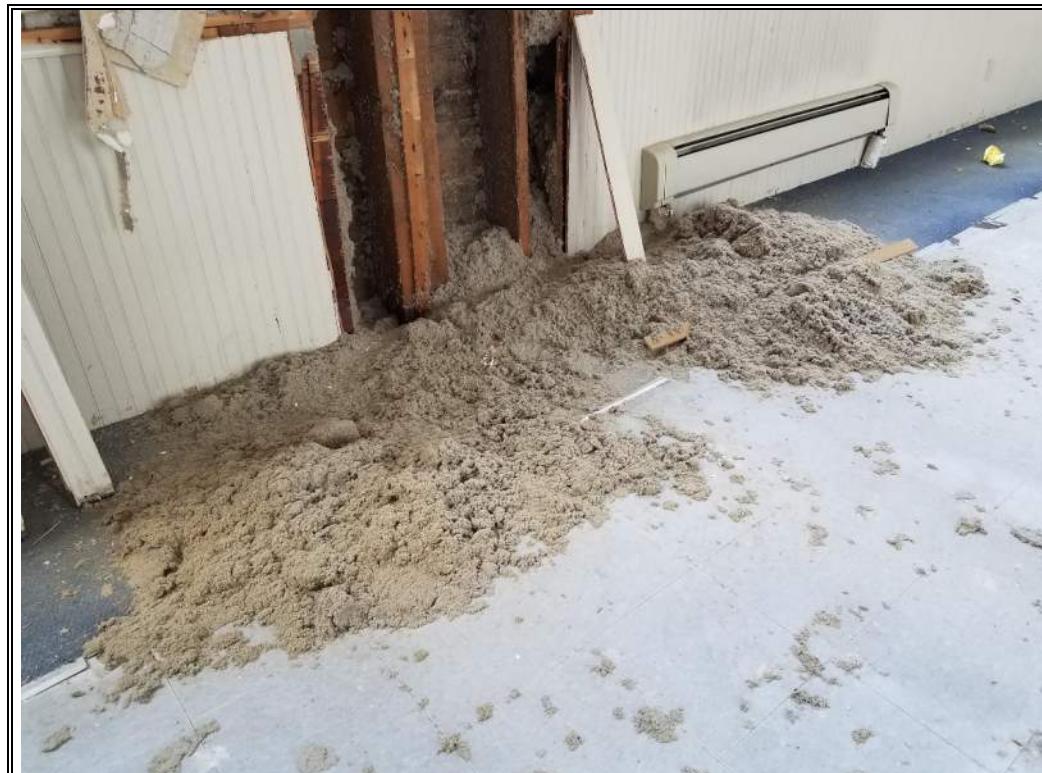
Upper level –
open wall, loose
insulation,
possible ACM,
wainscoting

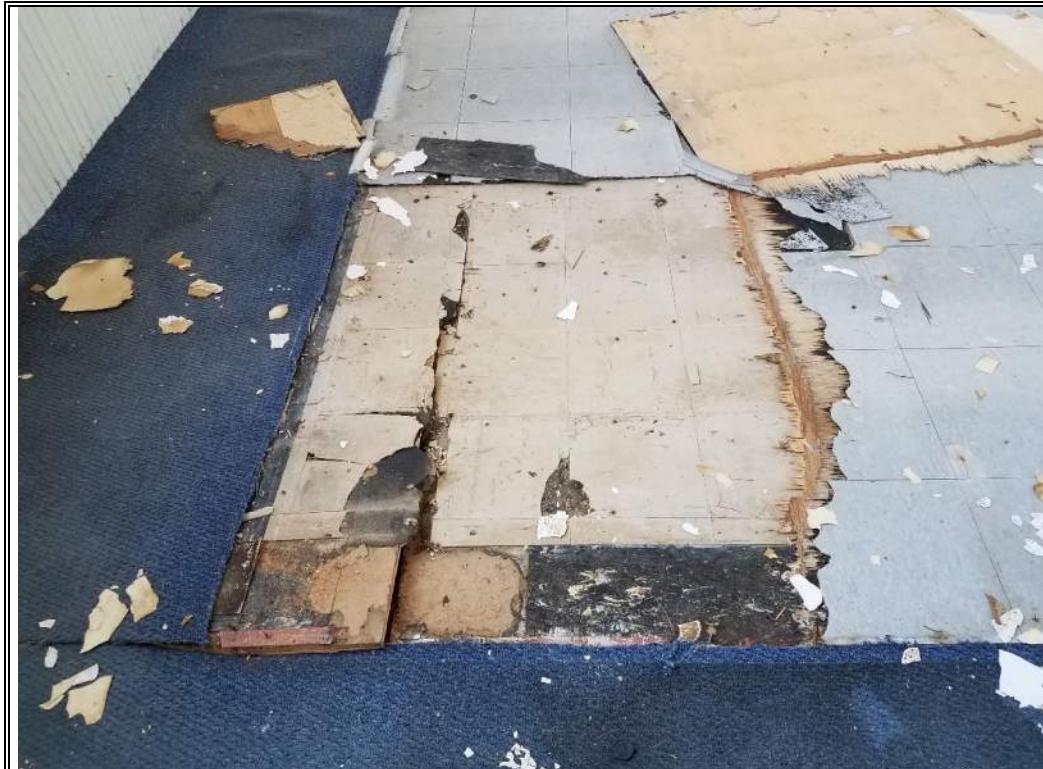
Photo Number
19

Upper level –
floor tile, likely
ACM tile layer
below the visible
layer

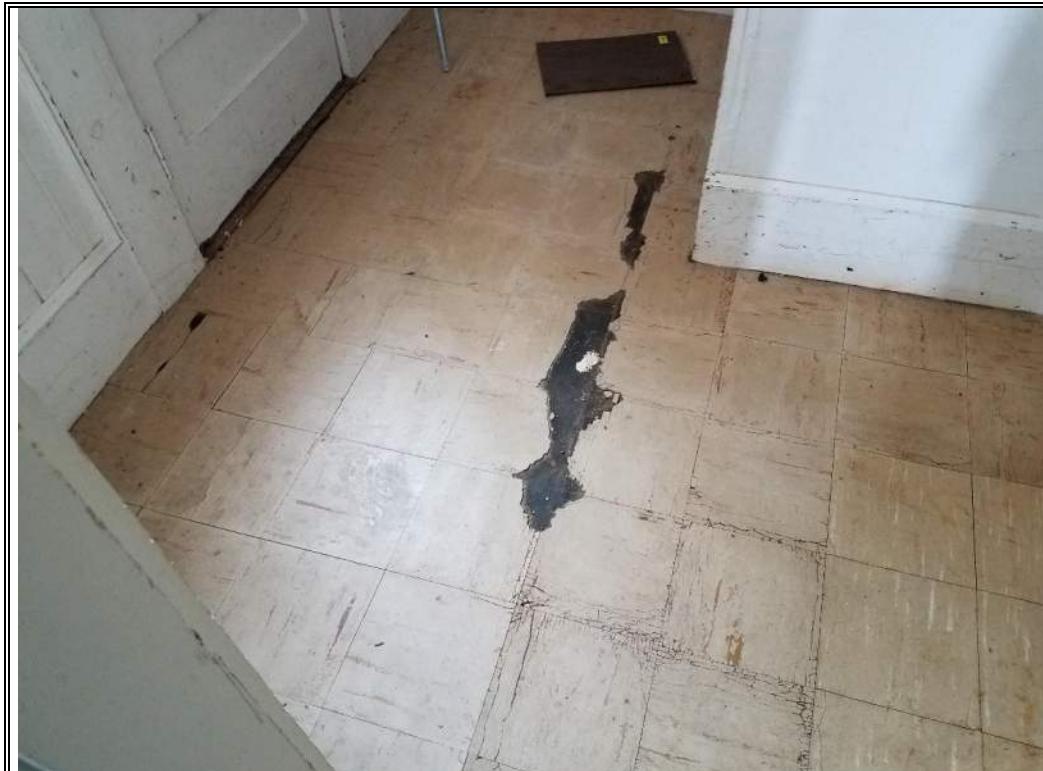
Upper level –
floor tile, likely
ACM tile layer
below the visible
layer

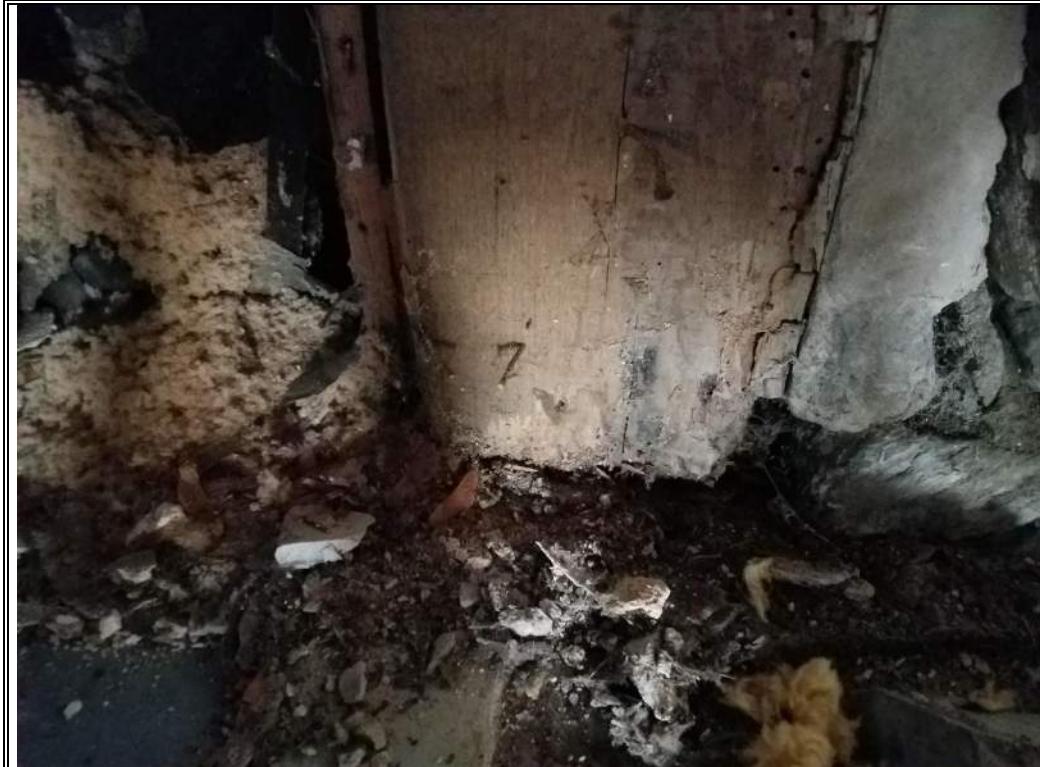
Photo Number
29

Lower level –
some rot where
wood is in contact
with ground

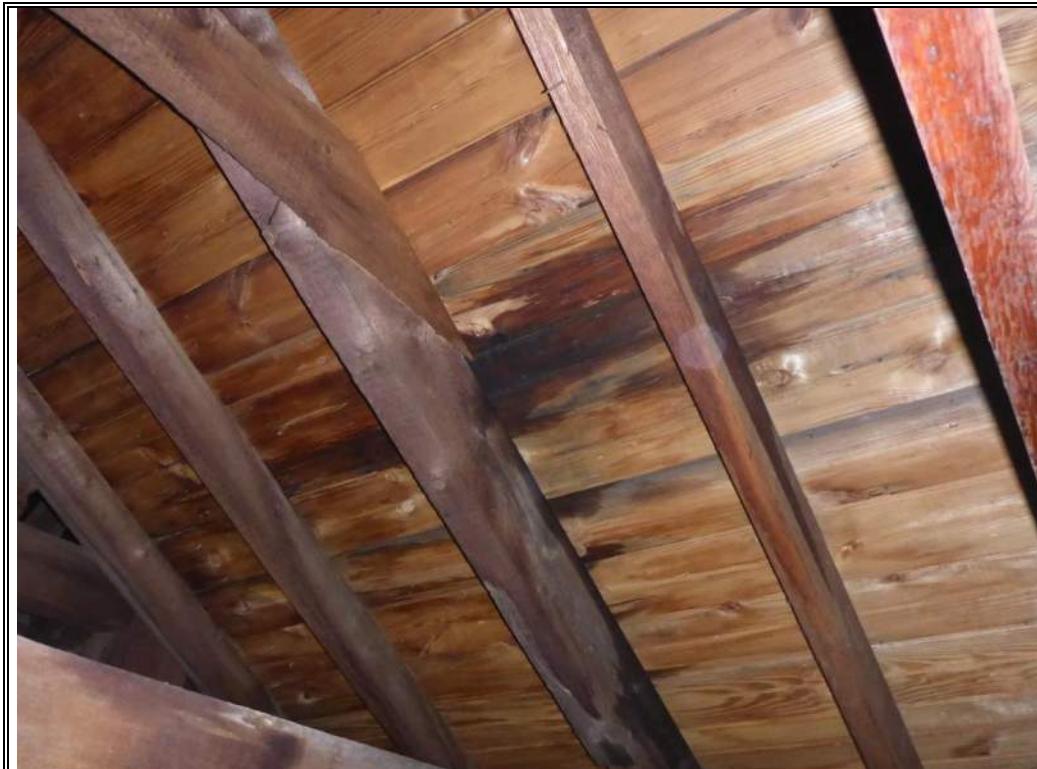
There is evidence of a few roof leaks which may be the result of ice dams and/or some flashing failure around the chimney, for example. These did not appear to be extensive, however.

Attic/roof –
typical framing,
some water stains,
likely predates
current roof
shingles

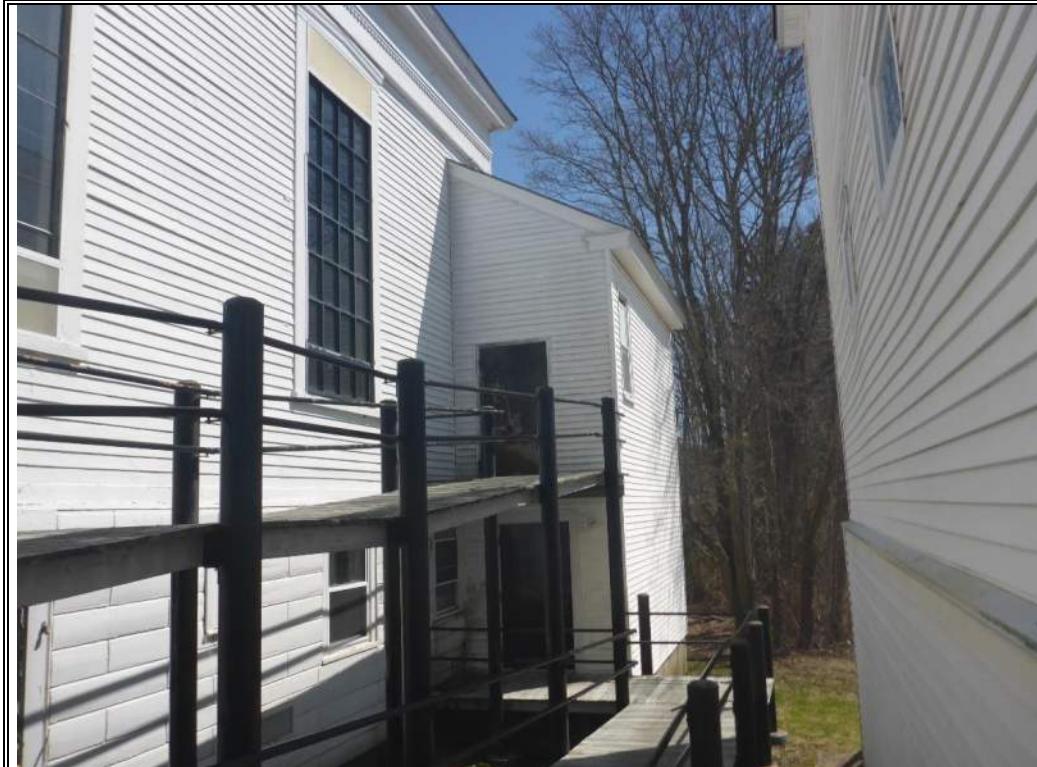
Photo Number
75

Deck/ramp – railings and structural integrity seriously deficient, unsafe for use.

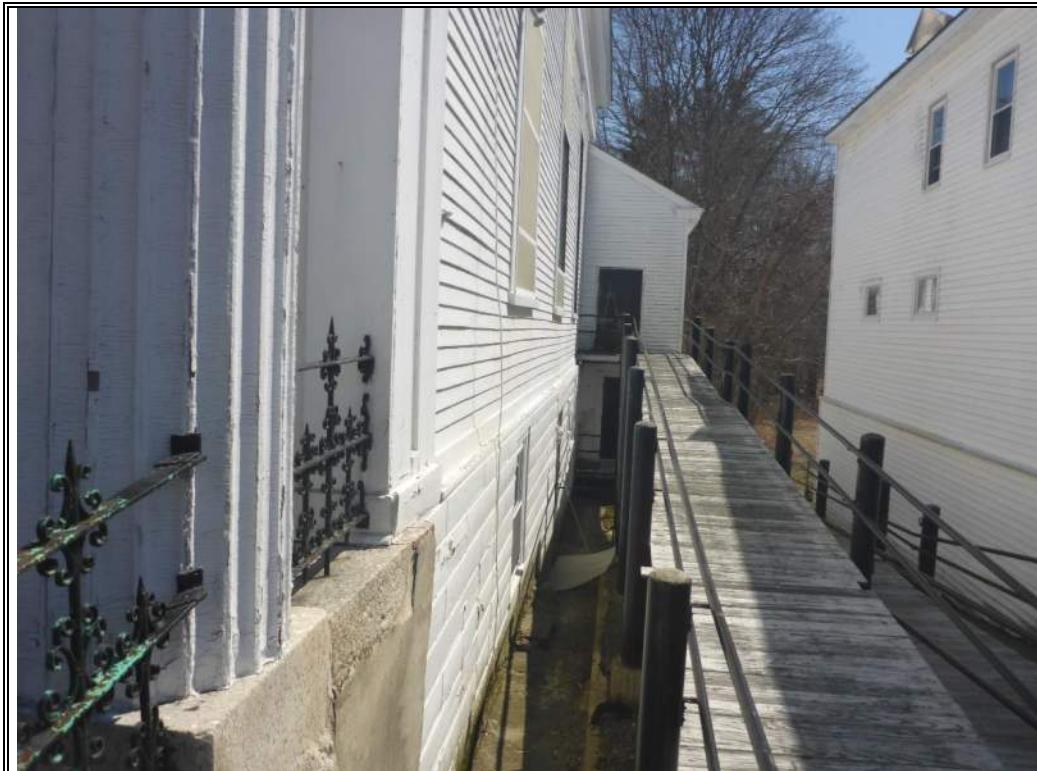
Deck/ramp – railings and structural integrity seriously deficient, unsafe for use.

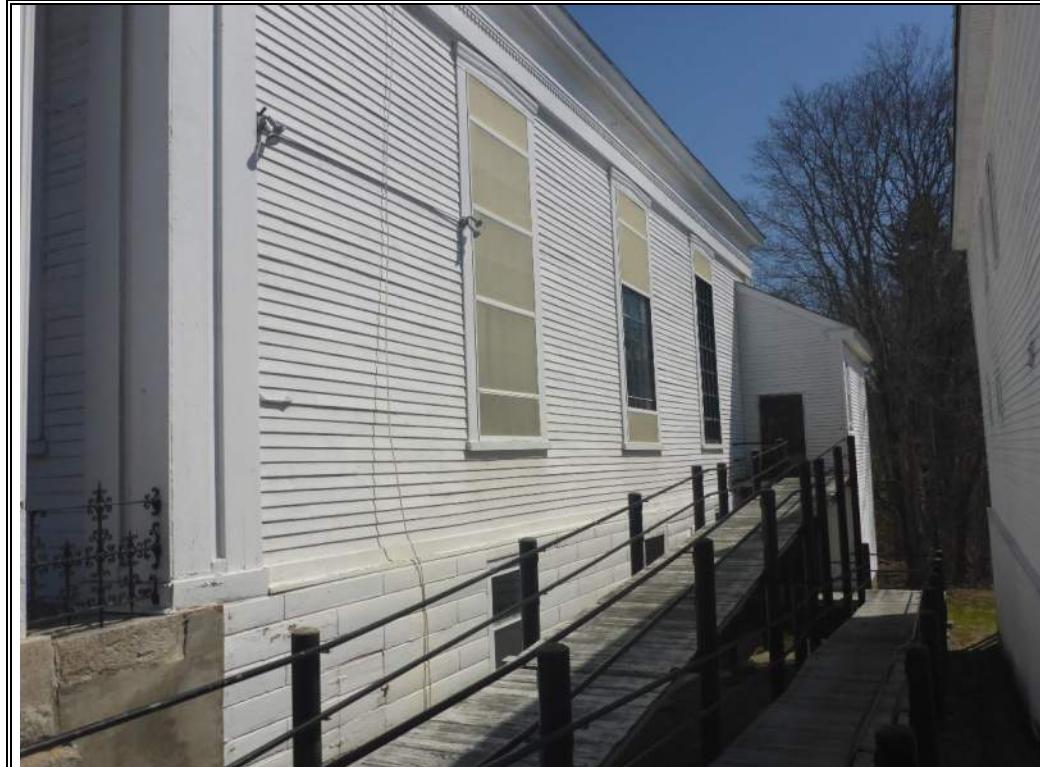
Deck/ramp – railings and structural integrity seriously deficient, unsafe for use.

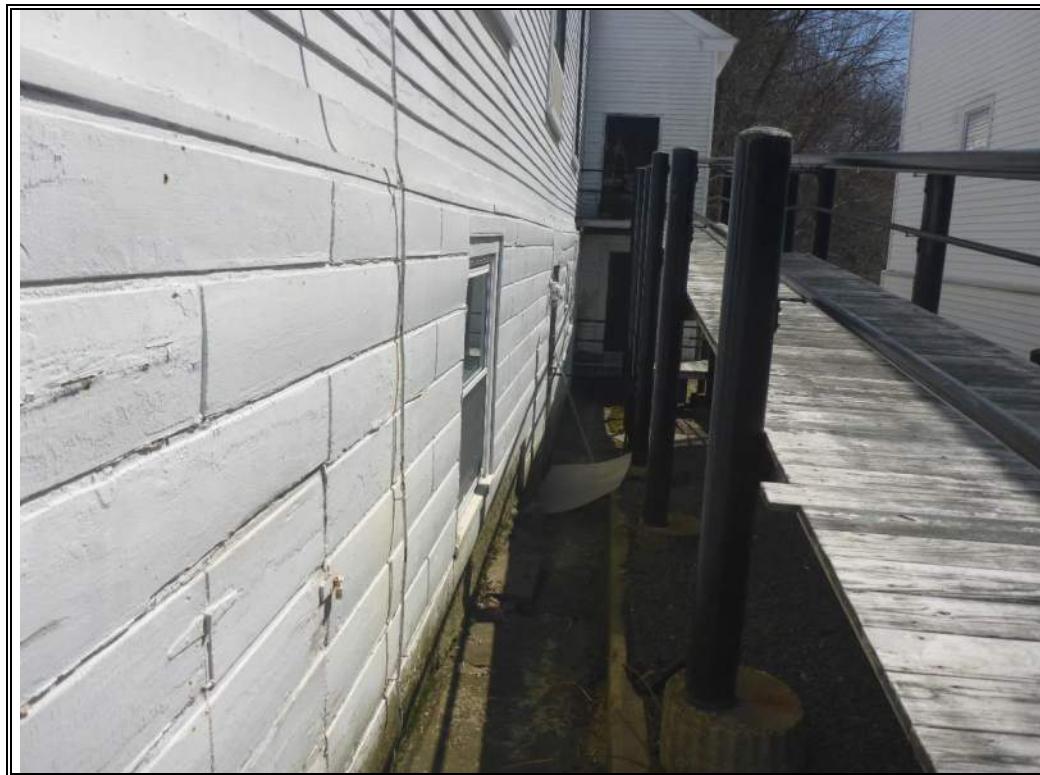
Deck/ramp – railings and structural integrity seriously deficient, unsafe for use.

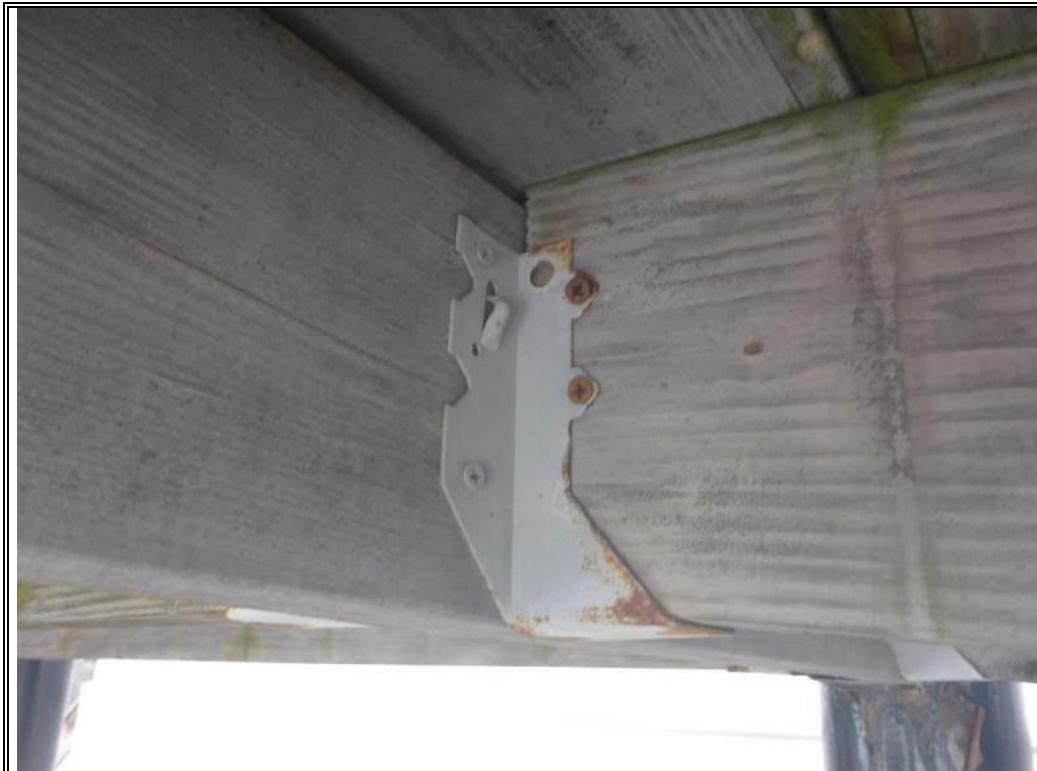
Deck/ramp – joist hangers improperly connected with sheetrock screws

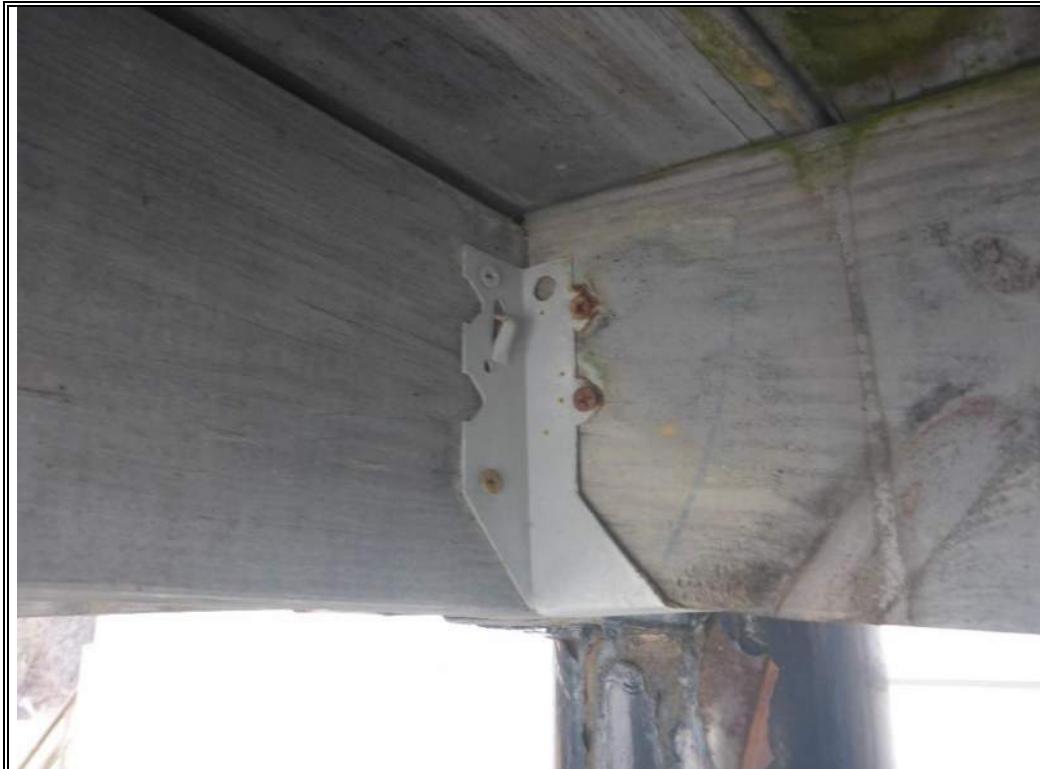
Photo Number
81

Deck/ramp – joist
hangers
improperly
connected with
sheetrock screws

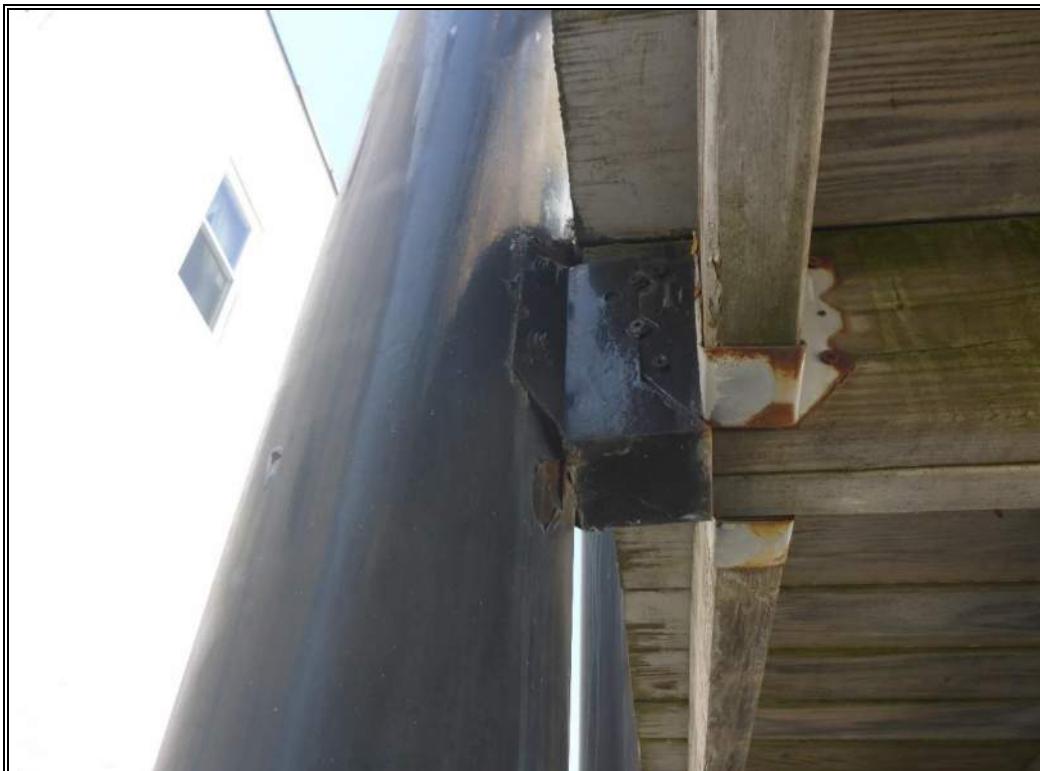
Deck/ramp – not
adequately
connected to posts

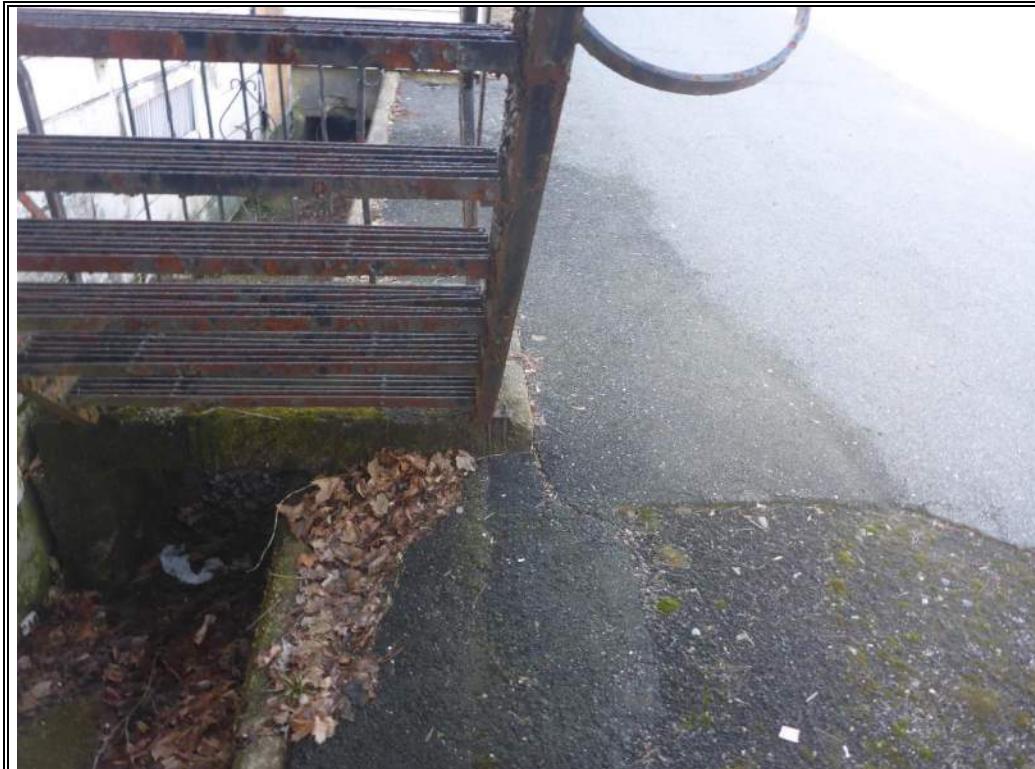
Photo Number
83

Left side stair,
corroded at base

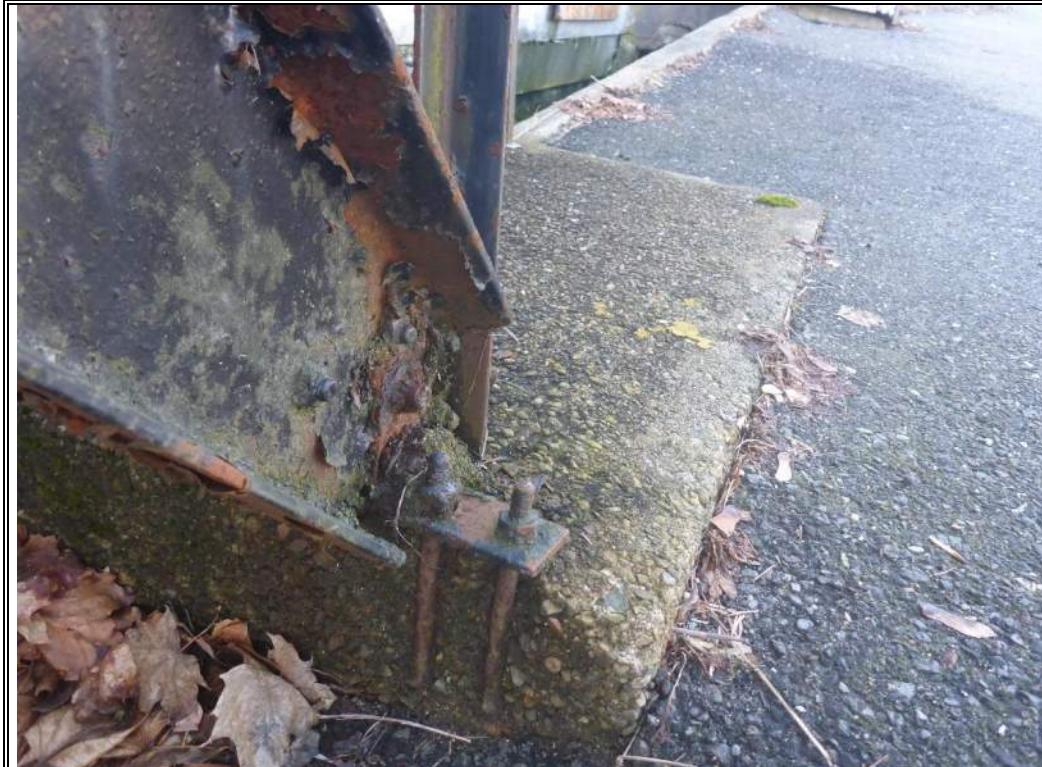
Photo Number
85

Left side stair,
corroded at base

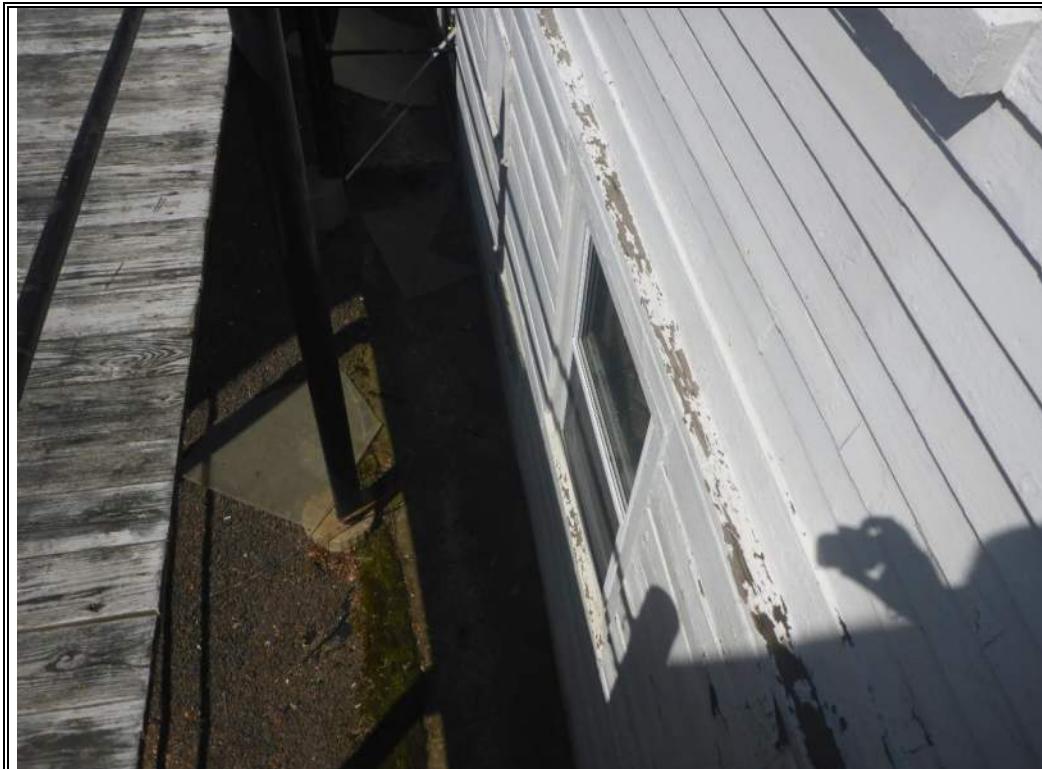
Exterior/details –
paint needed

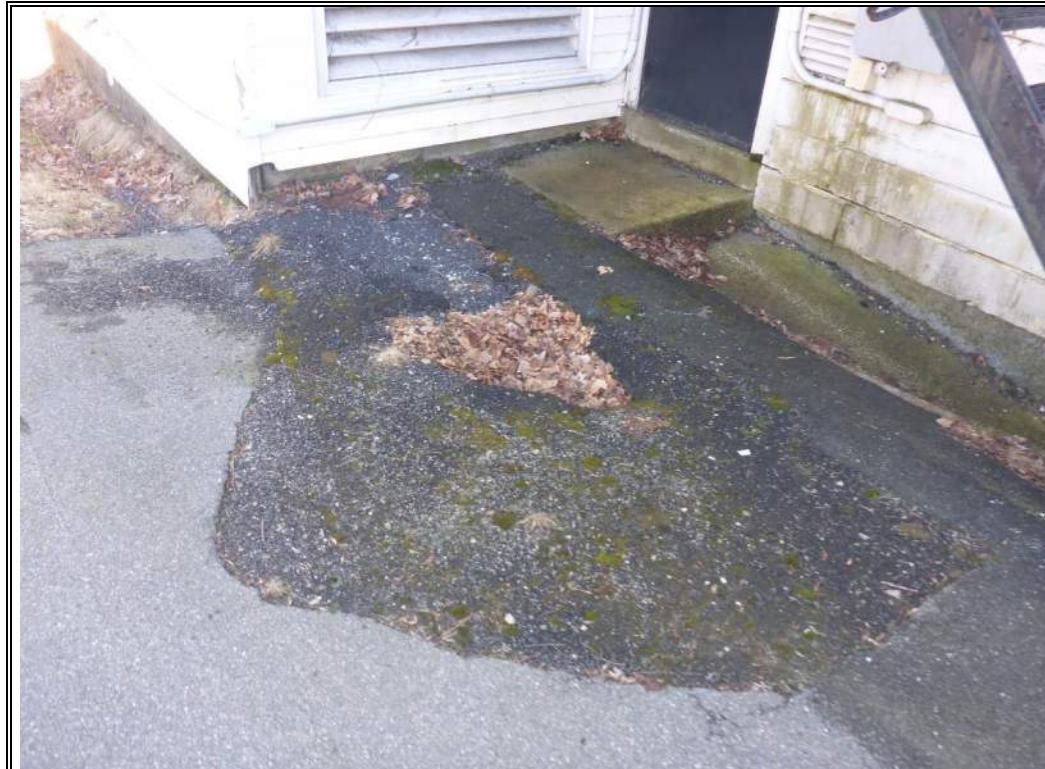
Photo Number
87

Exterior/details –
ponding and
marginal drainage

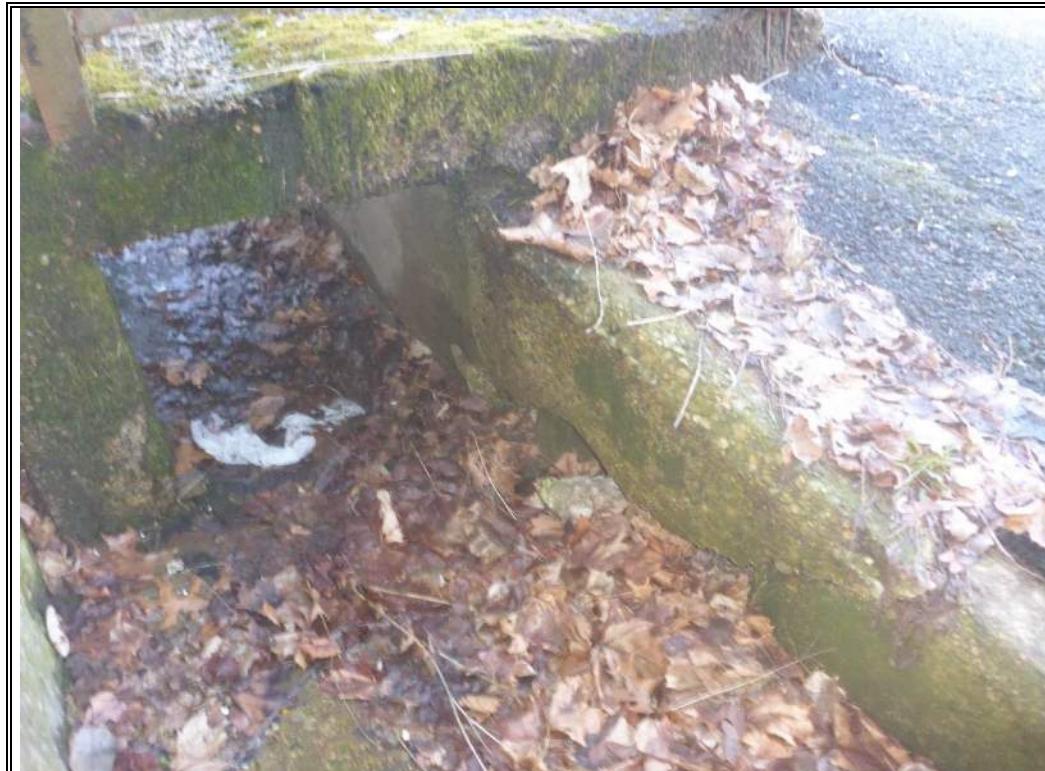
Exterior/details –
blocked drainage
channels

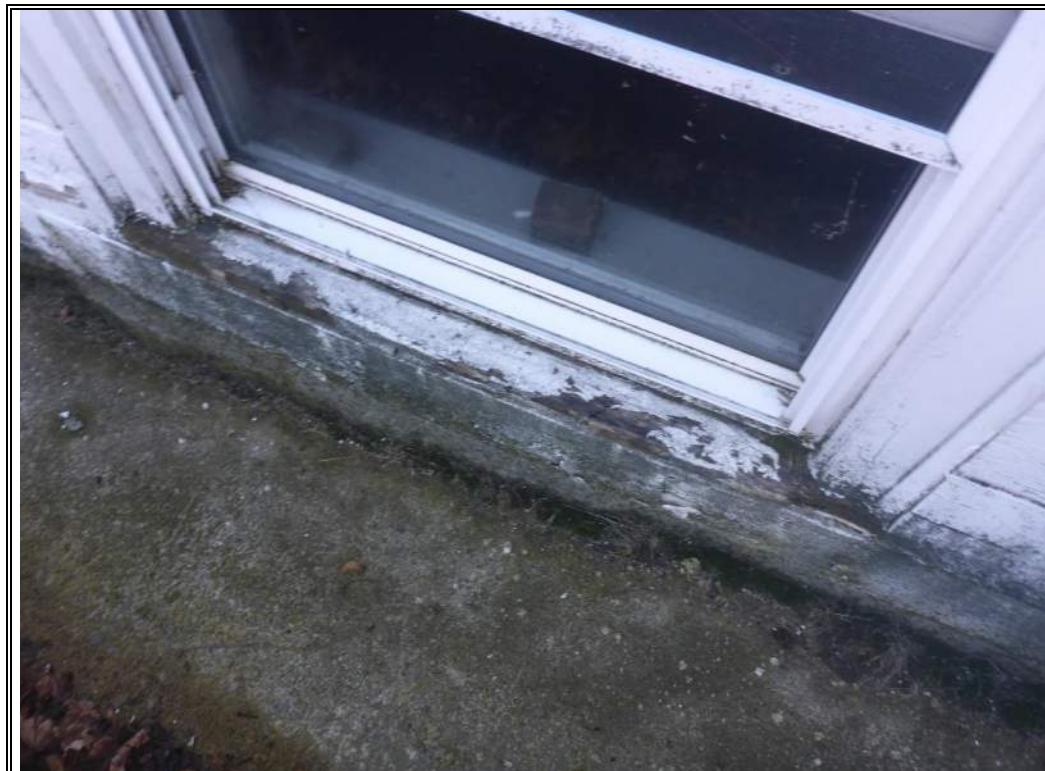
The exterior of the main building is primarily wood clapboard and wood panel siding. The rear newer addition is vinyl siding. There are a few areas (see photos) where there is some rot in the wood siding and wood trim. This is not extensive but would need attention. At a minimum, if this building is to remain unoccupied for some period of time, the exterior should be thoroughly prepared and painted. Those areas where there is evidence of rot should be addressed to remove and replace the rotted wood and apply an appropriate paint or wood preservative.

Exterior/details –
rot in trim

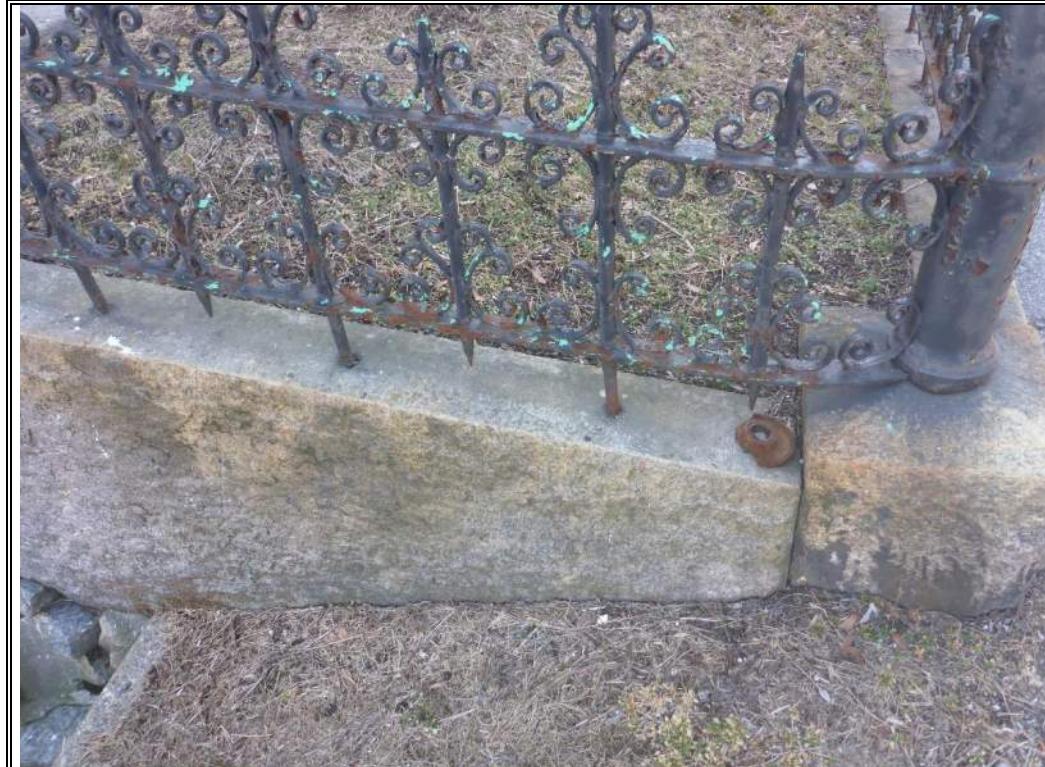
Photo Number
91

Exterior/details –
railing at front,
needs paint and
some repair

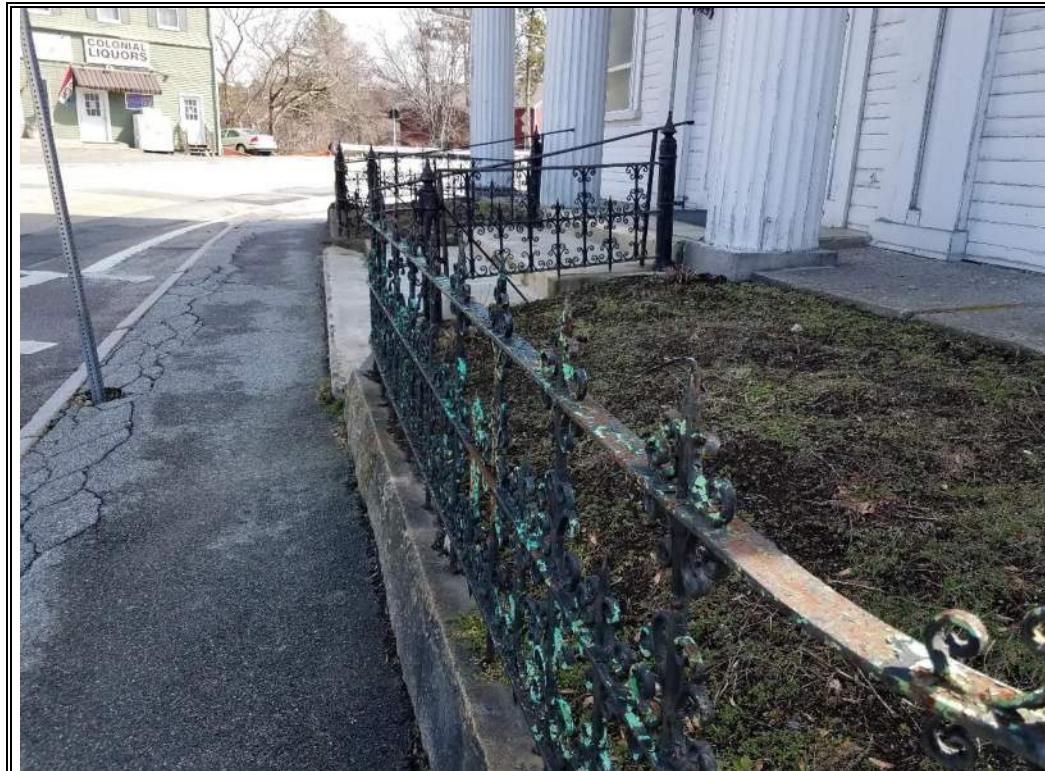
Exterior/details –
railing at front,
needs paint and
some repair

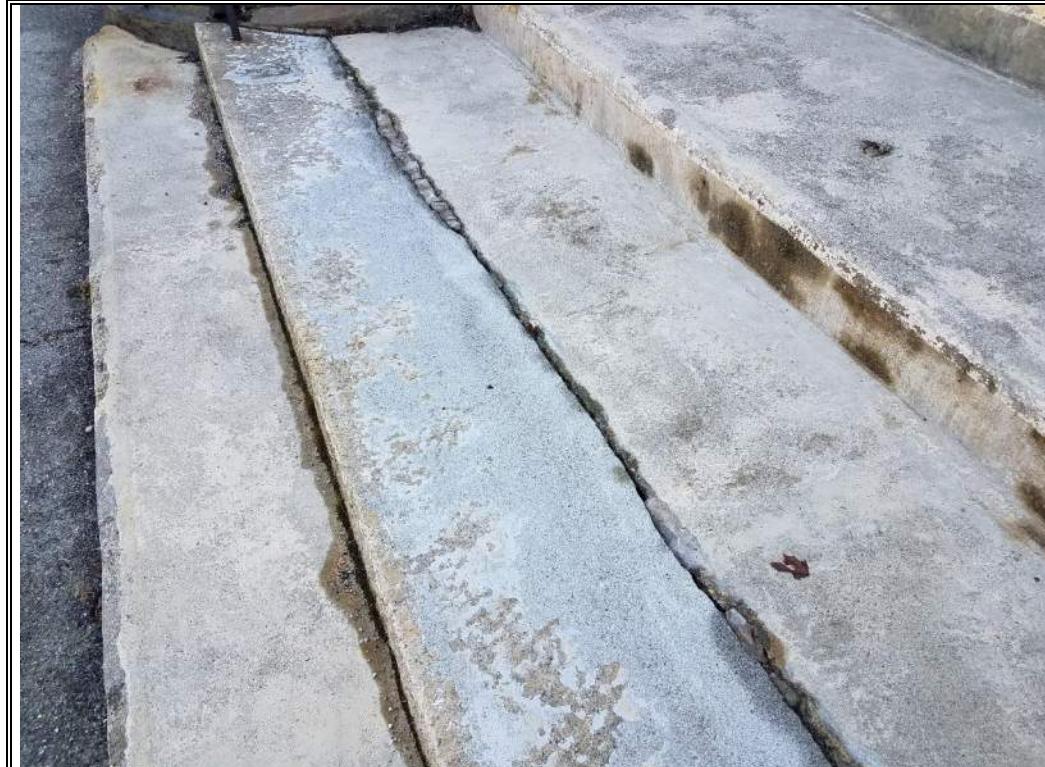
Photo Number
93

Exterior/details –
some movement at
front steps

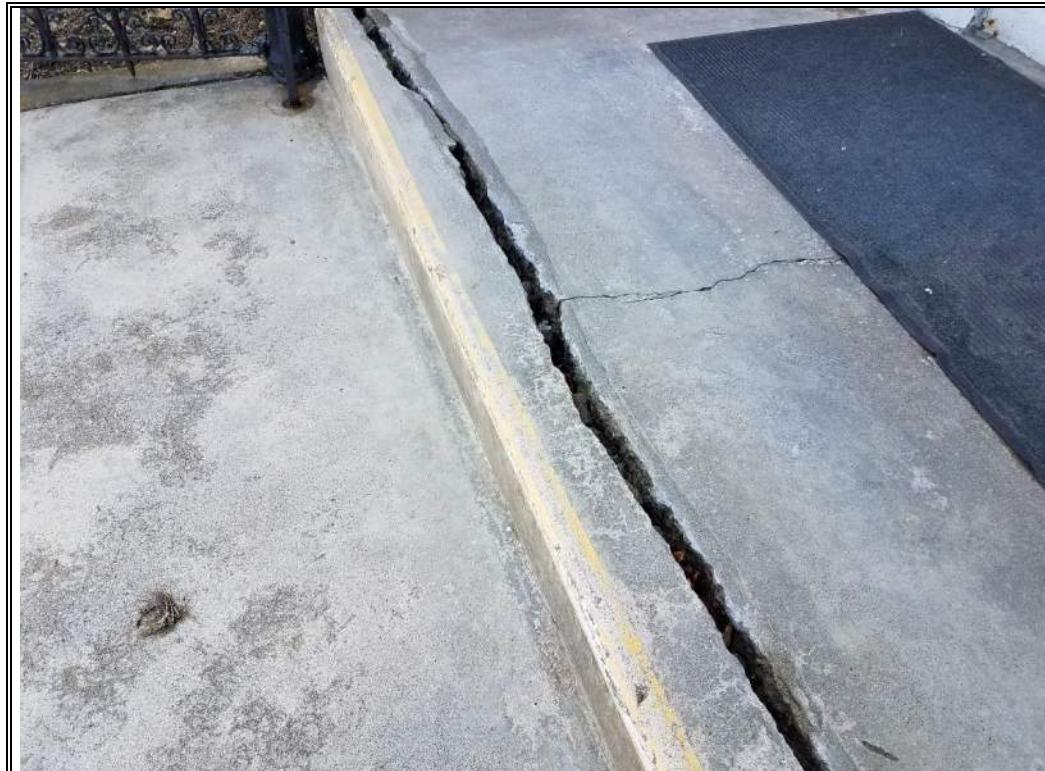
Exterior/details –
some movement at
front steps, most
likely soil
settlement
