STRUCTURAL EVALUATION

Holy Angels Church
3 Milford Street
Upton, MA

April 26, 2019

Project Number: 19-0104-MA
Date of Inspection: April 4, 2019
Engineers: H. Alan Mooney, P.E.
Nate Powelson, P.E.

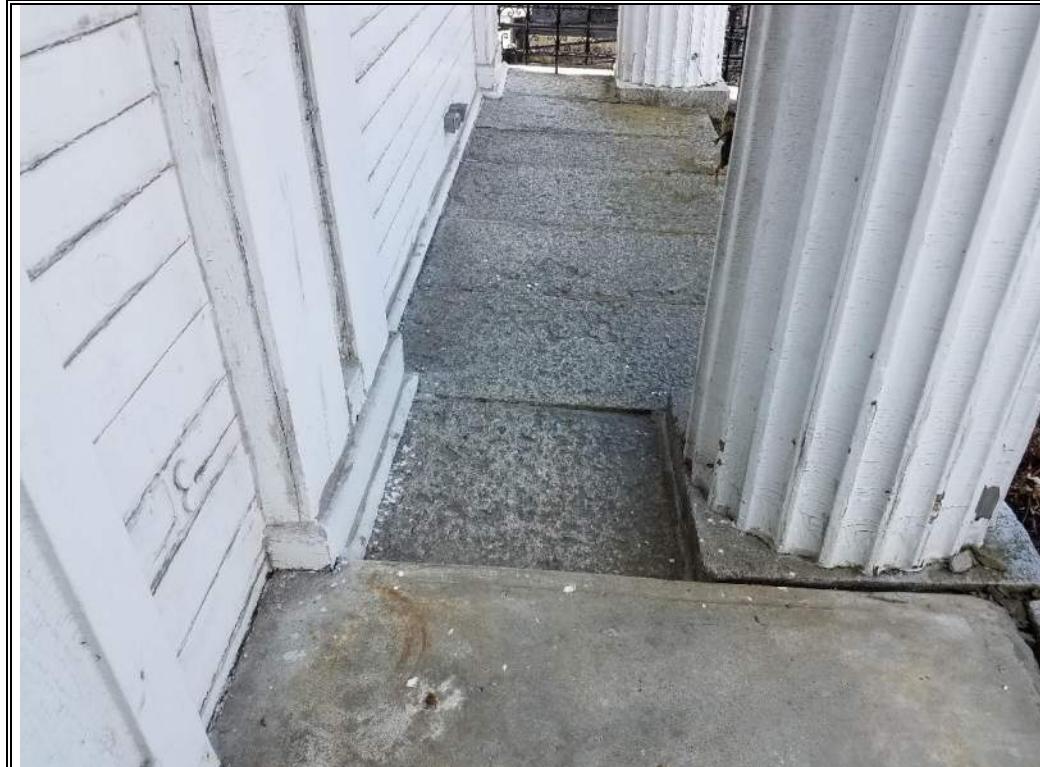
Photo Number
97

Exterior/details –
tripping hazard

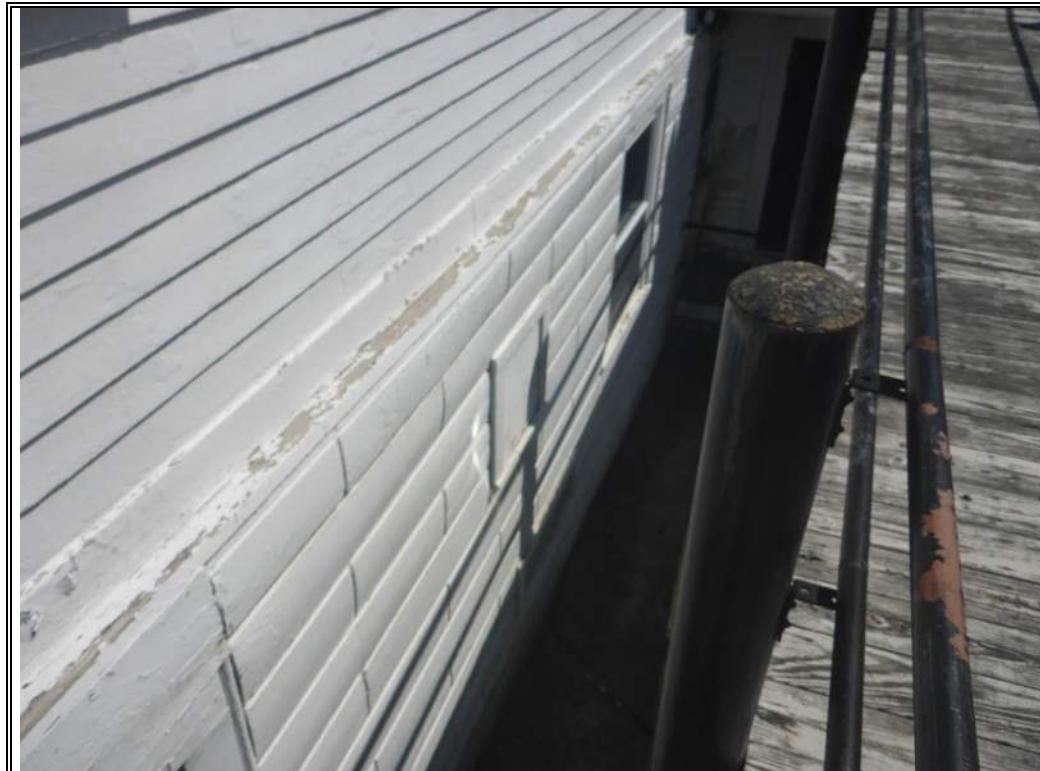
Exterior/details –
siding and trim
needs paint. Also
note poor railing
connection

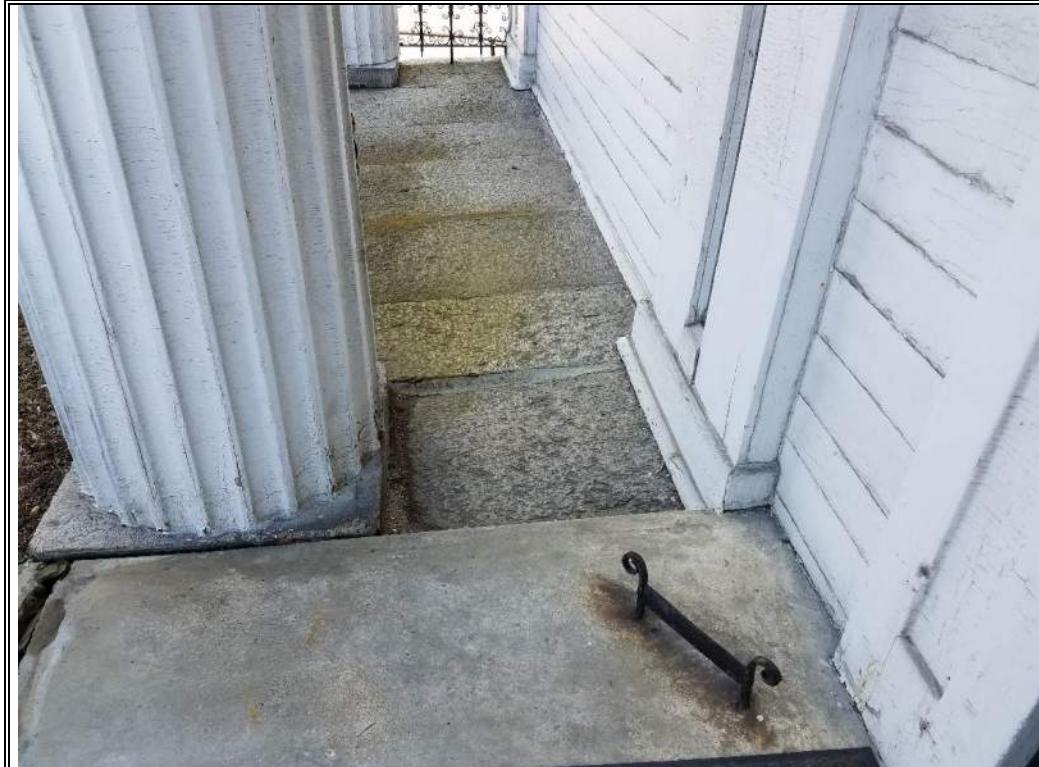
Photo Number
99

Exterior/details –
tripping hazard

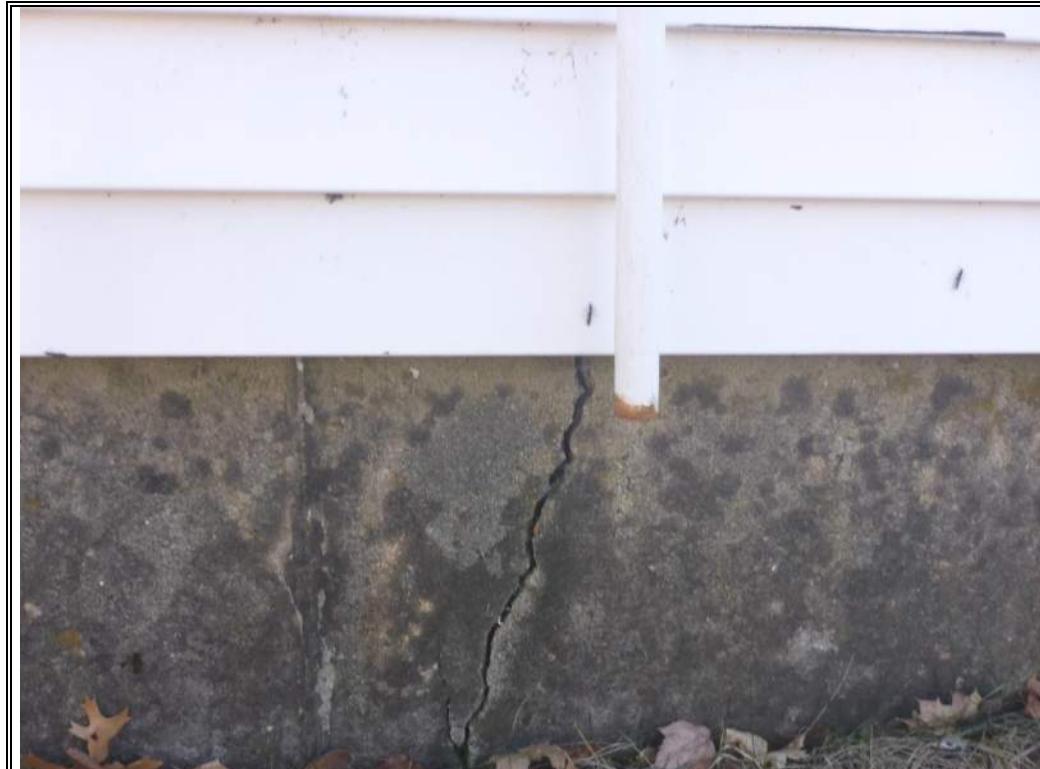
Photo Number
101

Exterior/details –
foundation crack,
not structurally
significant

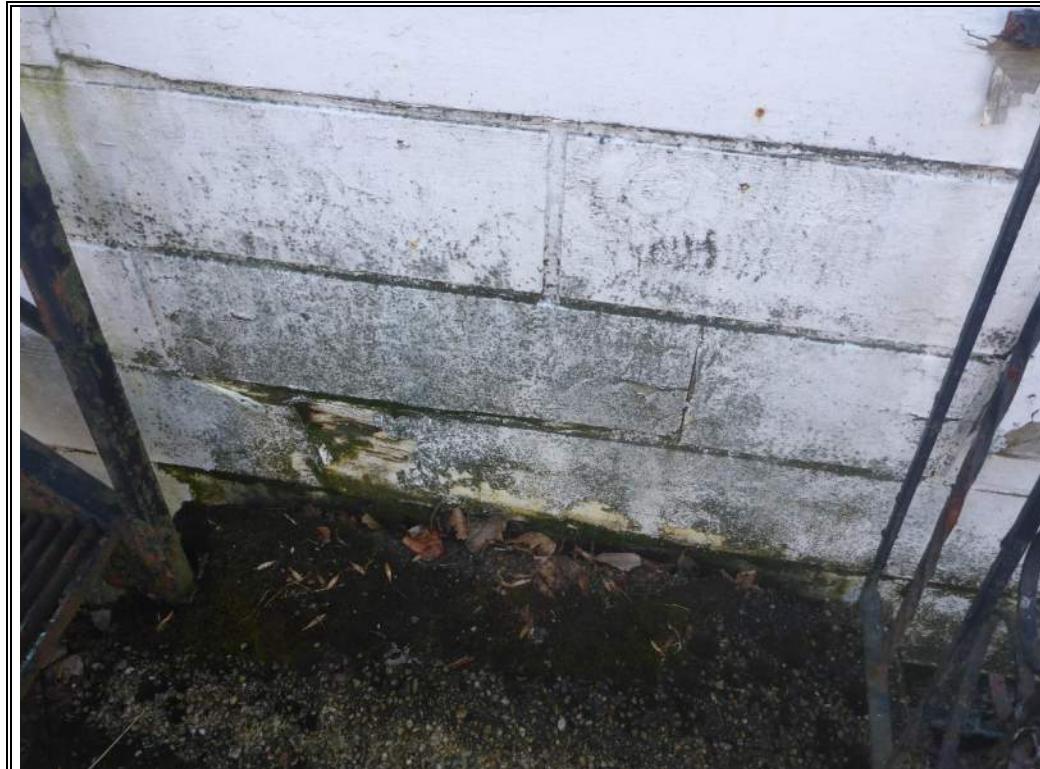
Photo Number
105

Exterior/details – showing drainage channel and some rot due to wood exposed to water

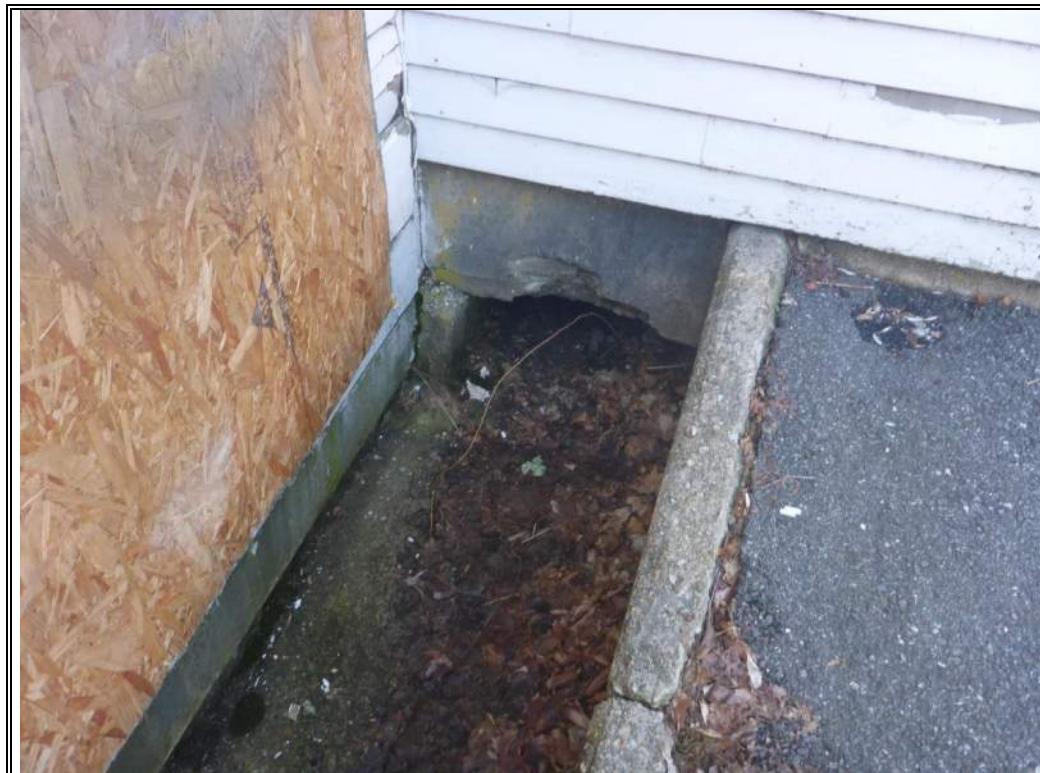
Exterior/details – showing drainage channel and some rot due to wood exposed to water
