Upton, MA

# Water Quality Limited Waterbodies Requirements

*May 2023*

## BMP RETROFIT SITE INVESTIGATIONS

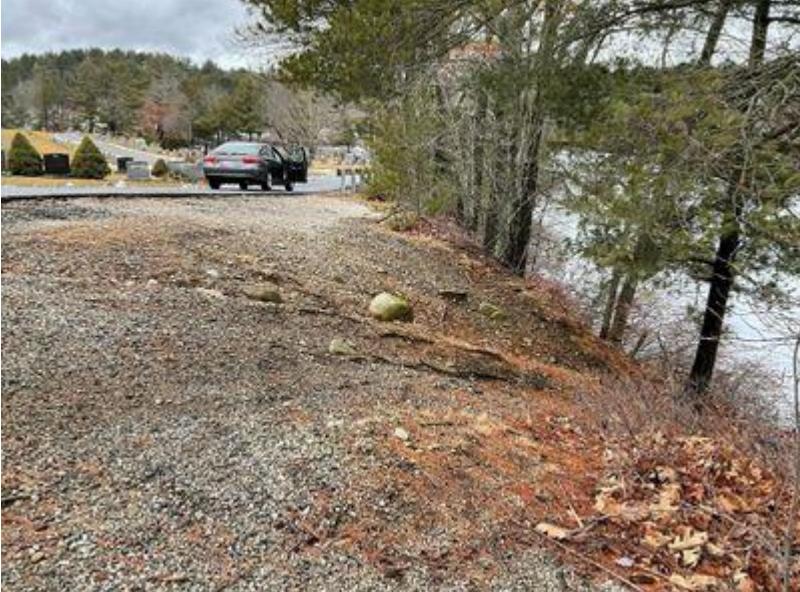
<p>Eroded area along perimeter roadway leading to Pratt Pond.</p>

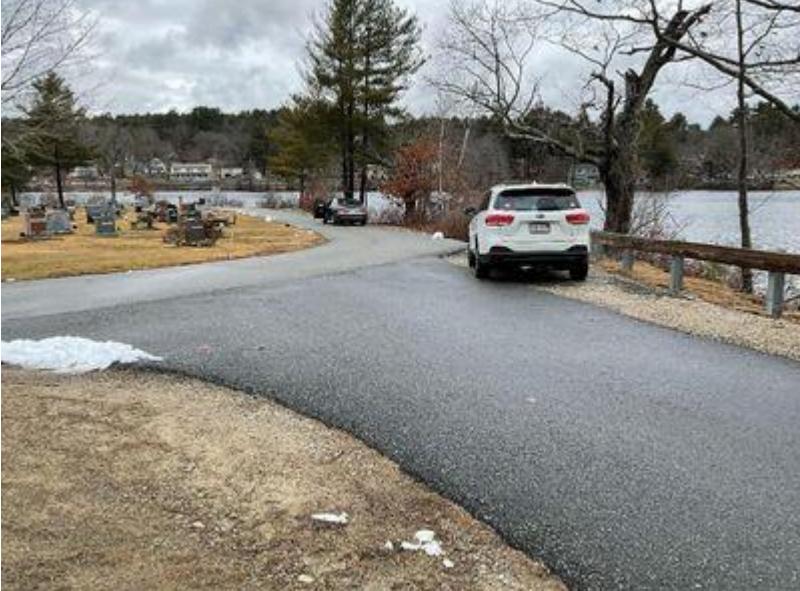
White car is parked in area where opportunities exist for WQS ending in vegetated basin.

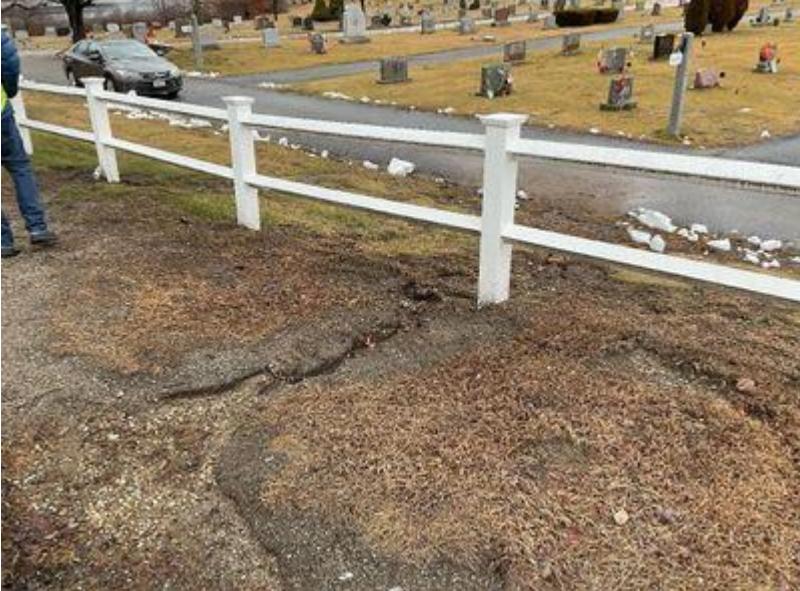
<p>Channelized erosion entering site along North Main Street, with deposited sediment visible in background.</p>

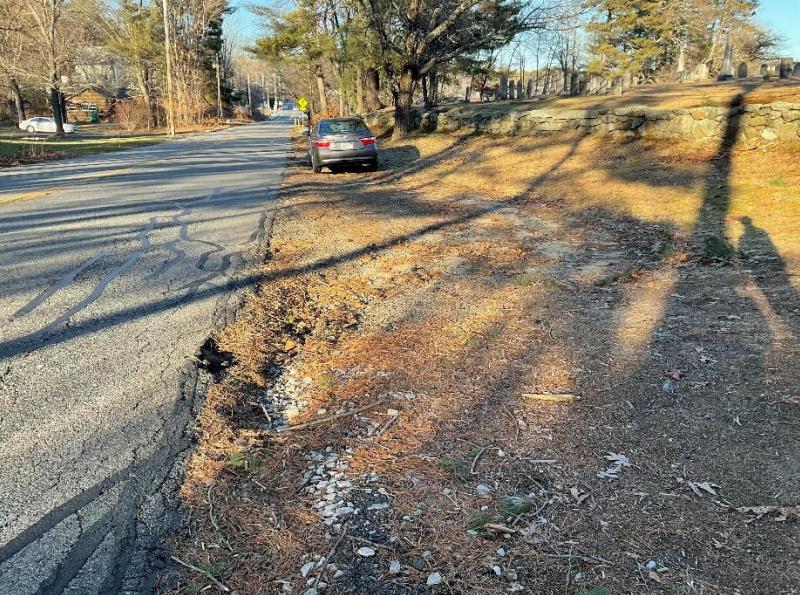
<p>Existing channelized erosion along School St, facing north.</p>

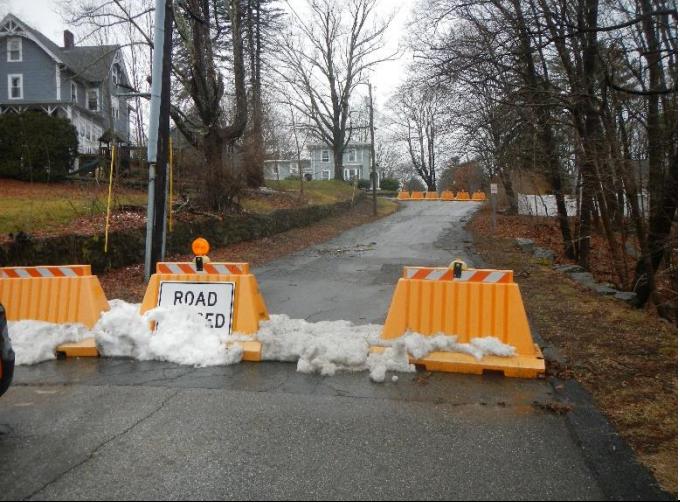
Roadway leading west from parking lot – opportunities for swales are limited given steep slopes and existing retaining walls.

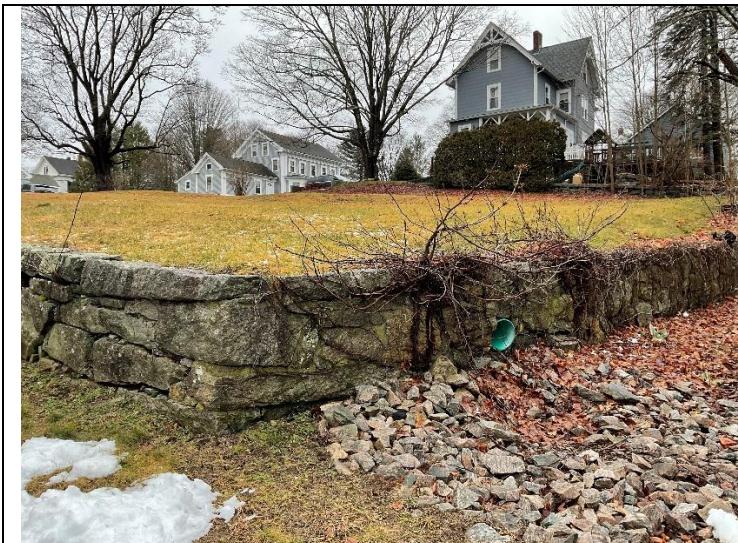
Existing discharge through retaining wall into riprap.

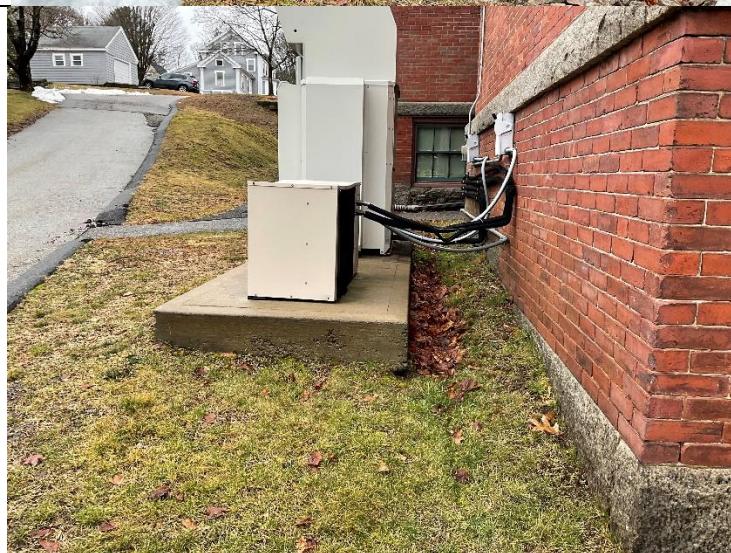
Eroded soil beneath drip edge is beginning to scour existing concrete pad – opportunity to reroute to leaching basin. Equipment presents challenge to installing drip edge.

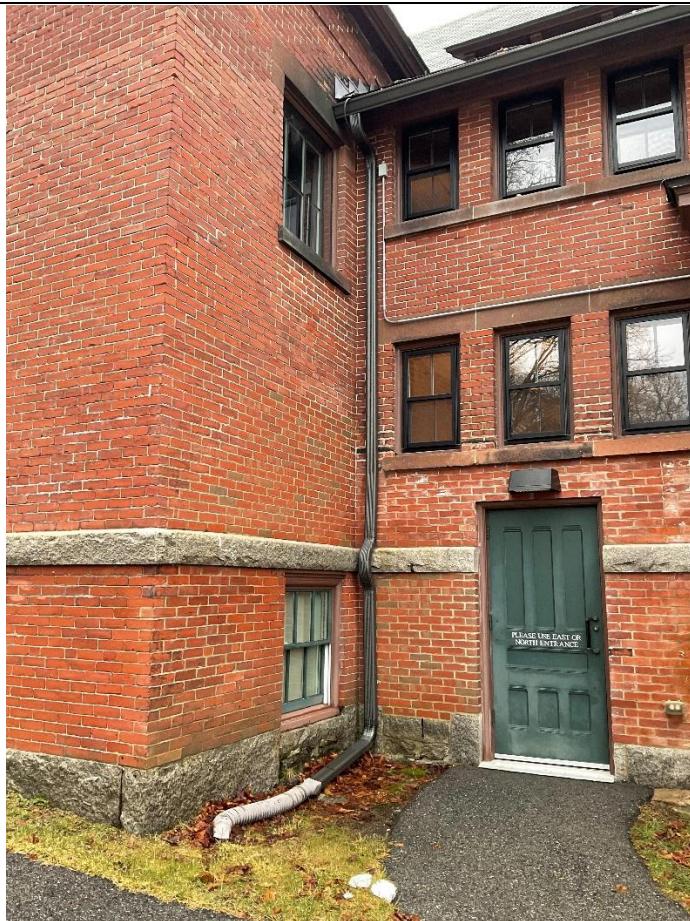
Existing downspout discharges to ground – opportunity to discharge to leaching basin, would require cutting and restoration of existing HMA path.

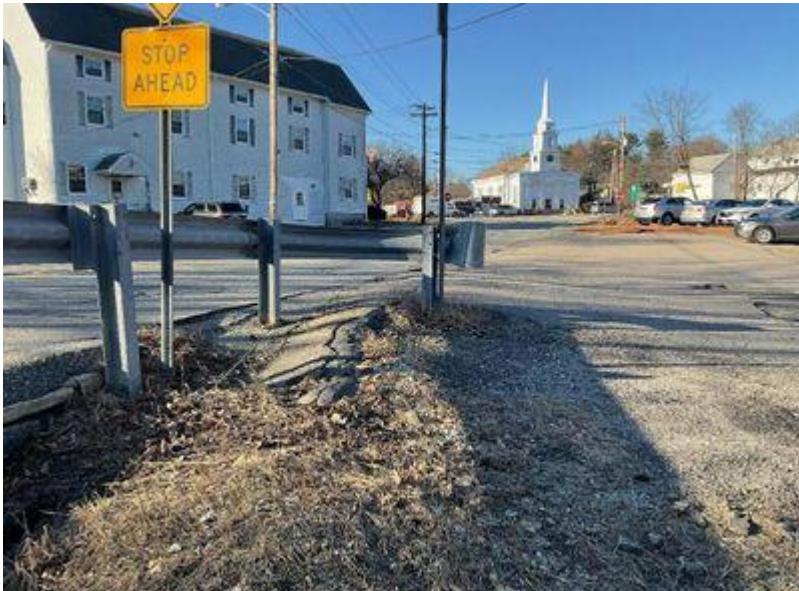
A photograph of an existing paved waterway. The waterway is paved with asphalt and has a yellow "STOP AHEAD" sign on the left. In the background, there is a multi-story building on the left and a church with a steeple in the distance. The sky is clear and blue.	Existing paved waterway from Grove Ave, facing north.

Rerouting the existing paved waterway to a water quality swale with check dams along the south edge of the parcel would provide significant treatment of impervious stormwater runoff. The swale would then outlet to Center Brook with riprap outlet protection. Along the east edge of the parcel, an opportunity exists to install a shallow infiltration basin with a sediment forebay for pretreatment; overflow would flow to Center Brook through a stone spillway.

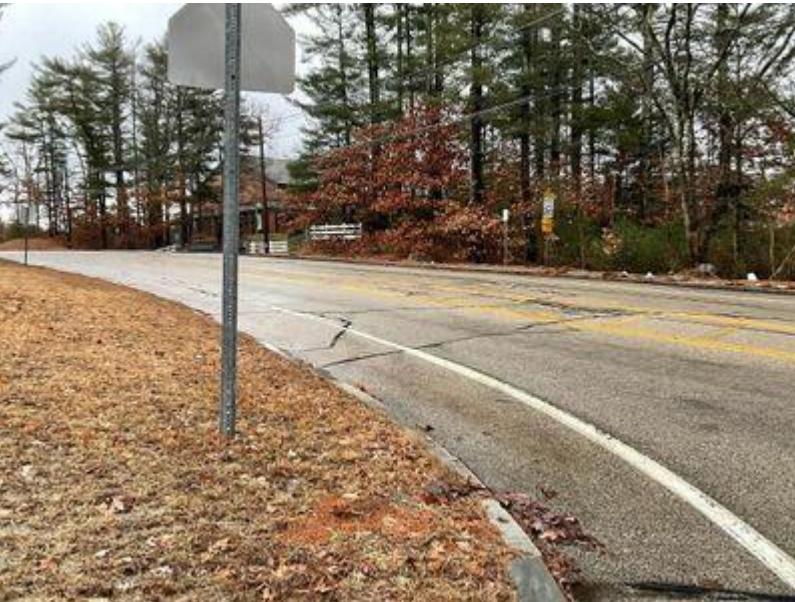
<p>Impervious catchment of catch basin 93-14, facing northeast along Pleasant Street.</p>

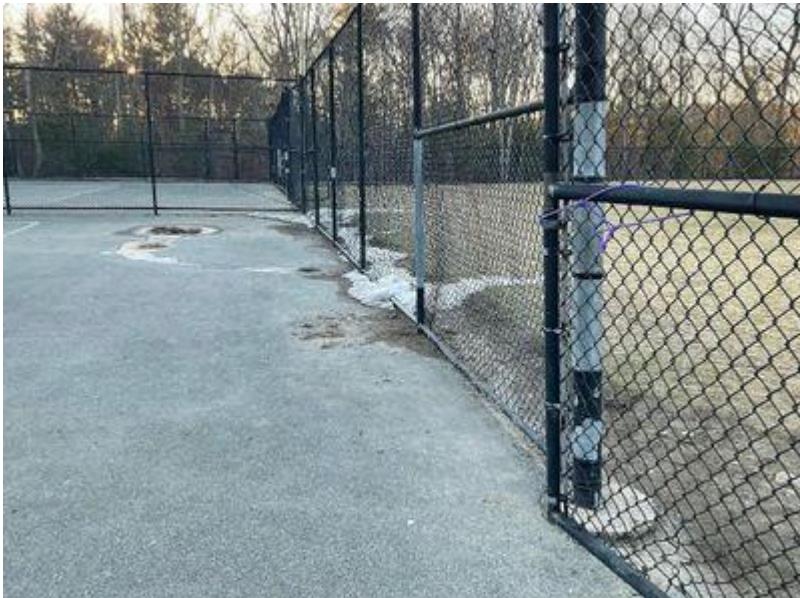
Evidence of ponding along back of basketball courts, facing west.

1. There is an opportunity to install a stone infiltration trench with a subdrain connected to the existing catch basin north of the school basketball courts. Ponding was observed on the court playing surface – installation of an infiltration trench along the north edge of the court would capture this water and allow it to infiltrate naturally. Any overflow would outlet to the connected catch basin.

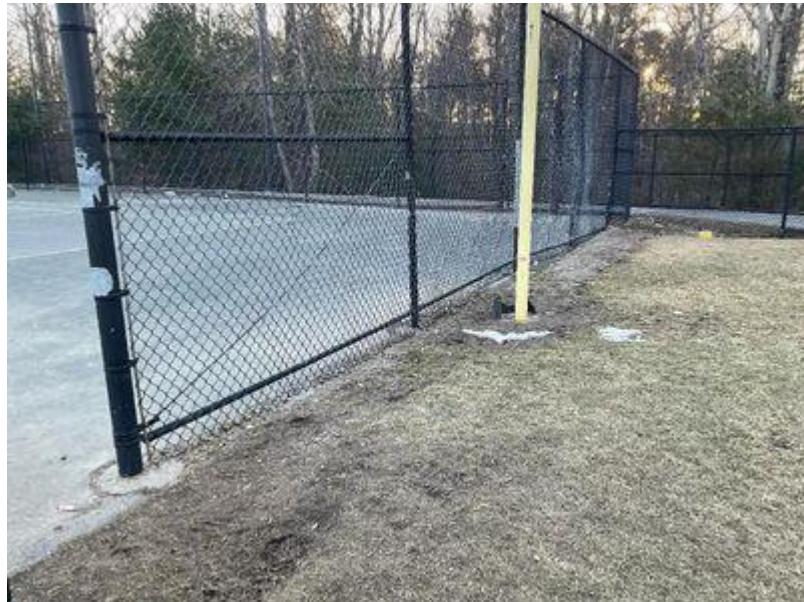
Grade change and soil accumulation at north end of basketball court, facing west.

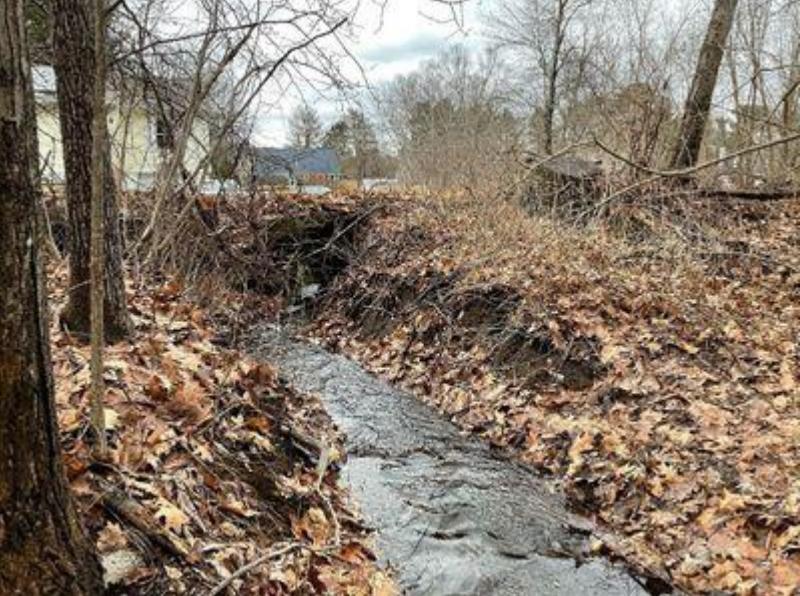
Existing outlet; opportunity for installation of inlet control structure and wet basin.

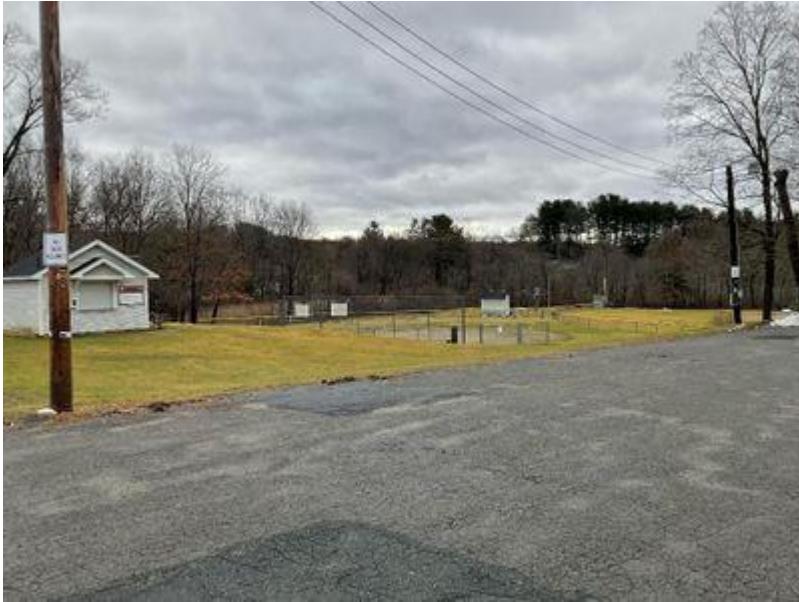
<p>Facing southeast from VFW parking lot to sloping area that leads to ballfields - opportunity for WQS along existing channelized area.</p>

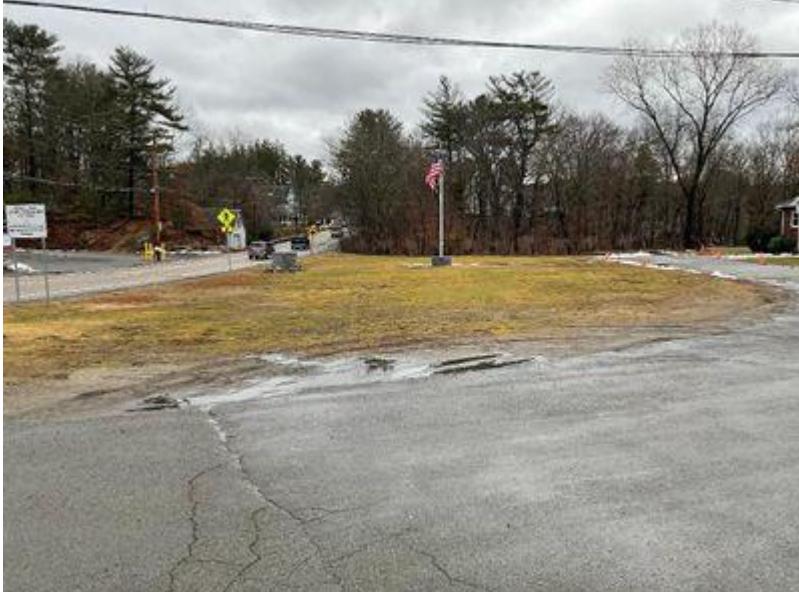
<p>Facing east from VFW parking lot to area near flagpole - opportunity for shallow infiltration area with sediment forebay.</p>

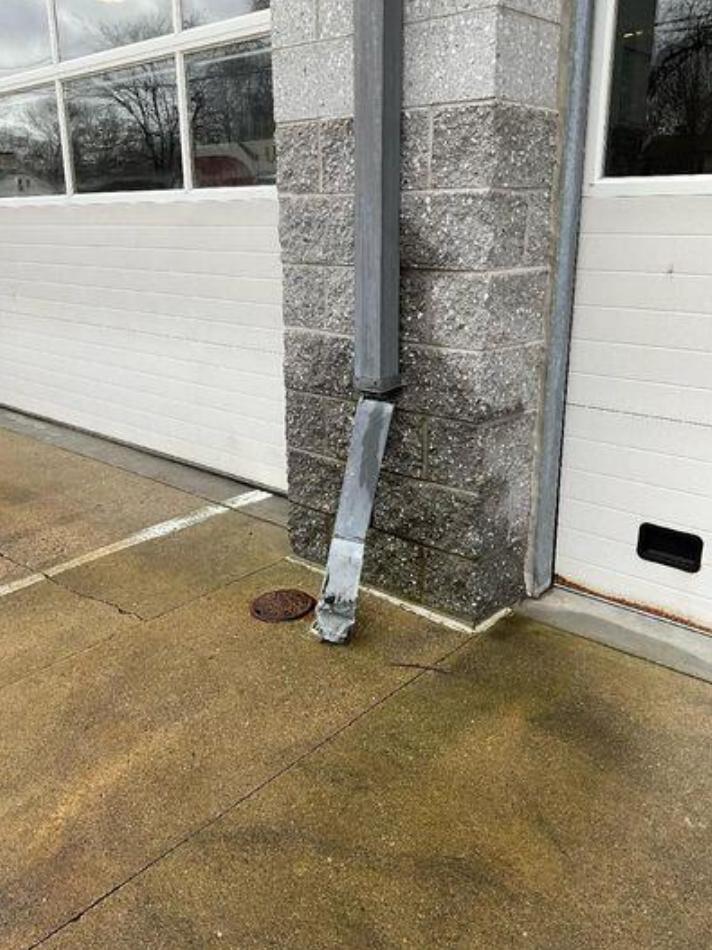
<p>Disconnected downspout along fire department vehicle bay.</p>

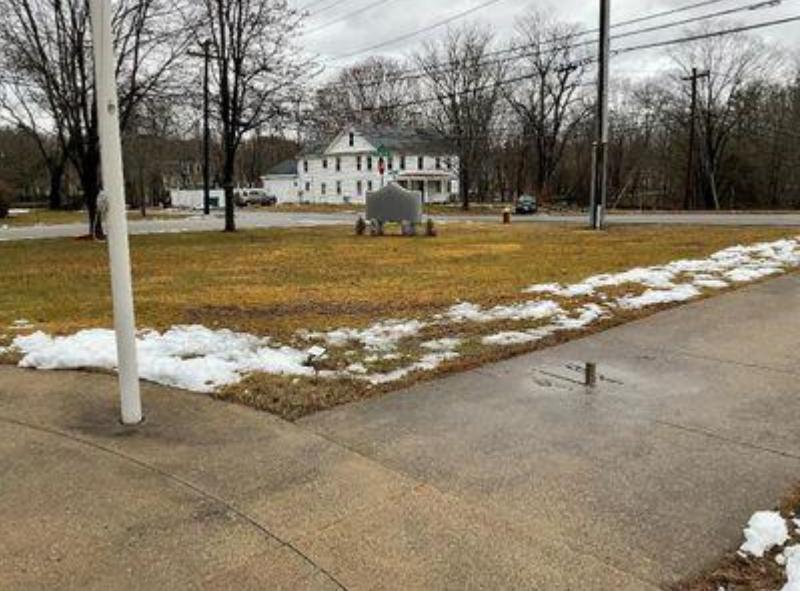
<p>Saturated low spot along walkway to main fire department building entrance from School Street.</p>

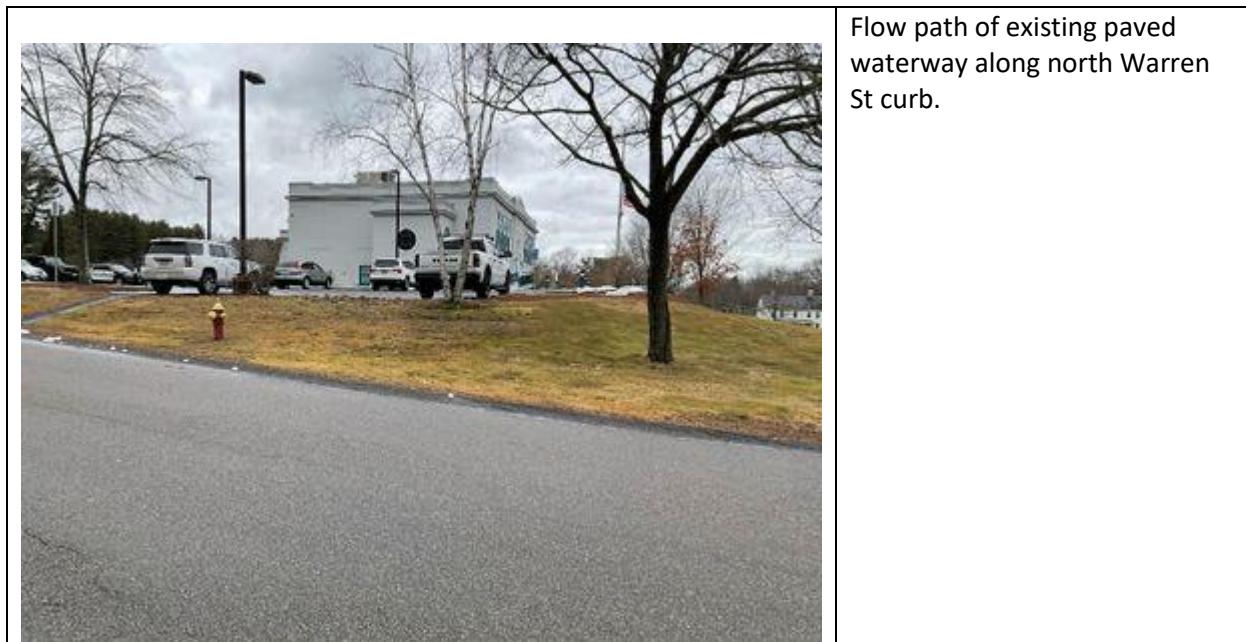
Flow path of existing paved waterway along north Warren St curb.
