**Town of Upton  
Self-Evaluation and Transition Plan  
August 2021**

# **TOWN OF UPTON – SELF-EVALUATION AND TRANSITION PLAN**

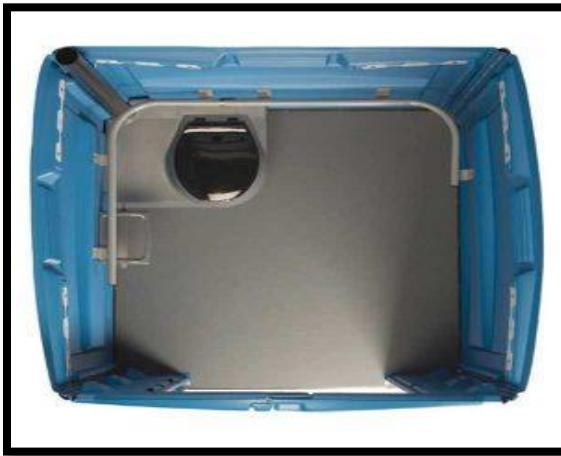
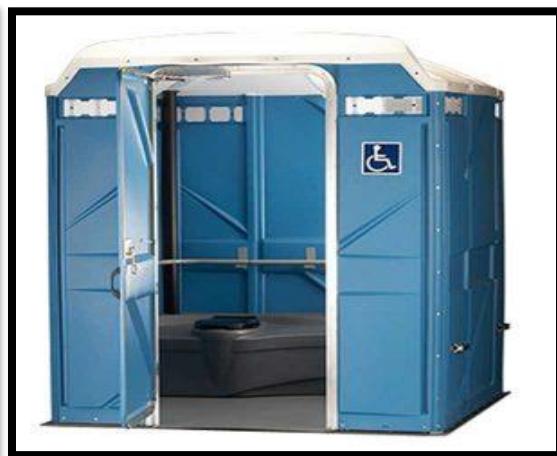
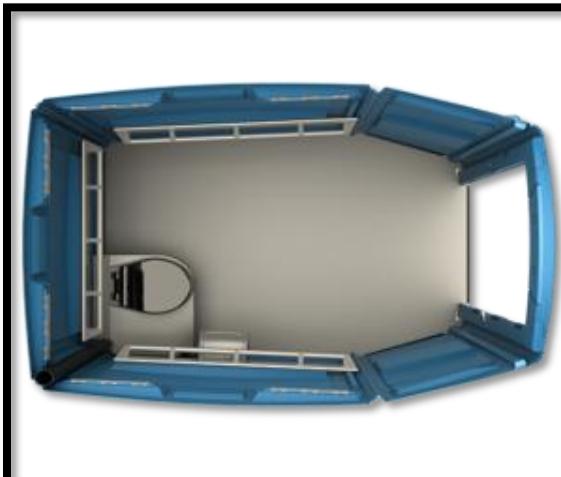
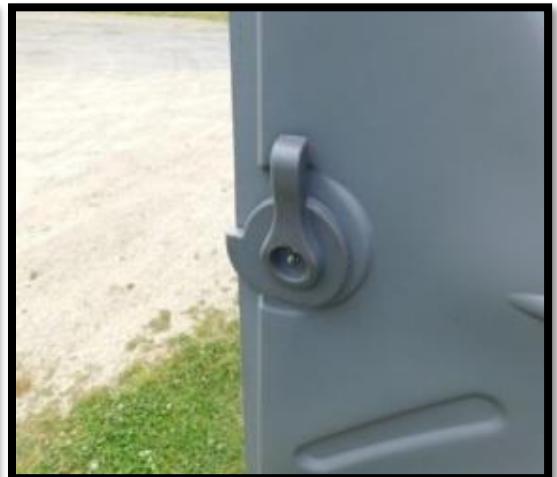
### Representative Examples of an ADA Compliant Portable Toilet

If the town provides portable toilets for short-term events or for seasonal use, then they must be "ADA Compliant". An important distinction to note is that "ADA Compliant" is not synonymous with "Wheelchair Accessible." Wheelchair Accessible usually indicates a ramped or ground level entrance with a wide enough door for a wheelchair to gain entry. Clearances; setbacks; and dispenser, grab bar, and water closet heights do not necessarily meet ADA or 521 CMR Standards. "ADA Compliant", however, generally means reinforced construction; ramped or ground level and wheelchair accessible entrance; spring loaded magnetic door that closes automatically; reinforced grab bars; dispensers, grab bars, and the water closet at the proper height and near, far and front setbacks; compliant door hardware; and enough interior space for a wheelchair to make a 360 degree turn that all fully comply with the 2010 ADA Standards and/or 521 CMR, whichever is more stringent. Illustrative examples of an "ADA Compliant" portable toilet are shown below.

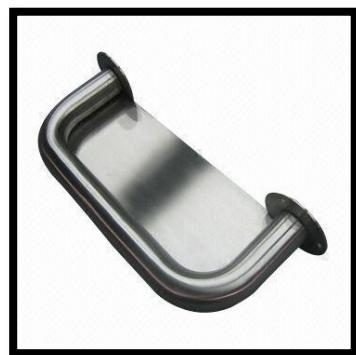
Both the 2010 ADA Standards (S. 604.5 Exception #3) 521 CMR (S. 15.8) provide exceptions for the requirement of grab bars in cells that are specifically designed without protrusions for purposes of suicide prevention. However, in recent years grab bars have been designed so they do not increase suicide risk. As shown, there are several ways for grab bars to be designed with adequate gripping surfaces, while ensuring that nothing can be tied onto them (see below). Consideration should be given (not required) to installing suicide proof grab bars in the accessible cell as feasible and necessary in the future.

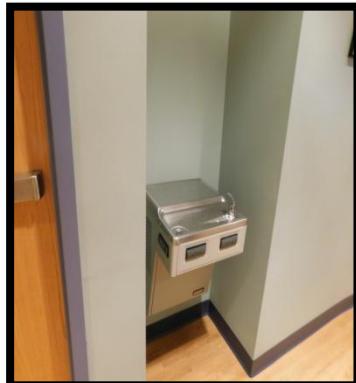
Photo Fire 8

<p><b>Drinking Fountains</b></p> <p>The Level 1 and Level 2 drinking fountains are non-compliant as they are "low" only and not "hi-low" fountains.</p> <p>See Photo Fire 8.</p>	211	36.1.1	<p>Option #1 – Discontinue use of the existing drinking fountains.</p> <p>Option #2 – remove the existing drinking fountains and replace with "hi-low" drinking fountains. The drinking fountains must comply as follows:</p> <p>Protruding objects compliance of no &gt; 4" protrusion between 27" and 80" a.f.f. (307); 30"x48" clear space requirement (305), and knee/toe clearance (306). Knee clearance is 9" to 27" a.f.f; 25" deep max. at 9" a.f.f. or 11" deep min at 9" a.f.f. and 8" deep min at 27" a.f.f. Width of knee clearance s/b 30" wide min (306.3). Toe clearance as part of c.f.s. 17" min – 25" max, 9" high a.f.f., 30" wide (306.2). The spout s/b 15" min from wall and 5" max from the front edge of the unit (602.5). Flow of water 4" high min and spout located max 5" from front (602.6). The spout height s/b 36" max. a.f.f. for "low" and 38" min a.f.f. to 43" max a.f.f. for "high". The controls s/b operable w/one fist; no &gt; 5 lbs force (309.4).</p>	4	3	N	\$0 to \$3,500

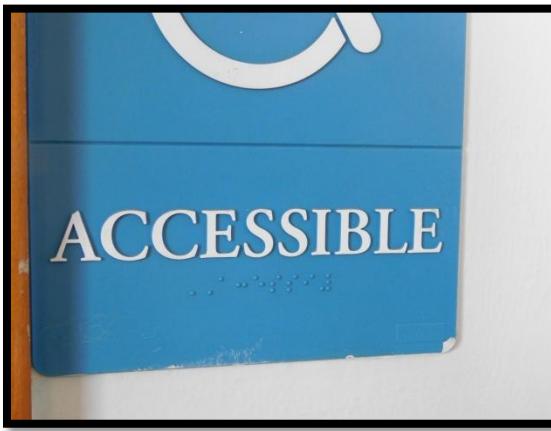
Photo Upton Center 2

**General Description or Obstacle Which Limits Mobility or Access:** The 2 designated accessible parking spaces and sole access aisle have excessive cross slopes. Only one designated accessible space has an access aisle. Interior room doors/closets lack tactile designation signage (bathroom exception) and those that provided signage was not designation signage but merely a notation of "accessible" in Braille as opposed to a room designation such as "Director's Office" or a room number. One interior door had non-compliant knob-style hardware. The sharps dispenser "disposal access", hallway coat hooks, and the call button to the adjacent housing complex connecting hallway are too high. The clear width to the Social Services office does not meet the minimum required clear width. Similarly, the storage items behind the door to the galley kitchen from the hallway restricts the clear width to only 29". Egress doors have excessive operating forces and too fast closing speeds. There are a number of protruding objects in the center. The computer table in the multi-purpose room lacks adequate knee clearance. The designated "accessible" bathrooms have numerous areas of non-compliance including sink piping

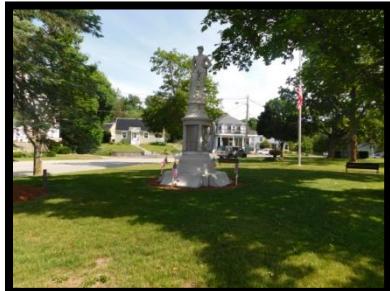
Photo Town Common 1

<p>surface of 1" due to heaving and settling. The asphalt sidewalk on Milford Street directly adjacent to the common has numerous abrupt changes in level surface and severe deterioration.</p> <p><b>See Photos Town Common 1, 2, 3, and 4.</b></p>			<p>requirement of stable, firm, and slip resistant. Modify and/or reconstruct the concrete walkway across the common and the asphalt sidewalk along Milford Street.</p>				
<p><b>Curb Ramps</b> The curb ramp at Main/North Main Street lacks a level landing and does not have a detectable warning strip.</p> <p>There are no curb ramps at the 2 concrete walkways and crosswalks from the common across North Main Street. The existing conditions are 8" granite "steps" which prevents full access to the common from North Main Street.</p> <p><b>See Photos Town Common 5 and 6.</b></p>	<p>403.4 405.2 406.3 303.2 705</p>	<p>21</p>	<p>Provide compliant curb ramps at all 3 locations which have detectable warning strips; a maximum running slope of 8.3%; a maximum cross slope of 2.0%; a maximum flared side running slope of 10.0%; a ramp width of at least 36"; no changes in level surface of greater than ¼" (unless beveled); and a top level landing (no more than 2.0% in all directions) that is at least the width of the curb ramp and at least 48" in length.</p>	<p>1</p>	<p>3</p>	<p>N</p>	<p>Up to \$10,000+</p>

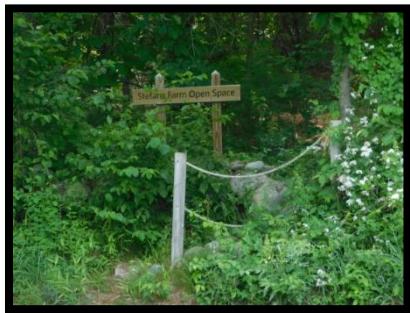
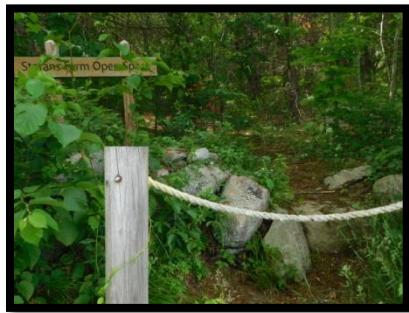
Trail. The trail is not formally maintained to a standard that would be considered to be an accessible route of travel.

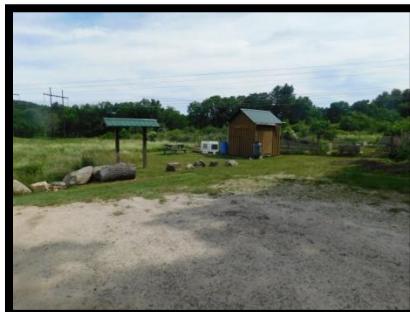
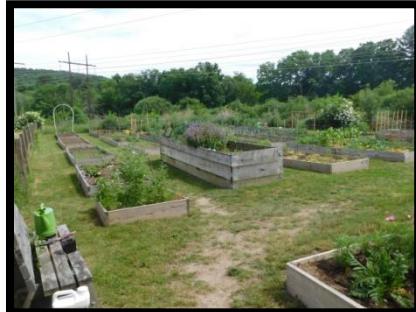
Community Gardens. Parking for the community garden area is an unimproved gravel and dirt surface. No signage or striping is provided. There are no compliant accessible routes of travel to the community gardens, picnic table, or water source (water holding tank). The faucets for the holding tank require pinching and twisting of the wrist. The gate to the community gardens is not flush at the base.

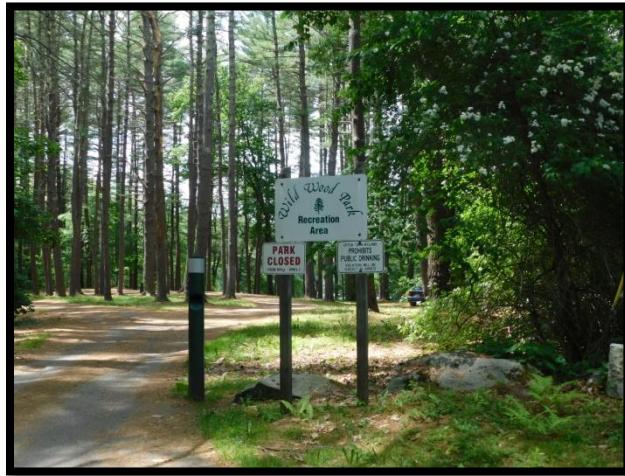
**General Description or Obstacle Which Limits Mobility or Access:** There are no designated accessible parking spaces for the park. There is no accessible route of travel to any areas within the park nor are there any formal accessible routes of travel or trails to areas within the park area.

**Recommended Action:** Should the town initiate formal improvements to this property to enhance overall site accessibility and usage, then compliant accessible parking, and limited accessible routes of travel would need to be provided. In addition, if picnic tables are provided, then at least one must be on an accessible route of travel and provide a minimum of 27" of knee height, 30" of knee clearance, and 19" of knee depth. Portable "ADA" accessible toilets must fully comply with the 2010 ADA Standards and 521CMR for "bathrooms" as also provided in Section IX of this Plan.

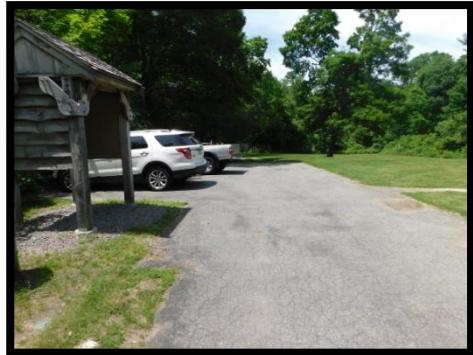
Photo Heritage 1

<b><u>Accessible Route of Travel to Bench Viewing Area Near the Pond</u></b>	402 403 405	20 22 24	<p>The running slope of the unimproved route of travel to the level turnaround near the bench and pond viewing area varies from 5.0% to 8.3% in some areas as well as in exceedance of 8.3%. The route of travel is not firm or stable with loose stone and gravel as well as numerous abrupt changes in level surface of greater than <math>\frac{1}{4}</math>". The route of travel from the lower turnaround area to the bench and viewing area has running slopes of up to 8.0%</p> <p><i>Note: Accessible routes over 5.0% up to 8.3% require railings.</i></p> <p><i>See Photos Heritage 3 and 4.</i></p>	2	3	L	TBD
<b><u>Benches</u></b>	221.2 802.1	14 19	<p>There is no level surface area for wheelchairs at the bench.</p> <p><i>See Photo Heritage 4.</i></p>	2	3	N	Included in above
			Option 1: Construct an accessible route/ramp to the lower level turnaround area and to the bench. The accessible route/ramp must be at least 4' between paired railings, cannot exceed 30' in length without a level landing, and cannot exceed the maximum 8.3% running slope and 2.0% cross slope. Construction must be in full compliance with S. 405 of the 2010 ADA Standards and S. 24 of 521 CMR. <i>Note: Due to the terrain and slope, it may be infeasible and cost prohibitive to construct a compliant accessible route of travel from the asphalt parking lot to the lower turnaround area and to the bench.</i>	2	3	N	Up to \$2,500

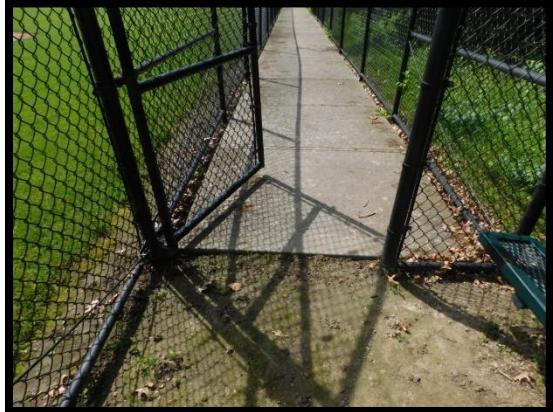
Photo Leland 1

**General Description or Obstacle Which Limits Mobility or Access:** There are no accessible routes of travel fully around the baseball fields, soccer field, baseball player benches, and bench near the tennis court. . Chain link gates throughout are not flush at the base and have latches that are too high. The bench near the tennis court lacks a level space for a wheelchair. The portable toilet is not an accessible toilet.

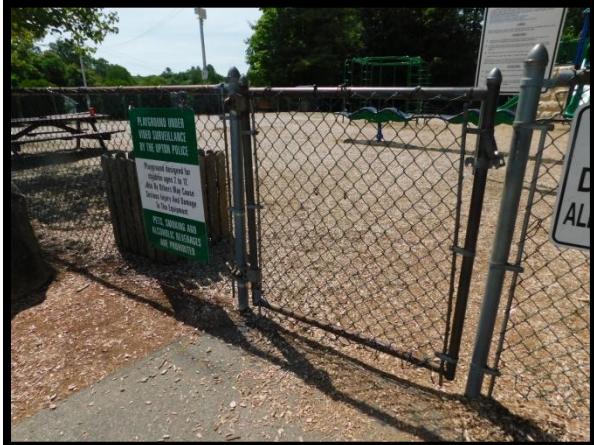
Photo VFW 1

**General Description or Obstacle Which Limits Mobility or Access:** One of the designated accessible parking spaces has excessive running and cross slopes. Neither of the 2 spaces is designated as "van" accessible. There is a paved accessible route to the playground area, however, no accessible route of travel exists around the playground or to the play equipment, benches, or picnic tables. Non-compliant wood chips are the primary surface throughout the playground. None of the picnic tables have sufficient knee depth. The chain link gates to enter the playground are not flush at the base. The portable toilet is not fully "ADA compliant". None of the play equipment is considered to be "accessible compliant".

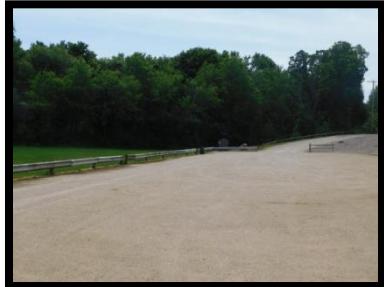
Photo West River 1

**General Description or Obstacle Which Limits Mobility or Access:** The surface of the designated accessible parking is a mixture of gravel and stone. The parking lacks striping. There is no accessible route of travel from the parking to and around the soccer field. The portable toilet is not on an accessible route of travel and is not fully "ADA compliant".

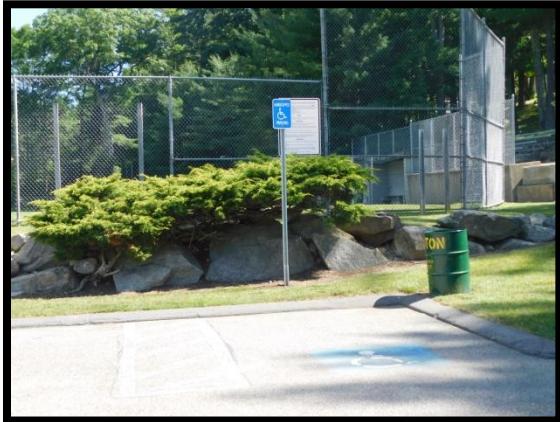
Photo Town Beach 1

**General Description or Obstacle Which Limits Mobility or Access:** The Lower Parking Area has up to 71 spaces, including designated accessible spaces. Although this area has the required number of accessible spaces, they do not meet current signage, location, and width requirements. The signage at all 3 parking spaces is too high, none are designated as van accessible, and the access aisle for the space near the baseball/softball field is not wide enough. The paved Soccer Field Parking van designated accessible space has signage that is too low and is too far from the front of the parking space. The Upper Gravel Soccer Parking Lot lacks designated accessible parking spaces, however, accessible parking is available at the field level.

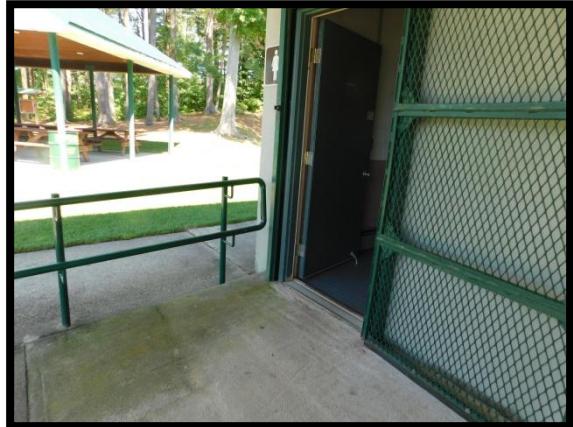
Photo Town Beach 12

bathrooms).								
The side and rear grab bars are 36" long, which is 6" too short.	604.5	30.8	Replace the existing grab bars with ones that are 42" long.	3	2	I	Up to \$500	
The toilet paper dispensers are too far from the front of the water closet and too low in height.	604.7	30.7.6	Relocate the toilet paper dispensers so they are a minimum of 7" and a maximum of 9" in front of the water closet measured to the centerline of the dispenser and at least 24" a.f.f. <i>Note: There also must be at least 1½" clearance below the grab bar to the nearest object or fixture.</i>	3	2	I	\$0	
The sink metered faucets require 10 lbs. of operating force which is too much and stay open for only 3 seconds.	309 606.4	39.5 30.9.6	Adjust/modify the faucets so they require no more than 5 lbs. of operating force and stay open for at least 10 seconds.	3	3	I	\$100	
The mirrors are 8½" to 11" too high.	603.3	30.11	Lower the mirrors to no more than 40" a.f.f. to the bottom of the reflecting surface.	3	2	I	\$0

The towel dispensers are 4" to 12" too high.	308	30.12	Lower the dispensers so they are 42" a.f.f.	3	2	I	\$0	
<b>Men's Bathroom Only</b> The flush control of the water closet is on the near wall side.	604.6	30.7.5	Replace the water closet or the tank of the water closet with one that has a flush control on the approach or wide side.	3	3	N	\$125 to \$350	
The urinal is 24" a.f.f to the top of the rim, which is 7" too high and the flush control is 8½" too high.	605.2 308	30.10	Lower the urinal so that it is no more than 17" a.f.f. to the top of the rim and the flush control is no more than 44" a.f.f. (521 CMR).	3	3	I	Up to \$350+	
<b>See Photos Town Beach 12, 13, and 14</b>

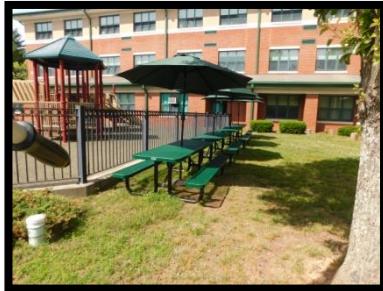
Photo Playground 1

**General Description or Obstacle Which Limits Mobility or Access:** There are 5 picnic tables at the front of the school which are not on an accessible route of travel and which lack knee depth (one also lacks clear width). The side playground also has a picnic table which is not on an accessible route of travel and lacks adequate clear width. The rear playground has chain link gates to enter the playground which are not flush at the base and also have a latch that exceeds the maximum reach range under the 2010 ADA Standards. Although there is an accessible route of travel around the rear playground area, there is no accessible route of travel into the playground area or to the play equipment. Non-compliant wood chips are the primary surface throughout the playground.

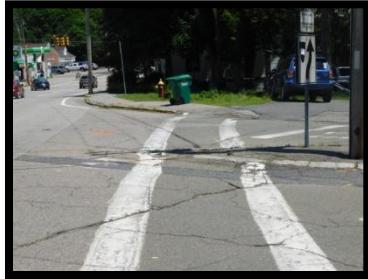
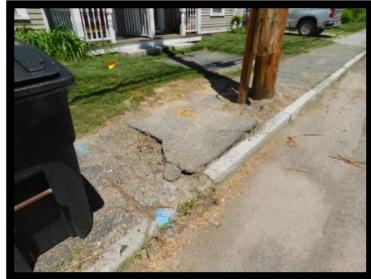
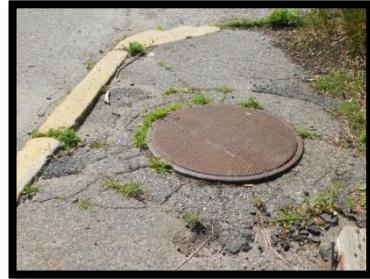
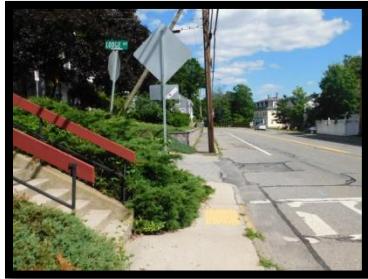
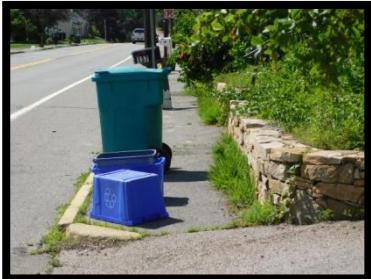
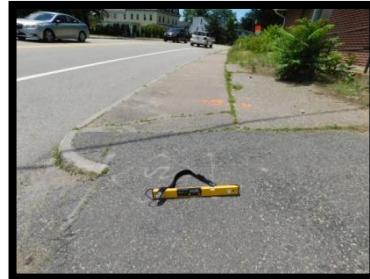
- Hartford Avenue South median in crosswalk
- Recycling and trash bins blocking sidewalk near Hartford Avenue South crosswalk/curb ramp
- Recycling and trash bins blocking sidewalk near #137 West Main Street near Lodge Avenue
- Mailboxes reducing sidewalk clear width near #137 West Main Street
- Manhole cover in sidewalk across from Upton Center creating 1" abrupt change in level surface
- Telephone pole (#67) across from Upton Center reducing sidewalk clear width to 28"
- Vegetative overgrowth near Lodge Avenue and also at #137 West Main Street reducing sidewalk clear width to 24" to 28"

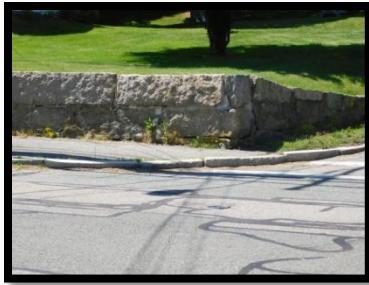
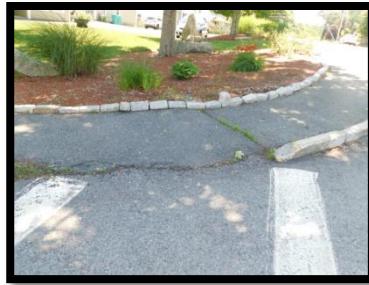
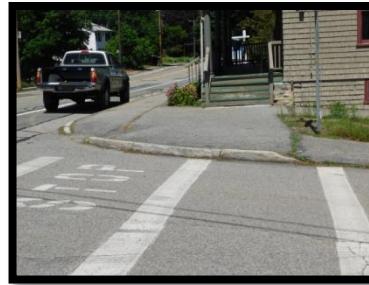
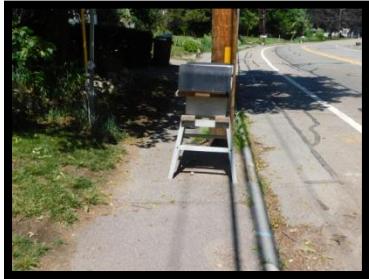
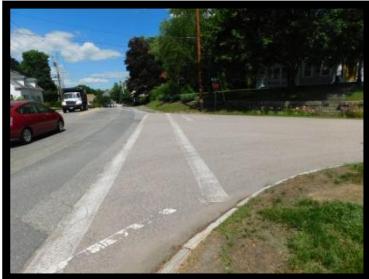
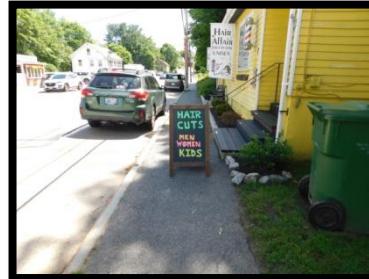
- Hair Affair business sign restricts clear width to 20"
- Recycling and trash bins blocking sidewalk near #101 Main Street
- Mailboxes reducing sidewalk clear width near #'s 87, 83, 81, 95, 77, 78, 68, 66, 41, 39, 37, 57A, 57B, 57C, and 15 Main Street
- Utility cover in sidewalk near #95 Main Street creating 1" abrupt change in level surface
- Telephone poles near #'s 111, 107, 77, 81, and 15 Main Street
- Vegetative overgrowth near #111 Main Street reducing sidewalk clear width to 30"
- Crosswalks terminating in granite curbing of 1" to 3"+ at Memorial School, Fiske Avenue, Pleasant Street, and Plain Street
- Telephone pole #5 "guy wire" across from library reduces headroom to less than 80" and is a protruding object

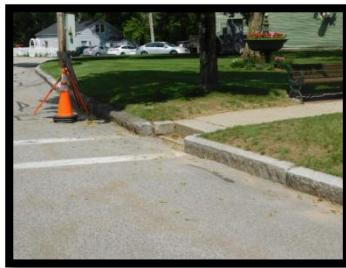
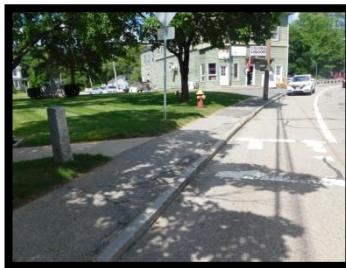
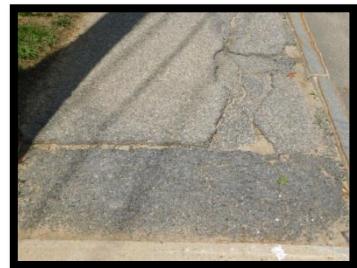
- Crosswalk across Warren Street near Town Hall ends in street on one side and has a 1" abrupt change in level surface on the Town Hall side
- Crosswalk across North Main Street near Town Hall has a 1" abrupt change in level surface at the ramp base
- Crosswalks (2) across North Main Street from the Town Common end in 7" granite steps on the Common side and at a street intersection at one crosswalk and in grass at the other crosswalk
- Crosswalk across Main Street from the Town Common to the Main Street businesses and white church building end in 4" to 5" granite curbing on both sides

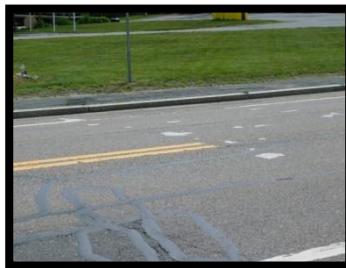
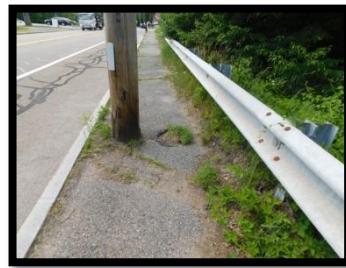
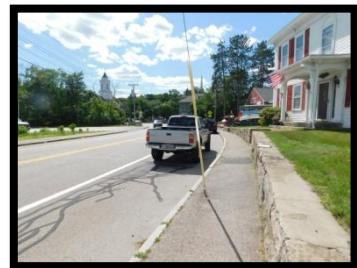
A telephone pole (#6) across from the VFW reduces the sidewalk clear width to 32". Due to the apparent removal of an older pole, there is an abrupt change in level surface of 1½".

A telephone pole (#4) "guy wire" near #10A Milford Street reduces headroom to less than 80" and is a protruding object
