A redevelopment feasibility study for

Upton Town Center

June 2025

PREPARED FOR
The Town of Upton, Massachusetts

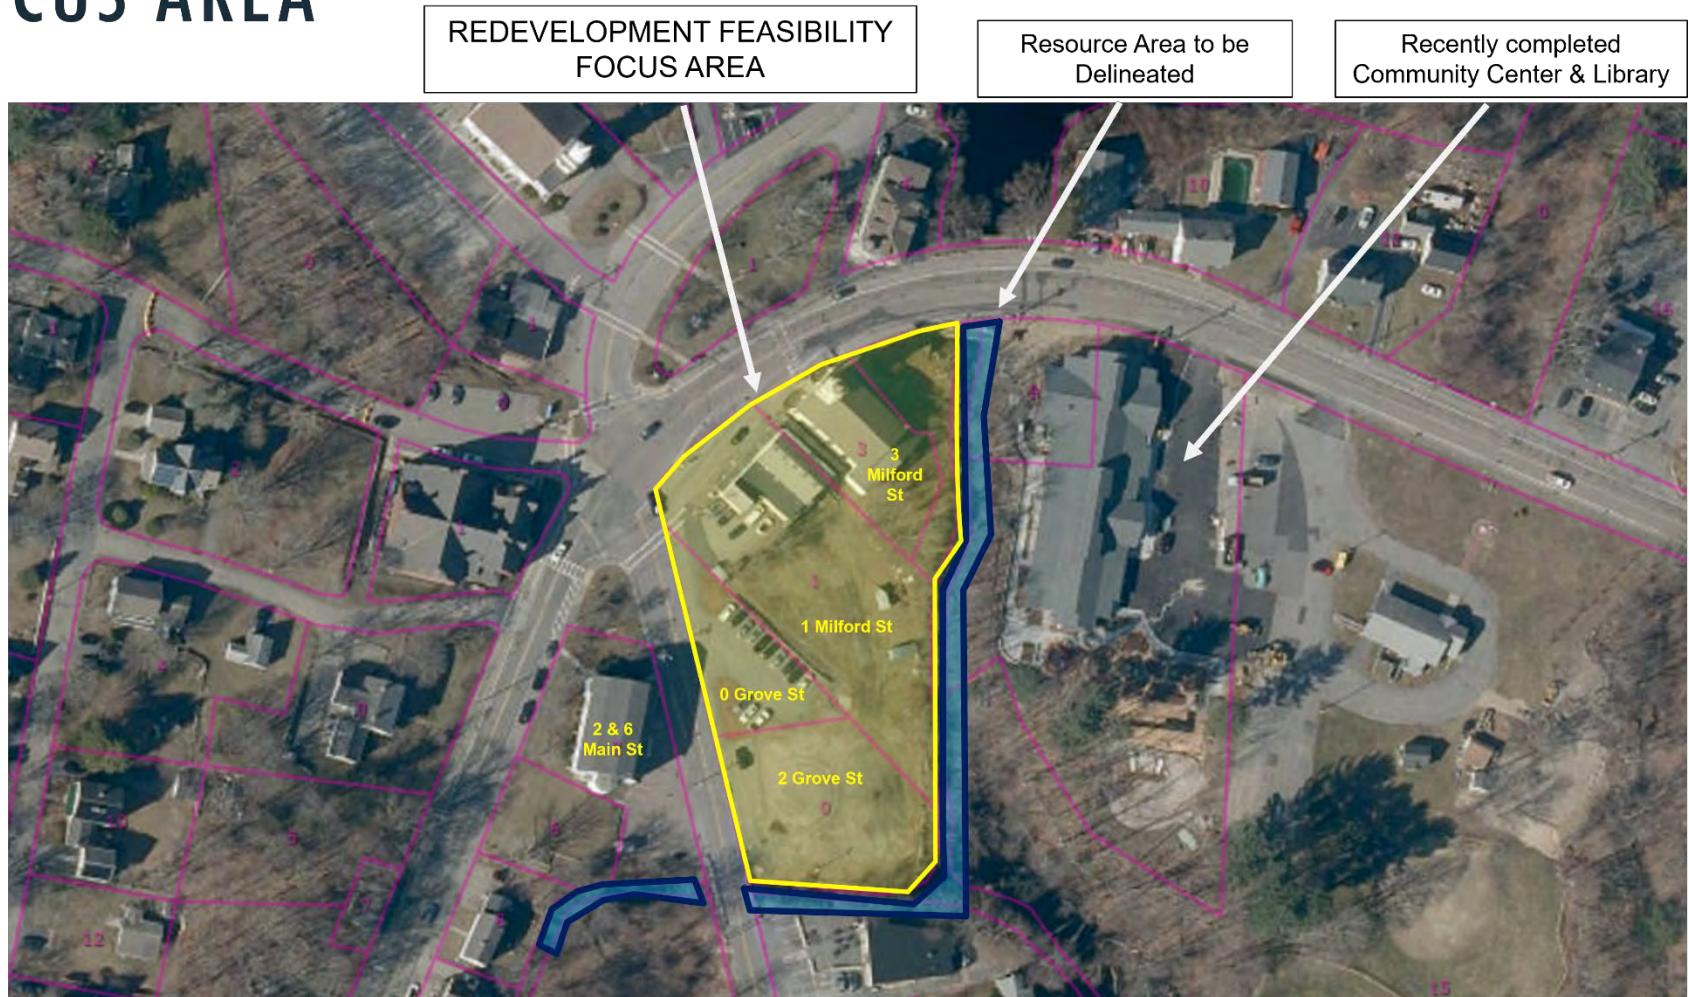
Figure 1 - Upton Town Center Project Focus Area

This redevelopment feasibility study includes four properties in Upton Town Center - 1 & 3 Milford Street and 0 & 2 Grove Street. Of these, 3 Milford Street (Holy Angels) and 0 Grove Street and 2 Grove Street (vacant lots used for parking) are Town owned parcels while 1 Milford Street (also known as the Arcade block) is a privately owned parcel. The project scope includes the following elements:

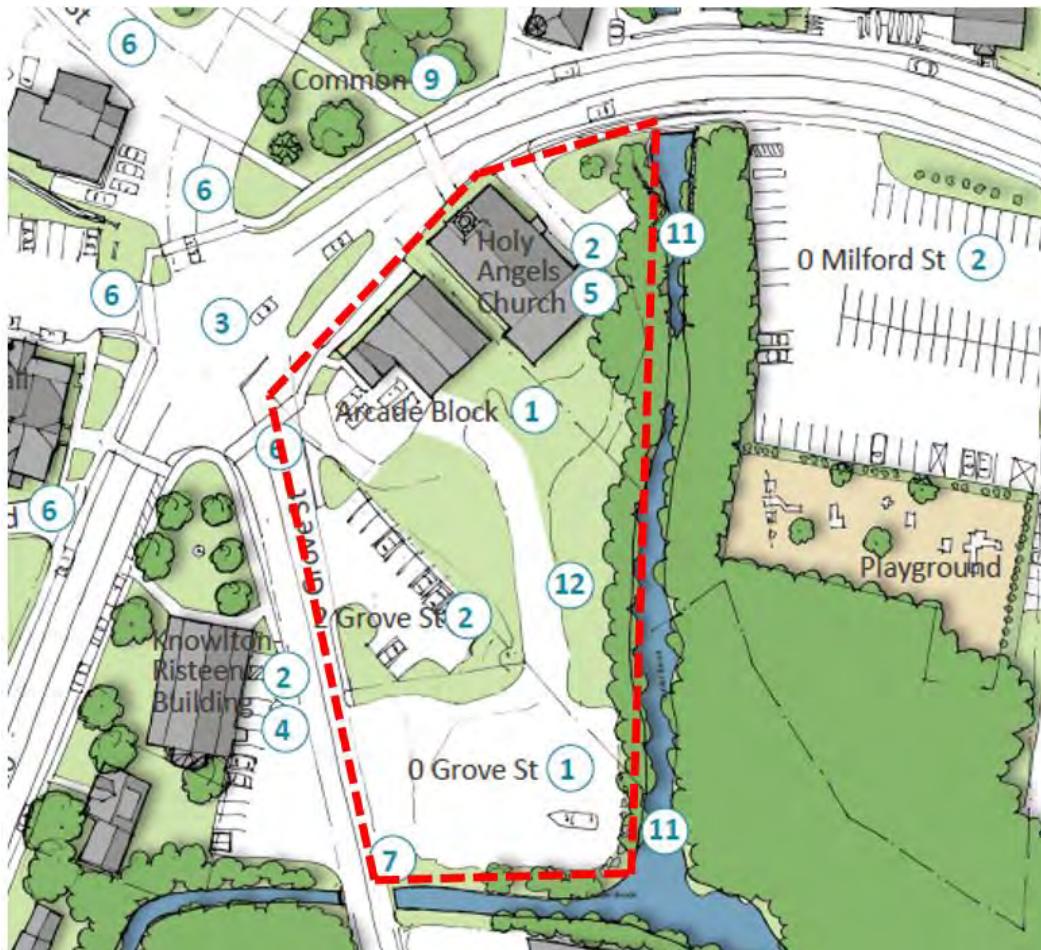
Figure 3 - Portion of the 2019 Vision Plan with the 2025 study area outlined in red

This image shows the existing conditions from the 2019 Vision Plan with the current study area for this project outlined in red.

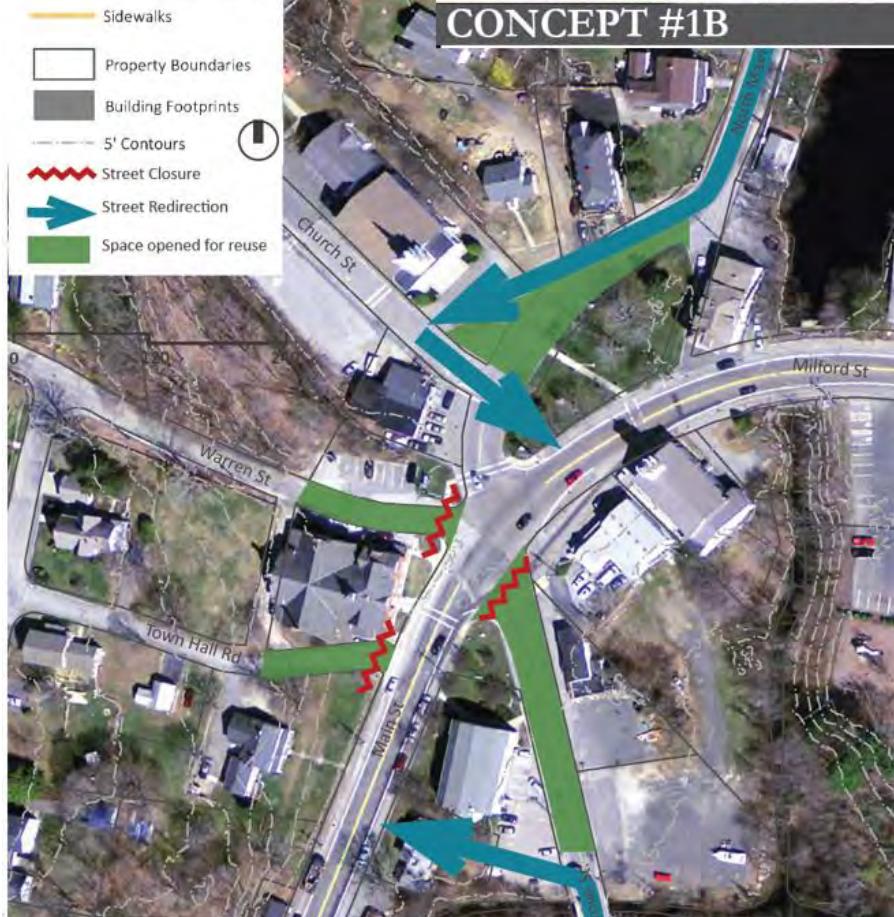
Figure 4 - Shows relocation of Grove Street

The Vision Plan showed the relocation of Grove Street to the south of the Knowlton Risteen Building. See Figure 4. While interesting, the scenario is incompatible with the current MassDOT TIP project design. As shown in Figure 5, the relocation of Grove Street significantly changed the parcel boundaries and resulted in a conceptual design with new buildings located between the Holy Angels Church and the Knowlton/Risteen building and a large parking area.

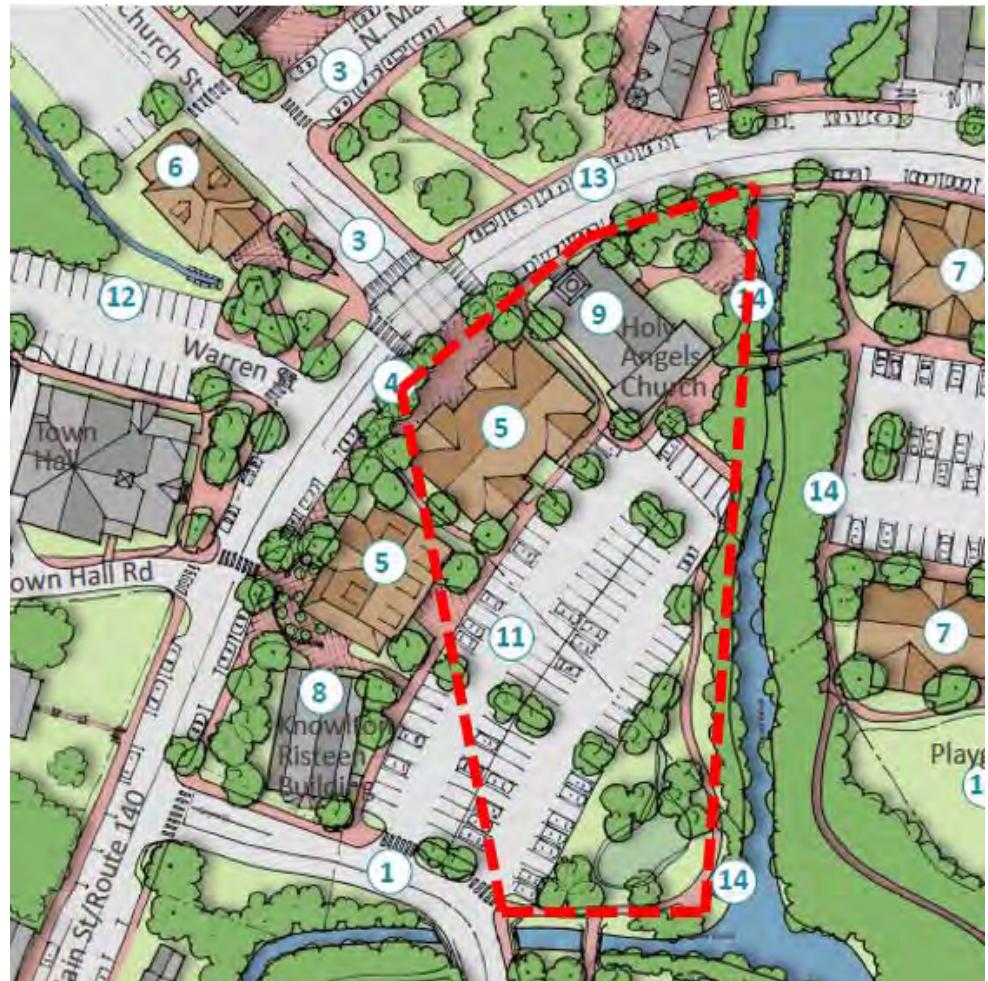
Figure 5 - Shows a conceptual design with the relocation of Grove Street

However, with the advancement of the MassDOT TIP project beyond the 25% design phase, the concept is no longer feasible.

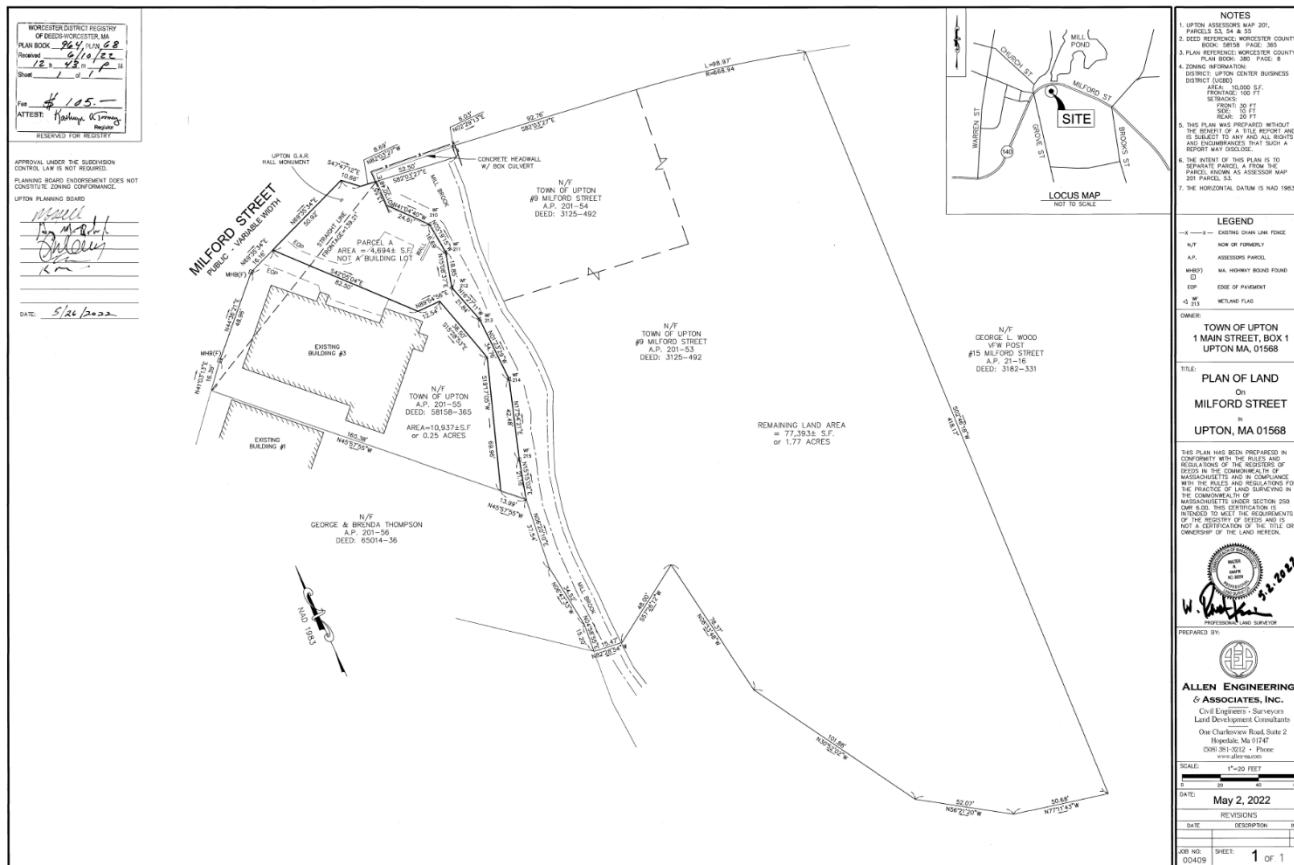
Figure 7 – ANR Plan endorsed in 2022

An Approval Not Required (ANR) plan was endorsed by the Planning Board on May 26, 2022 (Plan Book 964, Page 68) to separate 3 Milford Street from the parcel to the east shown as Parcel A which is a small, 4,694 square foot parcel owned by the Town.

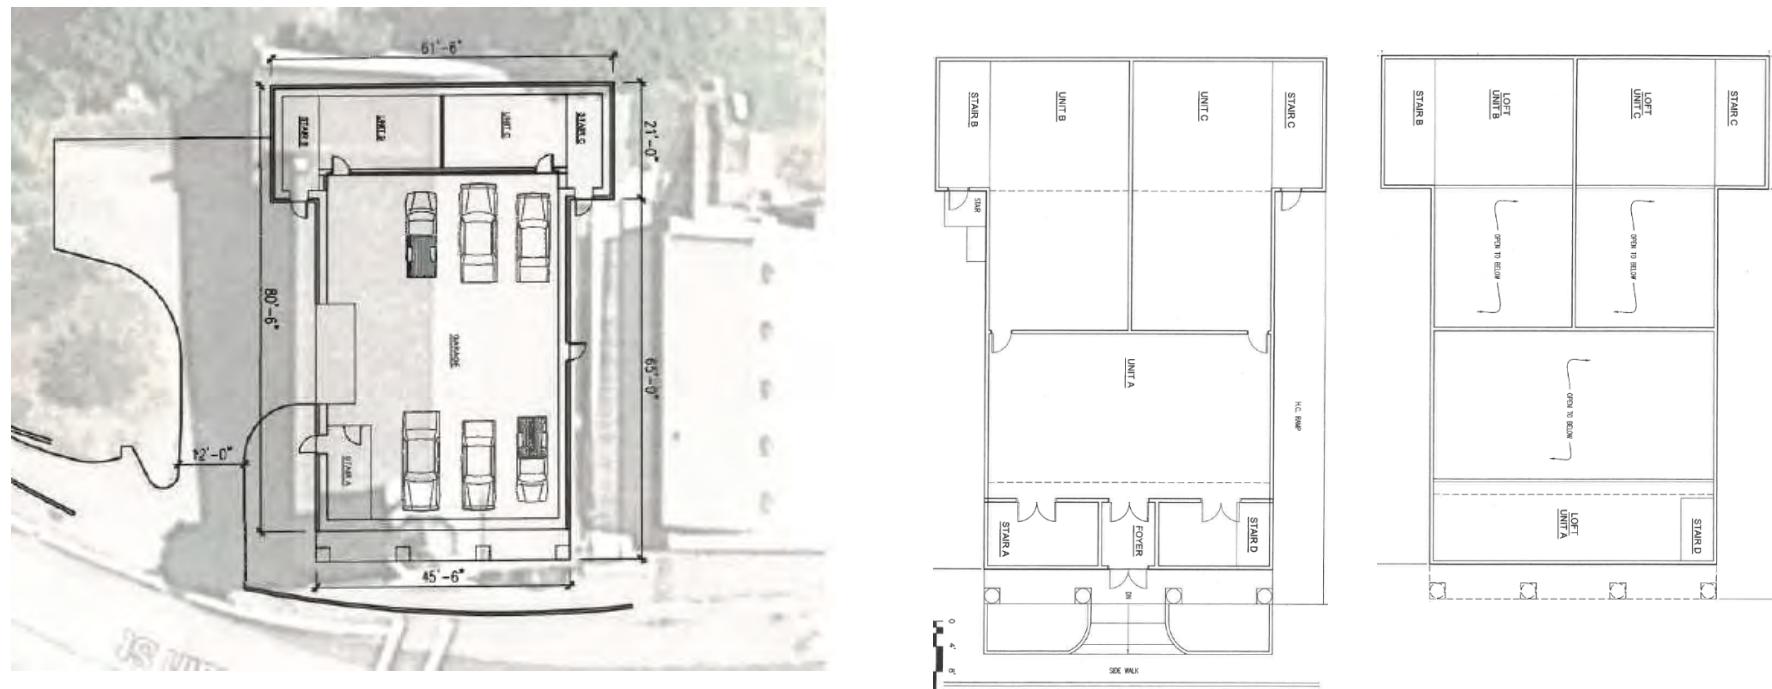
Figure 9 - Excerpt from approved plans showing three units and basement parking

In 2015, the Planning Board approved a Site Plan Review application to convert the existing church building into 3 dwelling units with enclosed parking spaces in the basement. The permit approval contained several conditions including approval of a fire suppression plan, no left turn onto Milford Street, and provisions for a 16-foot-wide driveway. The site plan showed a driveway width of 12 feet and given the steep slope and proximity to Main Street; it is unclear if the required width is achievable. The project was never initiated beyond the Planning Board permit phase.

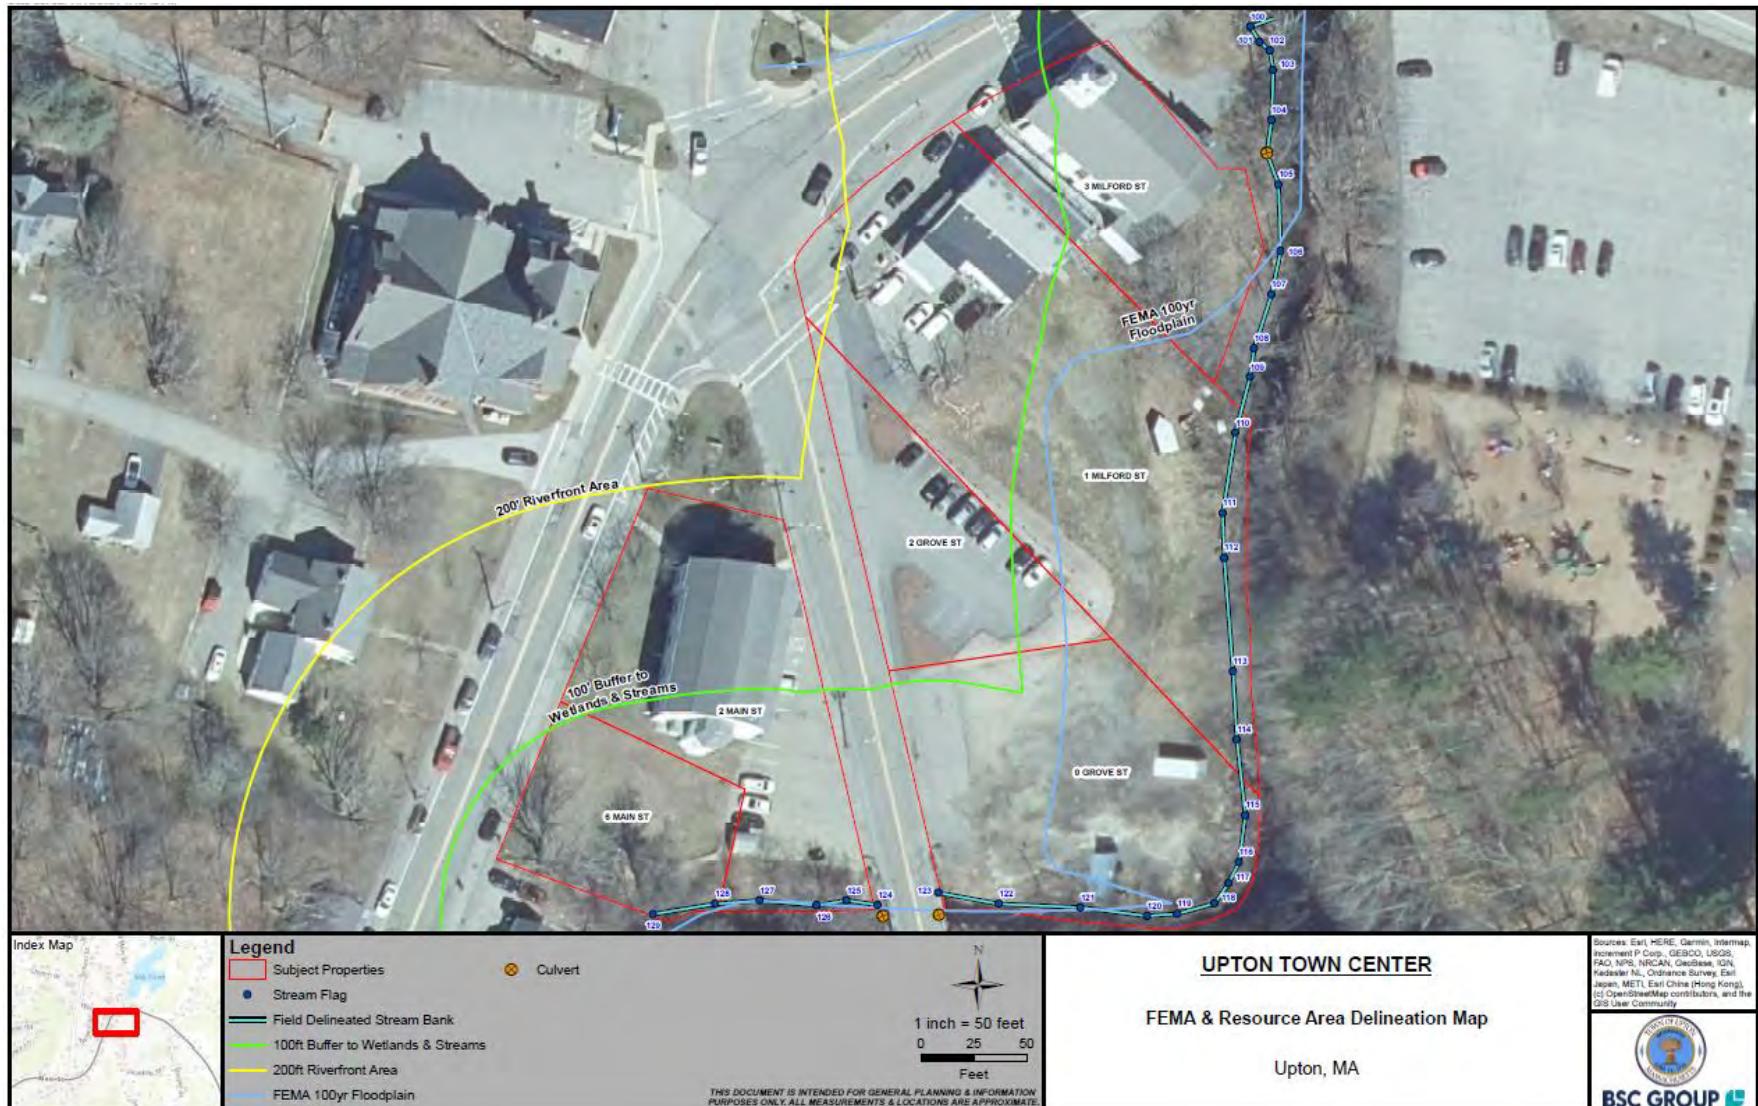
Figure 12 - Abbreviated Notice of Resource Area Delineation (ANRAD) plan

No Bordering Vegetated Wetlands (BVW) were identified on site. Other wetland resources include Bordering Lands Subject to Flooding (BLSF) and a 200-ft Riverfront Area, along with a 100-ft buffer zone to the Inland Bank. The Riverfront Area and 100-ft Buffer Zone boundaries are determined in GIS as 200-ft and 100-ft offsets from the Inland Bank boundary line.

The resulting plan is suitable for the Town to use as an Abbreviated Notice of Resource Area Delineation (ANRAD) filing with the Conservation Commission. See Figure 12. Once the ANRAD is approved, it will provide an agreed upon baseline from which any future development project would utilize for permitting with the Conservation Commission.

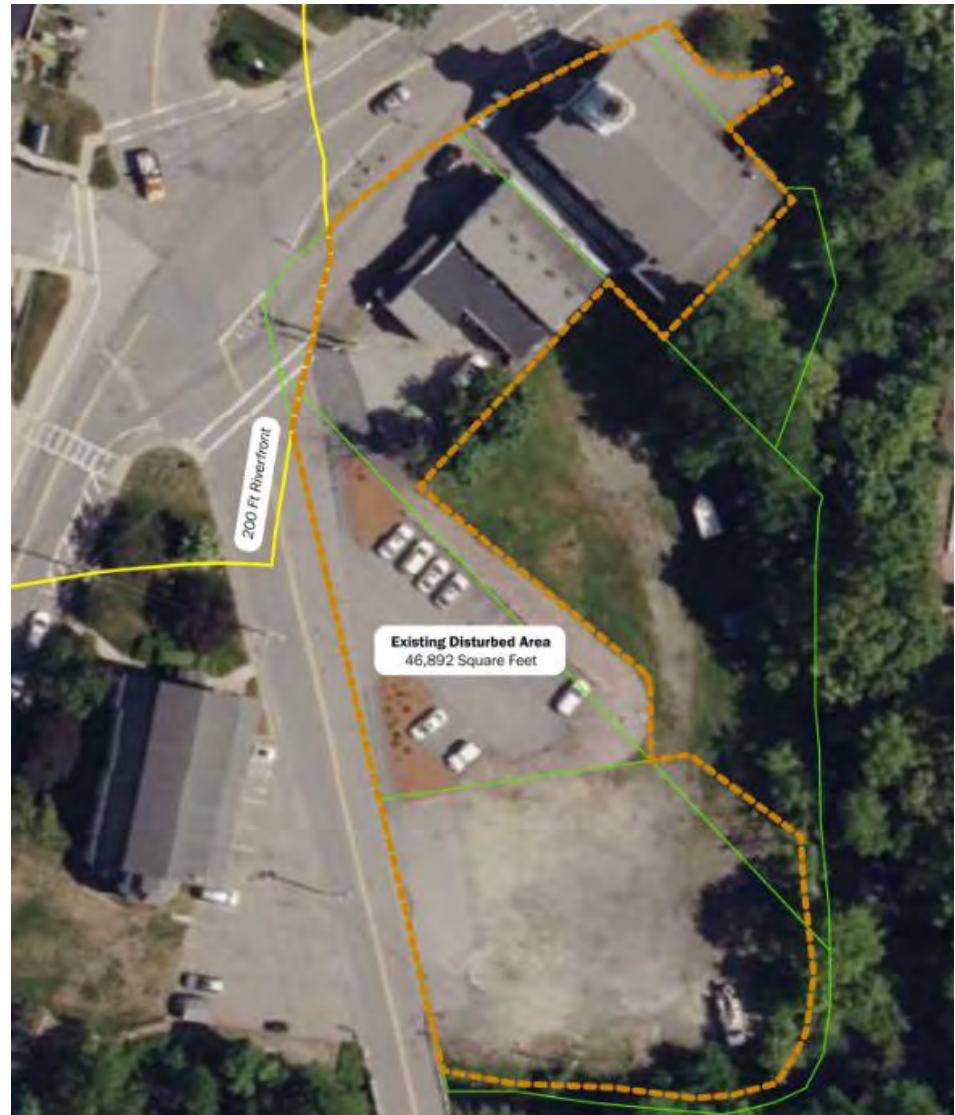
Figure 13 - Approximate area of RFA disturbance

As discussed in the Permitting Analysis, historical imagery was used to provide a preliminary calculation of areas defined under the Riverfront Regulations 310 CMR 10.58 as previously disturbed.

As shown on the map, approximately 1.46 acres are within previously disturbed riverfront area (RFA). This preliminary calculation is important for future redevelopment as it provides an estimate for land that can be eligible for redevelopment.

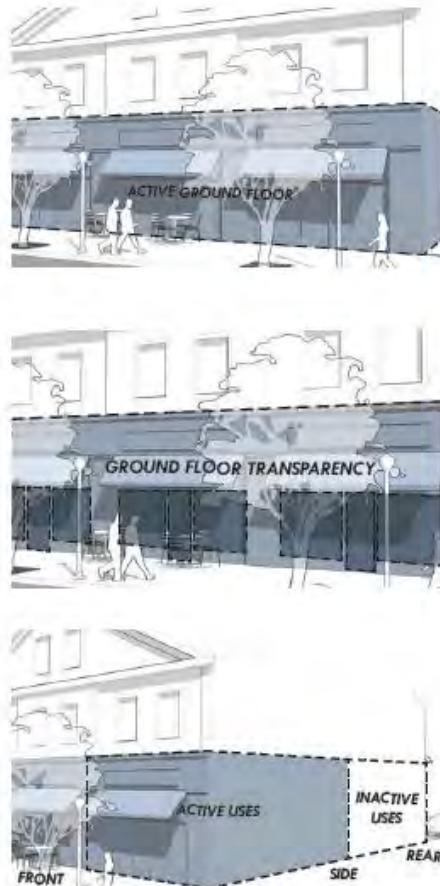
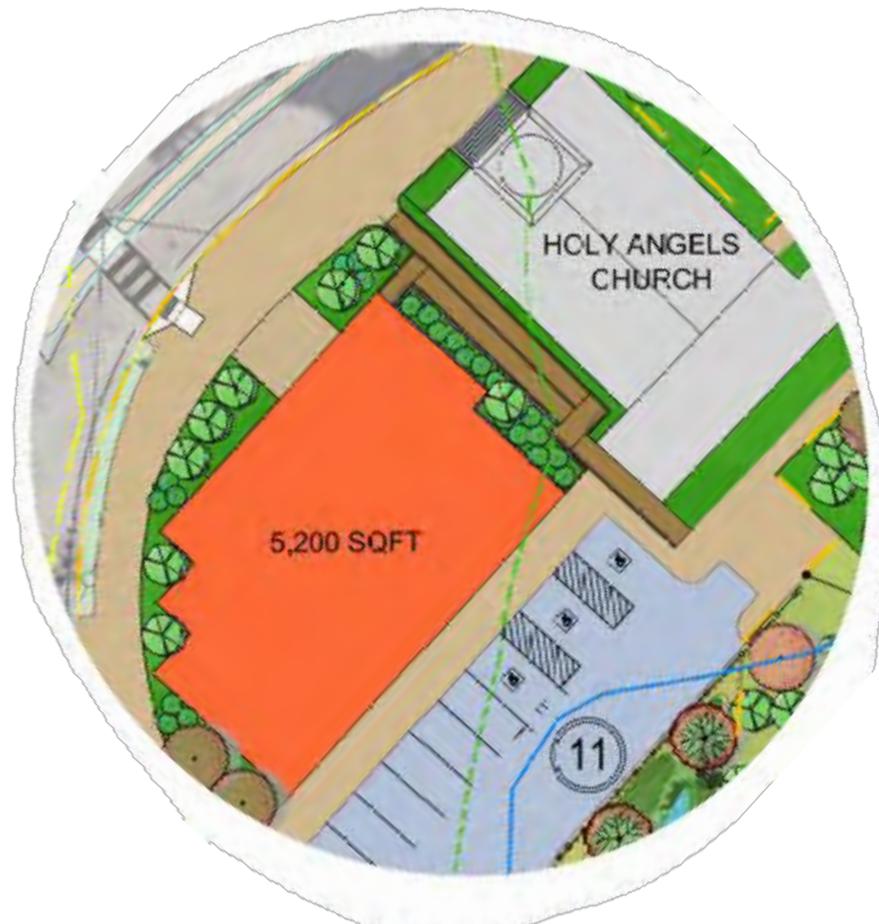
Figure 16 - Left: Excerpt from East Dedham Square Design Guidelines. Right: Proposed Concept Plan A.

Creating an active first floor area in a mixed-use building is essential to creating a walkable Town Center. This active space is traditionally occupied by shops, service businesses, restaurants, cafes, or art galleries. The least active uses should be oriented towards the back of the building and can include residential entrances and in some cases, can provide accessible units.

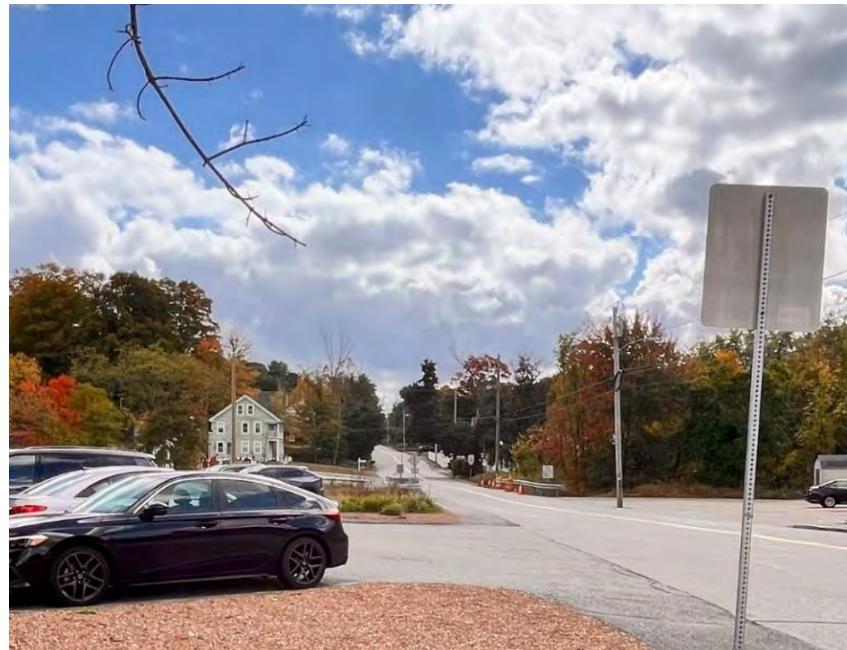
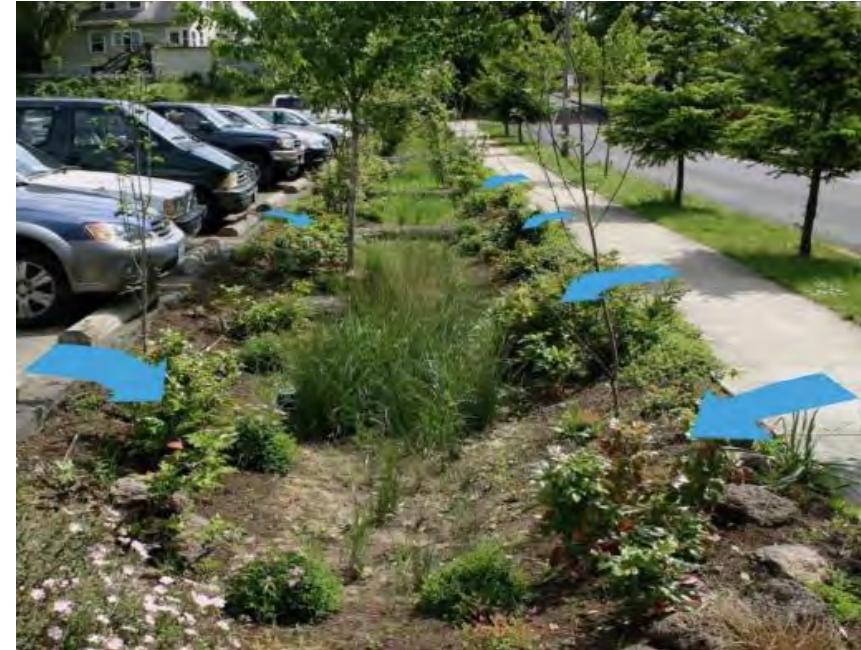
Figure 17 - Photo - Left: Existing town parking lot on Grove Street. Right: Parking lot runoff directed into a bioswale*

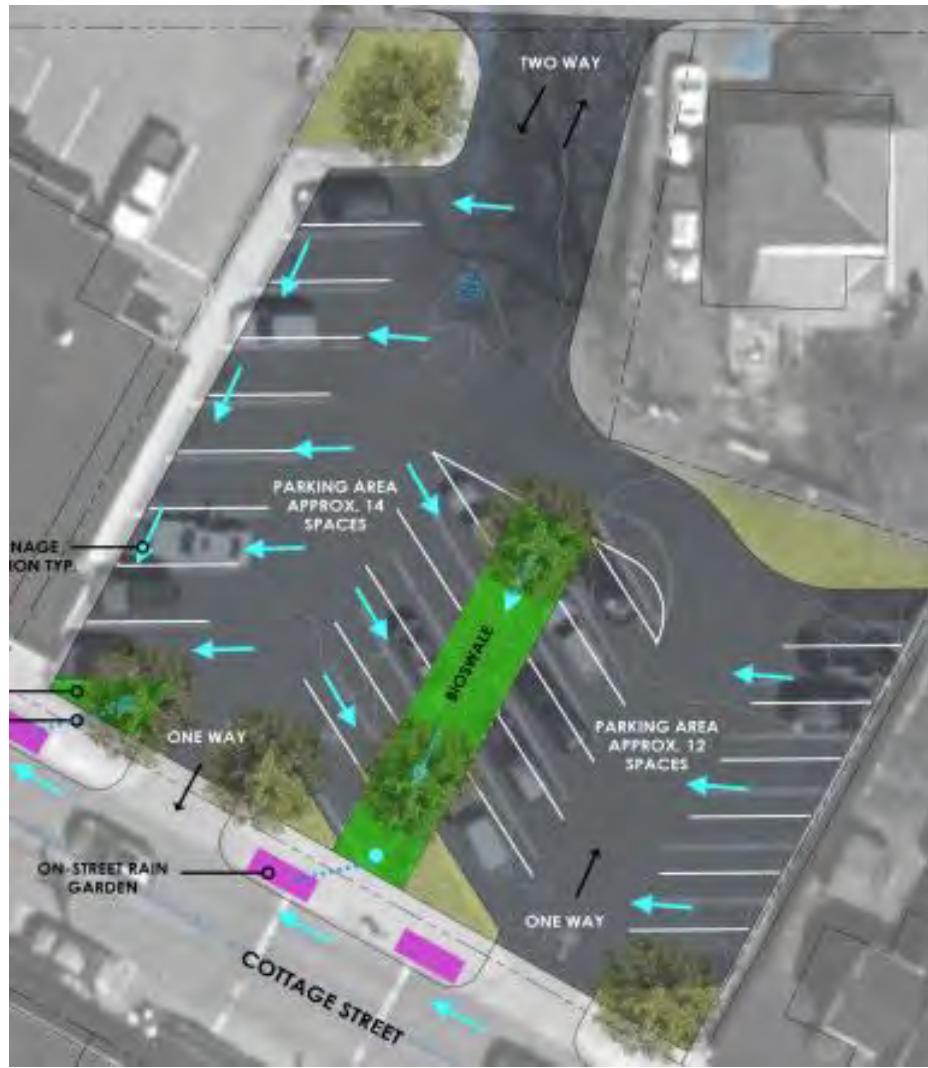
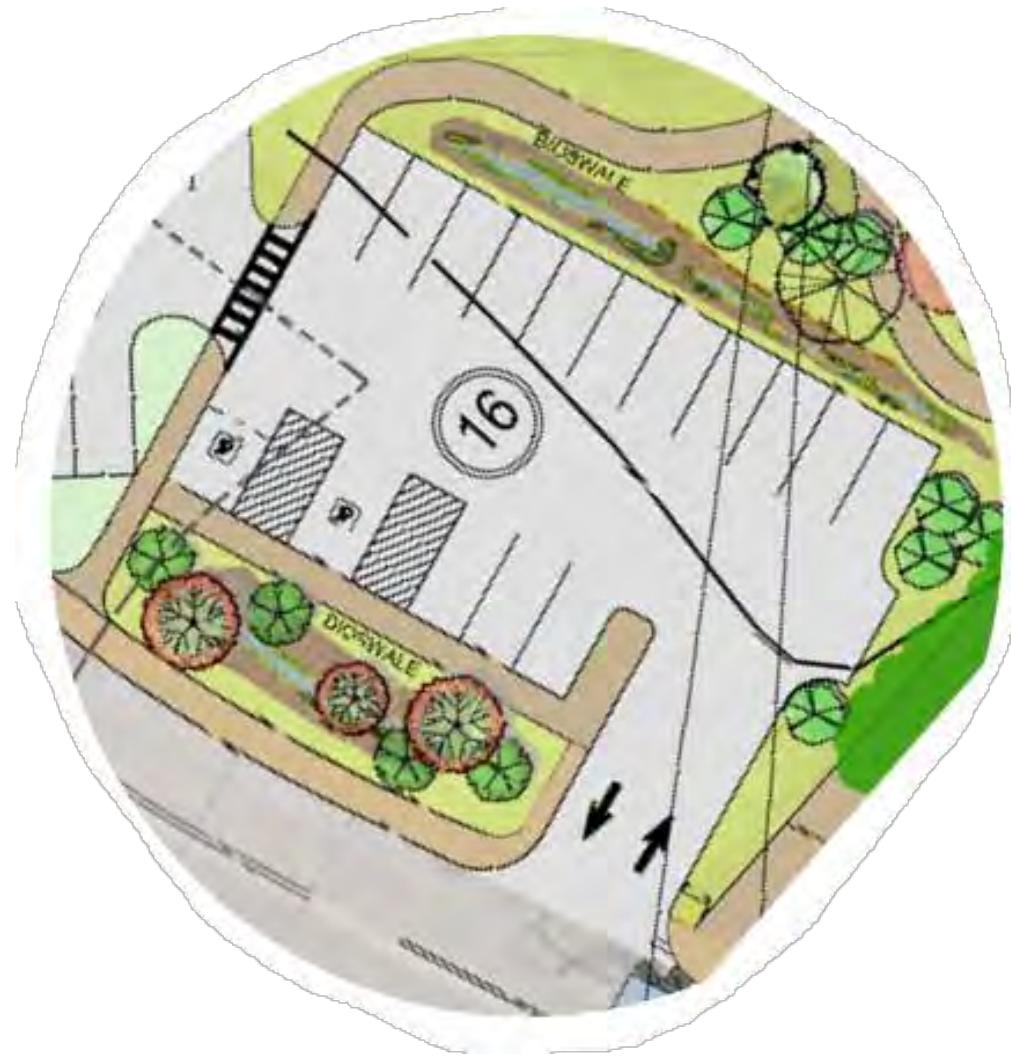
Figure 18 - Left: A municipal parking lot in Easthampton's Green Infrastructure Master Plan.
Right: Excerpt from proposed Concept Plan D showing the expansion of Upton's municipal parking lot on Grove Street.

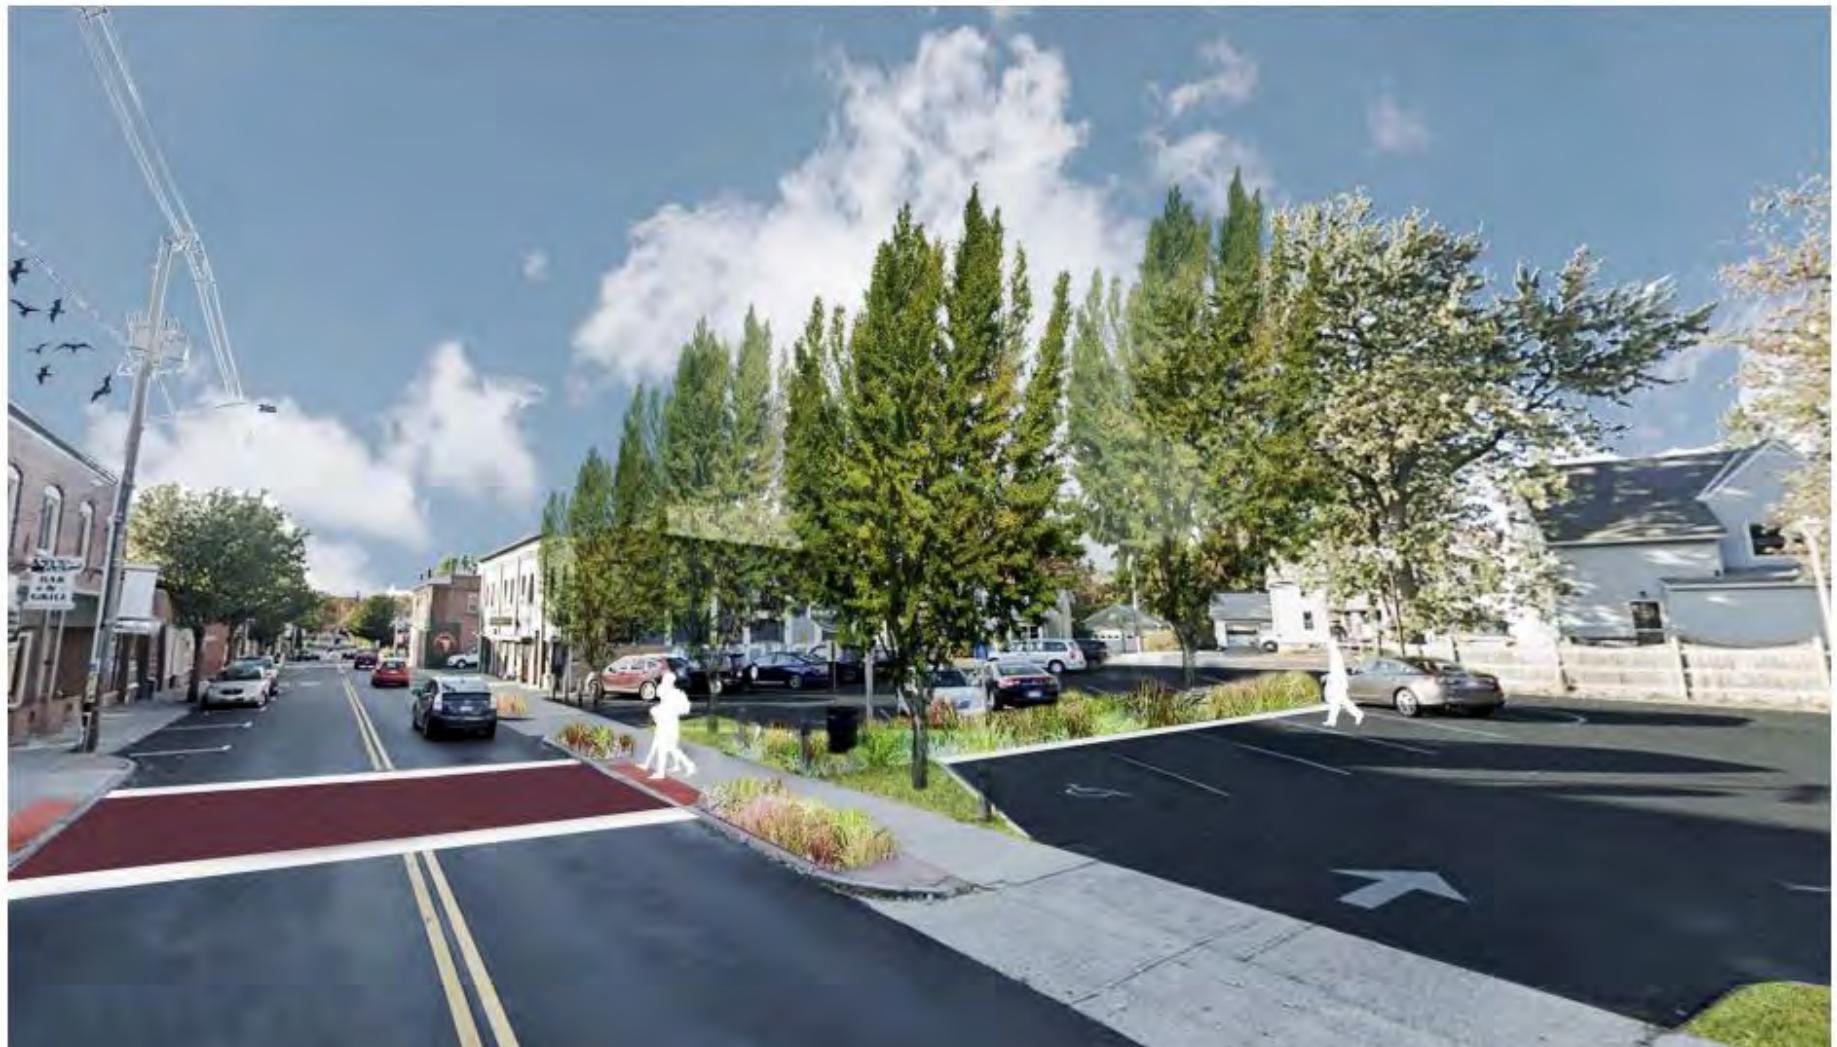
Figure 19 - Rendering of the municipal parking lot in Easthampton's Green Infrastructure Master Plan.

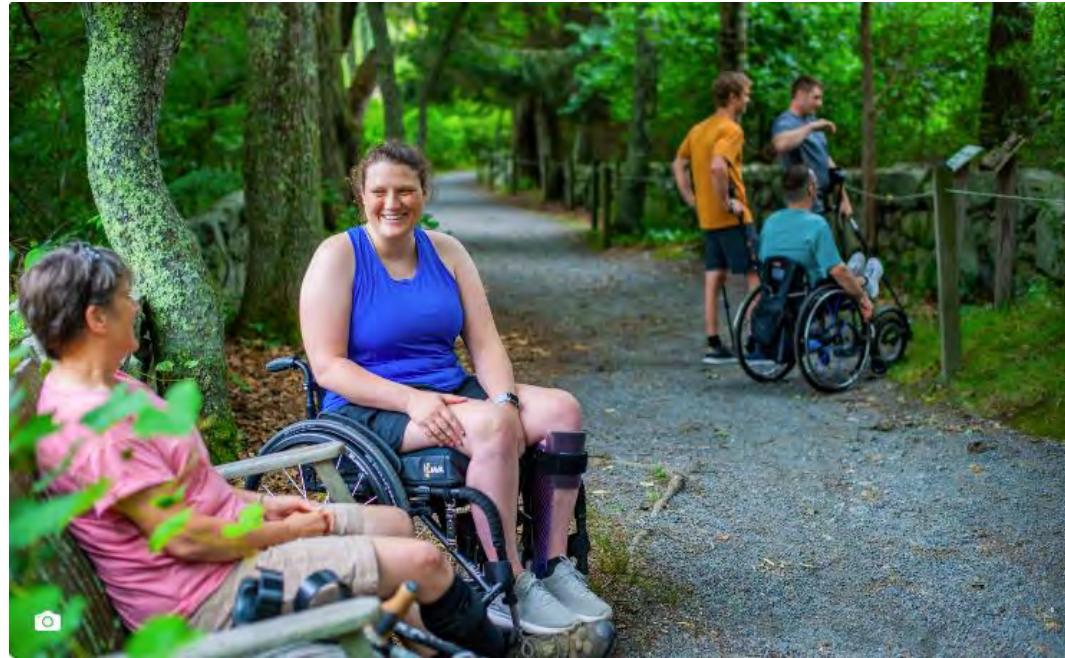
Figure 20 - Photo: Accessible trail from Mass Audubon All Persons Trail guide.

The two projects identified below, are prime examples of accessible trails adjacent to resource areas. Each provides accessible pedestrian access using a stone dust surface and meet the U.S. Forest Service standards for accessibility. Park projects that incorporate U.S. Forest Service standards into their design and construction are eligible for funding through state programs such as MassTrails and the Parkland Acquisitions and Renovations for Communities (PARC) program.

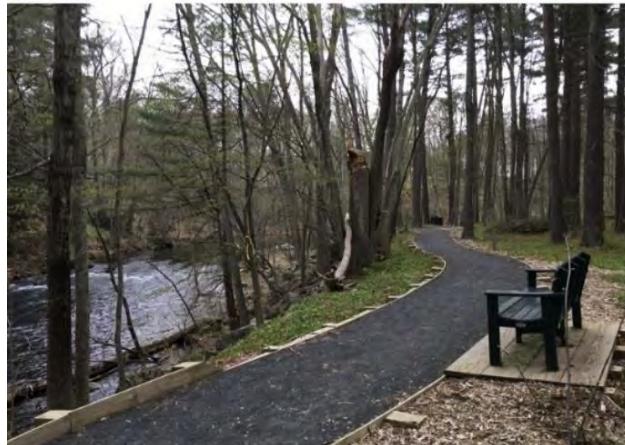
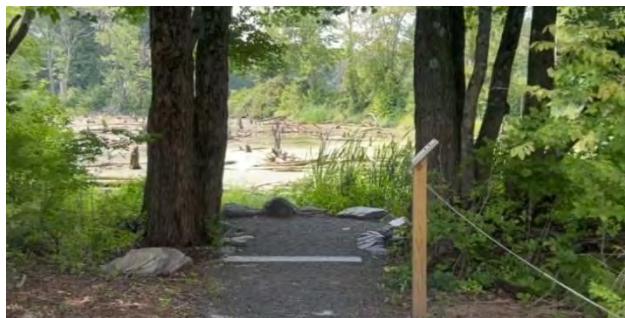
*Figure 21 - Photo - Top: Swift River Universal Access Trail Loop in Palmer MA (Marcy Marchello)
Bottom: Lake Wallace Sensory Trail in Belchertown MA (New England Outdoor Project)*

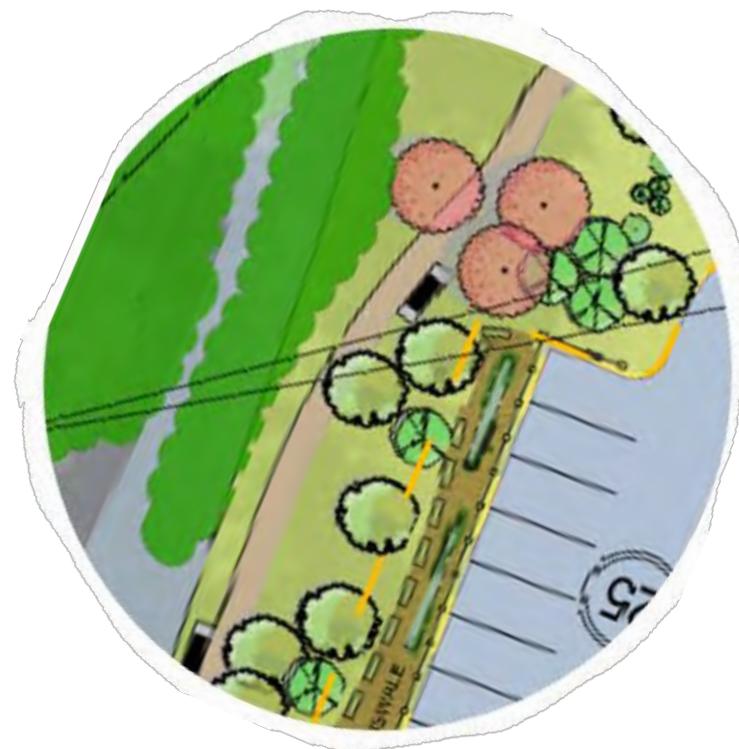
Figure 22 - Excerpt showing an accessible path from the proposed Concept Plans.

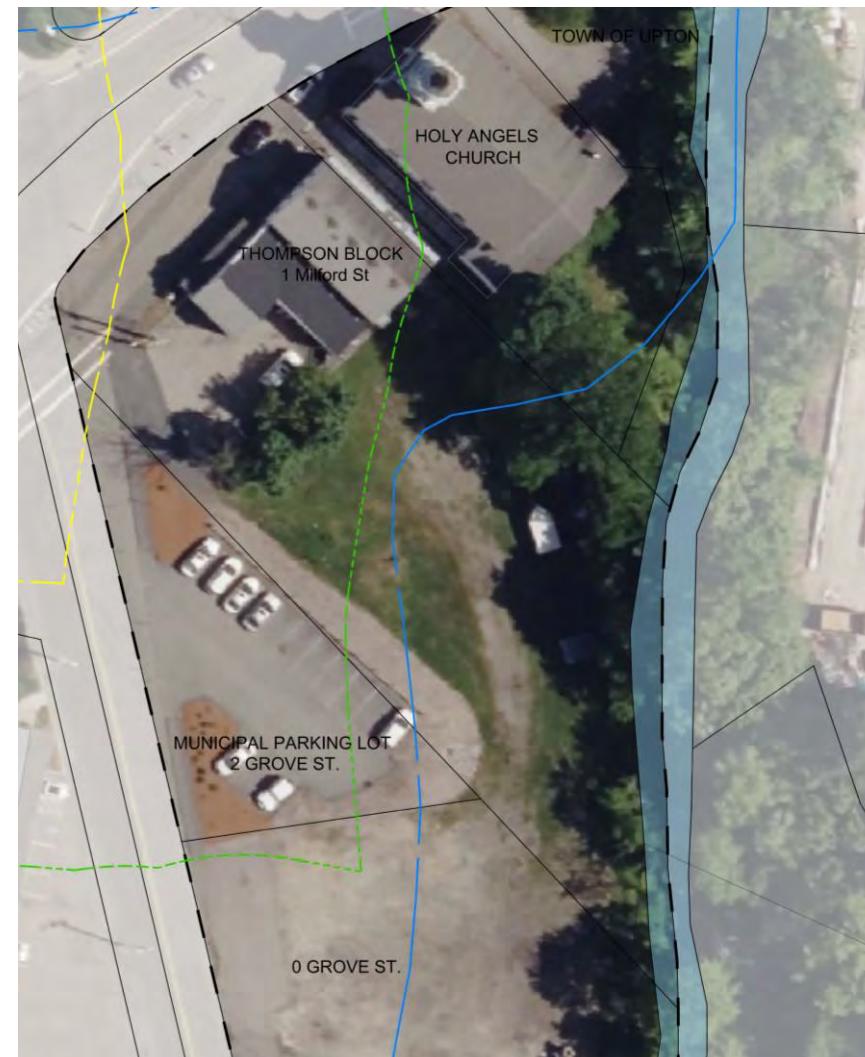
Resource Area Delineation

- Center Brook runs along site study area
- BSC ecologists delineated the top of bank
- Creates baseline data to make the permitting more predictable

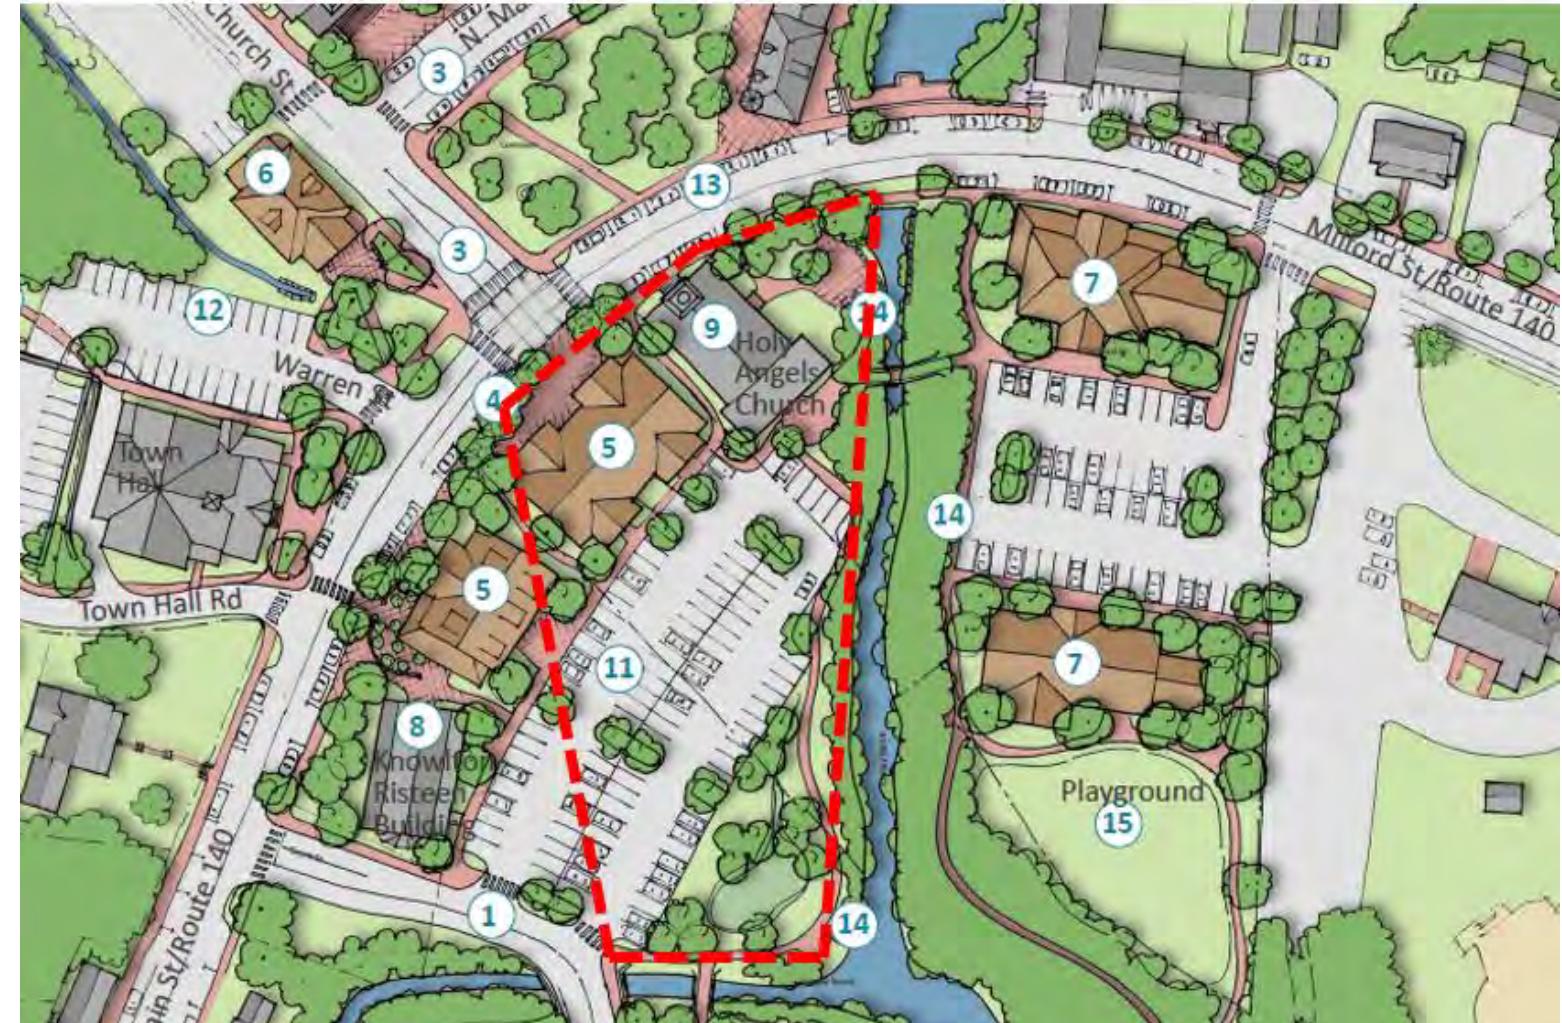
Town Center Vision

- 2019 Vision Plan
 - Created an ambitious and ultimately infeasible concept for the town center by relocating Grove Street.
 - This concept plan became infeasible as the MassDOT TIP project advanced.
