A redevelopment feasibility study for

Upton Town Center

June 2025

PREPARED FOR
The Town of Upton, Massachusetts

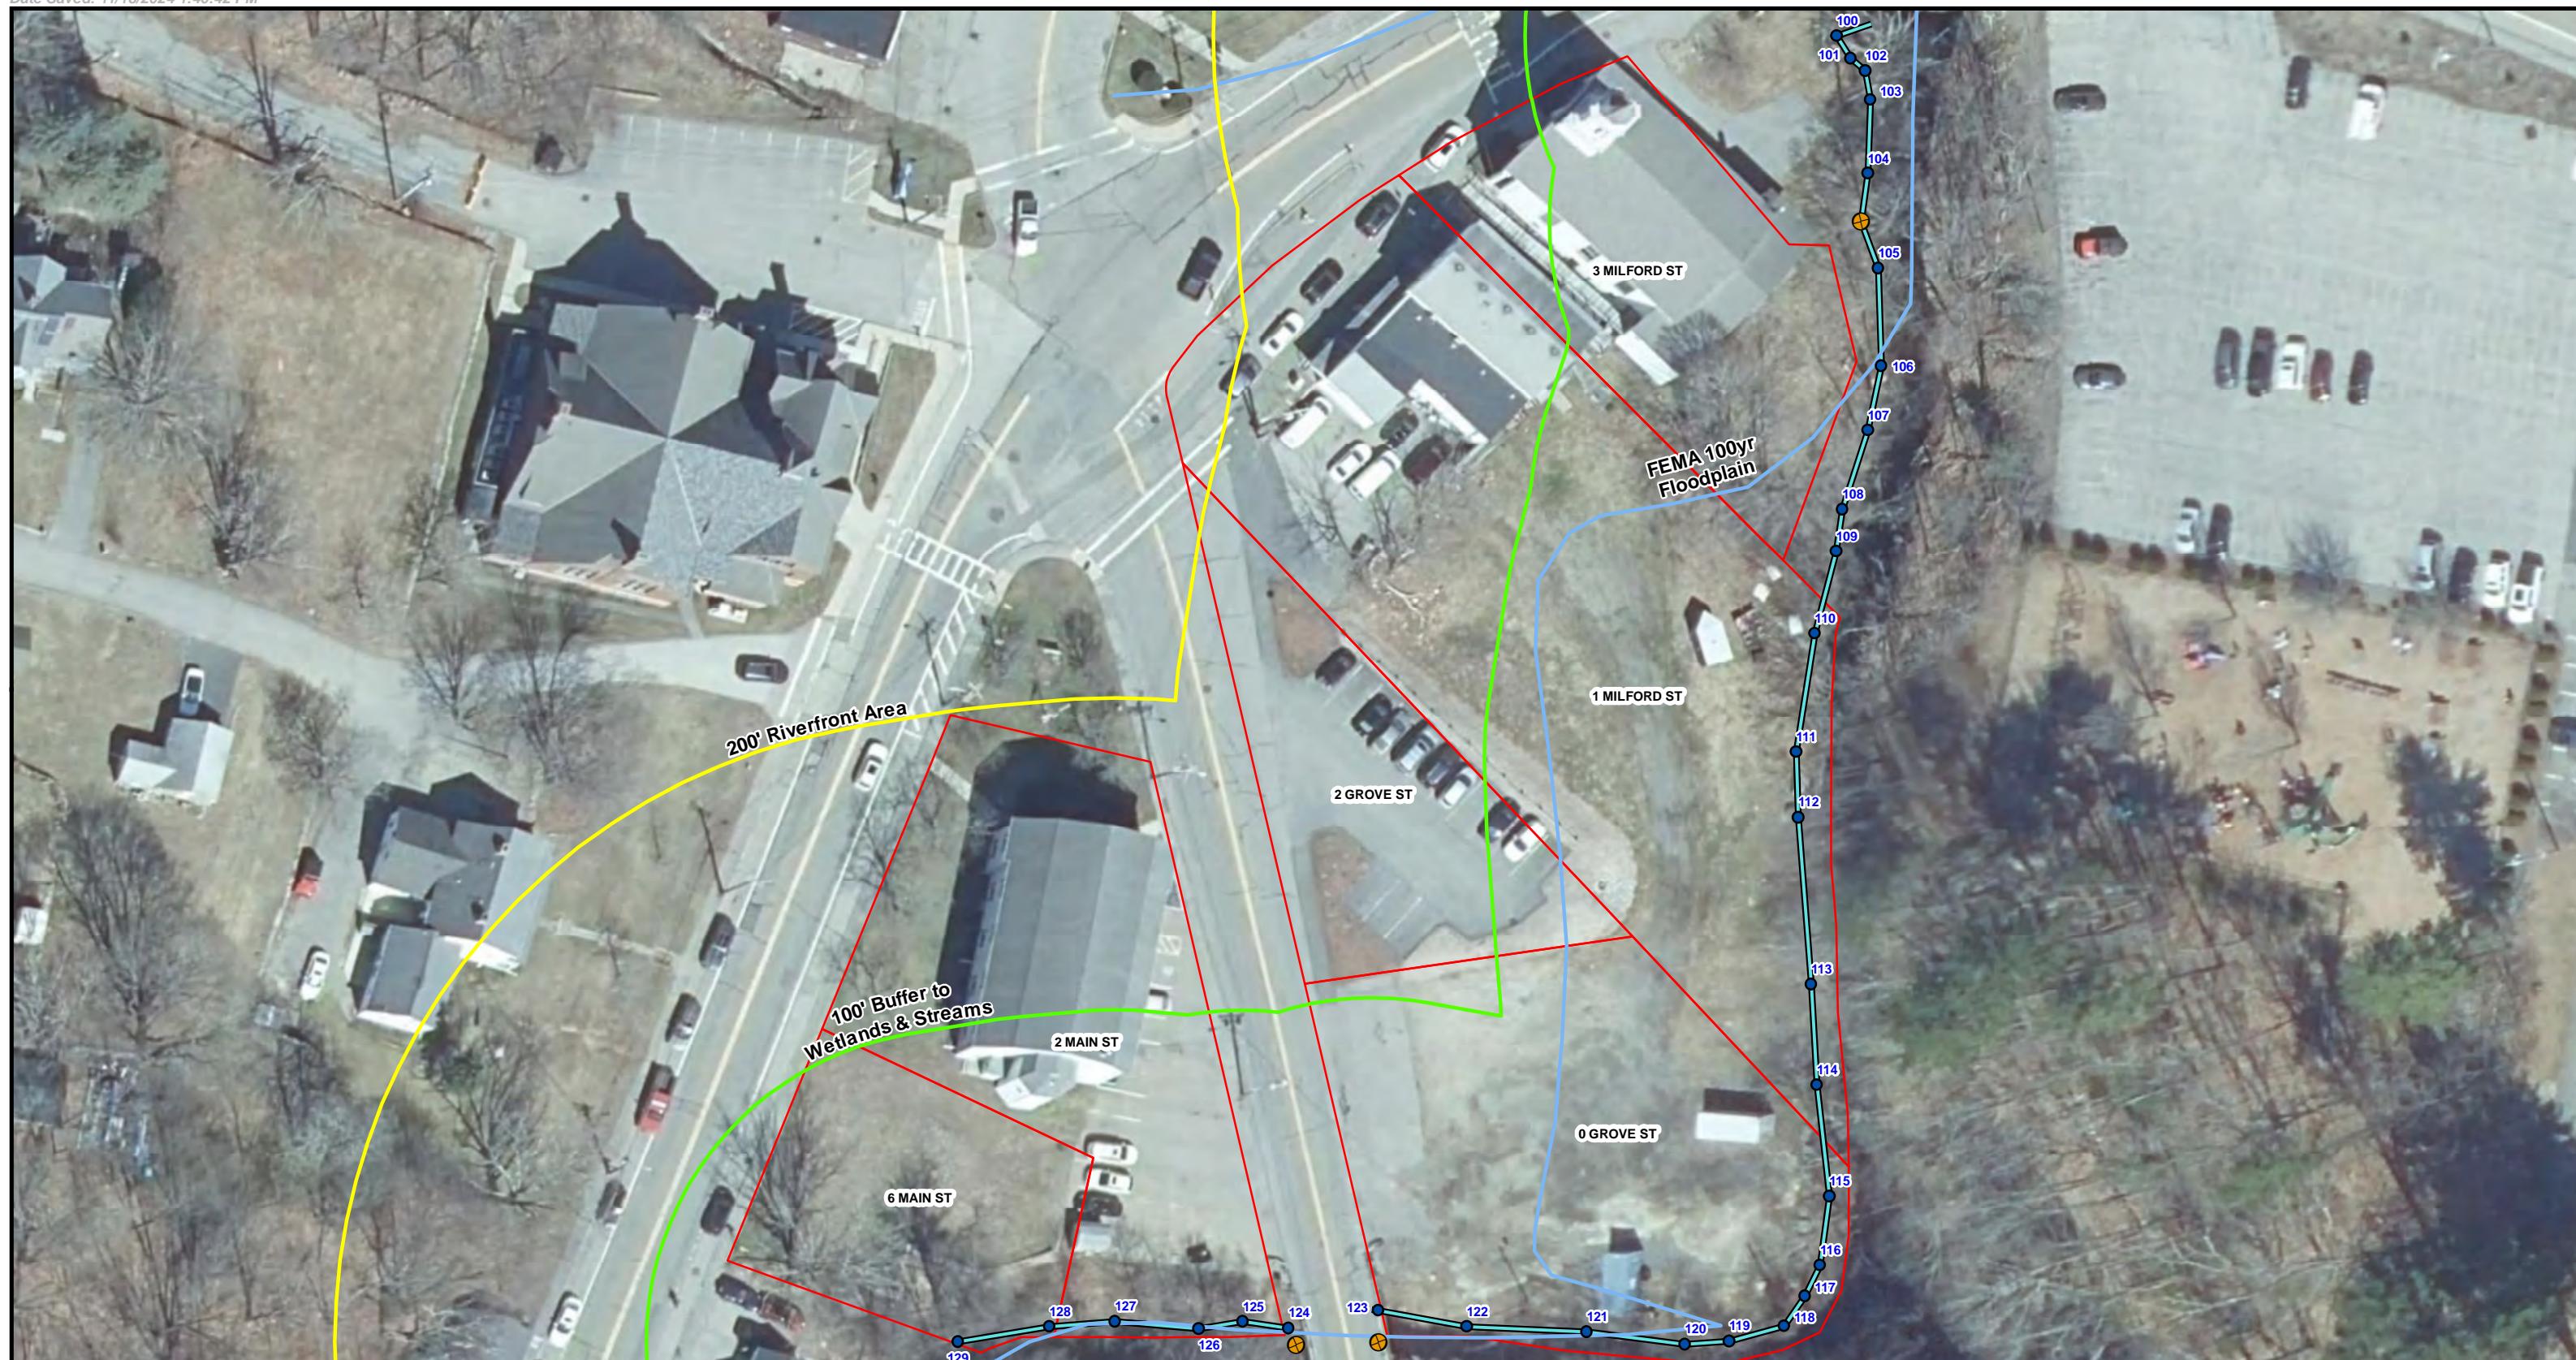
- Subject Properties
- Stream Flag
- Field Delineated Stream Bank
- 100ft Buffer to Wetlands & Streams
- 200ft Riverfront Area
- FEMA 100yr Floodplain

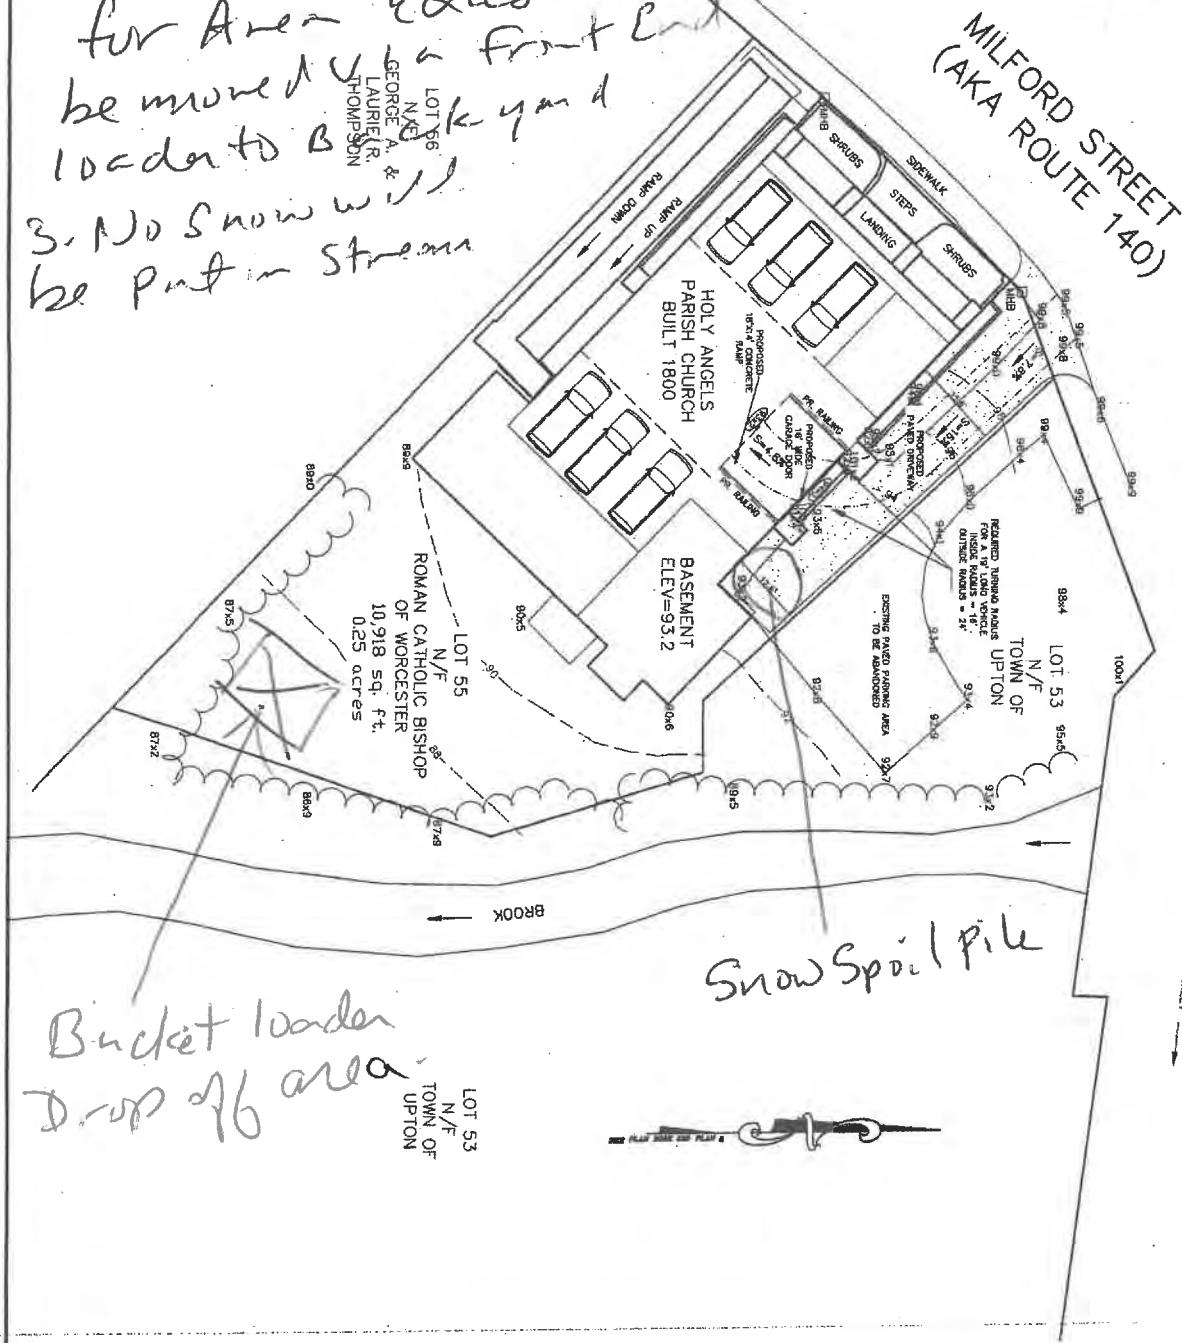
DATE: 12-3-14
SCALE: 1" = 20'-0"
PROJECT NUMBER: 201419
DRAWING NUMBER: SKC-2

0 10' 20' 40'
SCALE: 1" = 20'

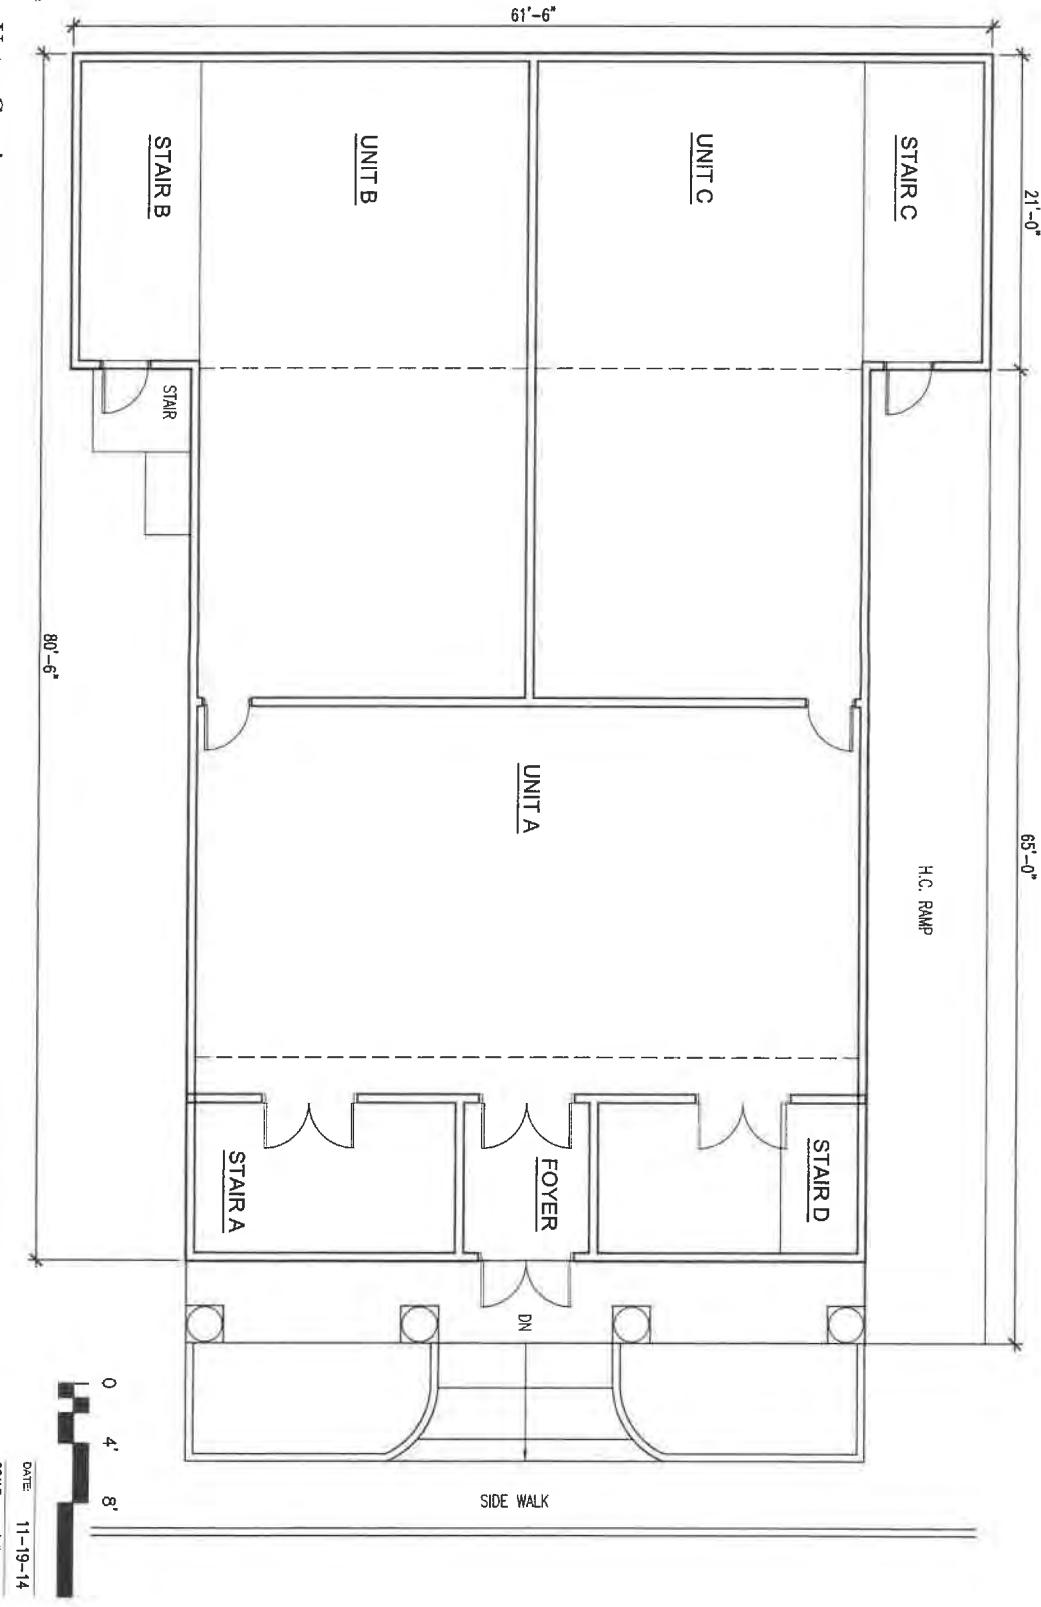
DRAWING NUMBER:
SKA-2

SCHEMATIC DESIGN
SECOND FLOOR PLAN

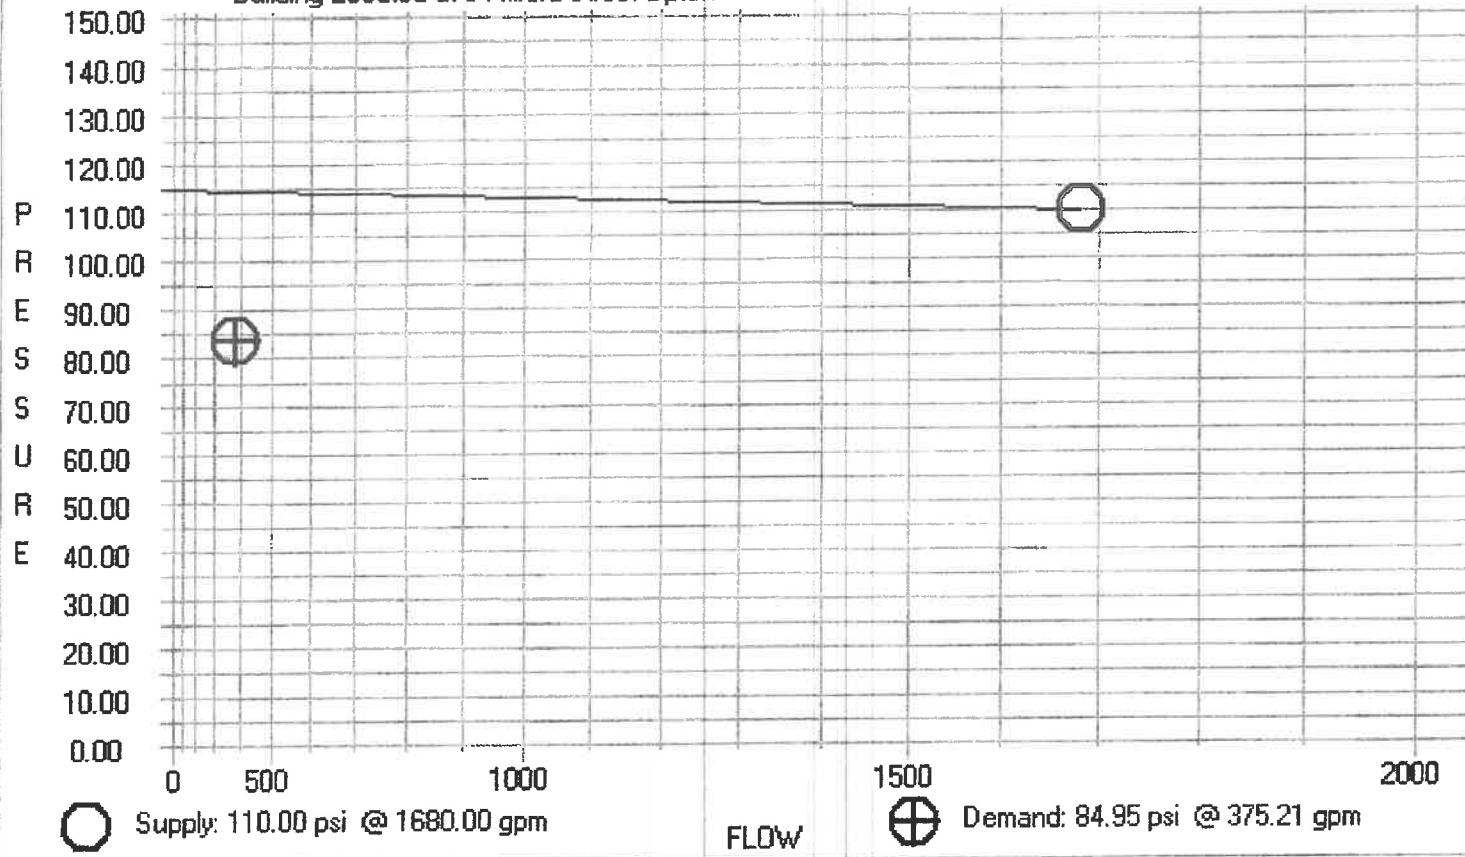
WATER SUPPLY/DEMAND GRAPH

Building Located at 3 Milford Street Upton

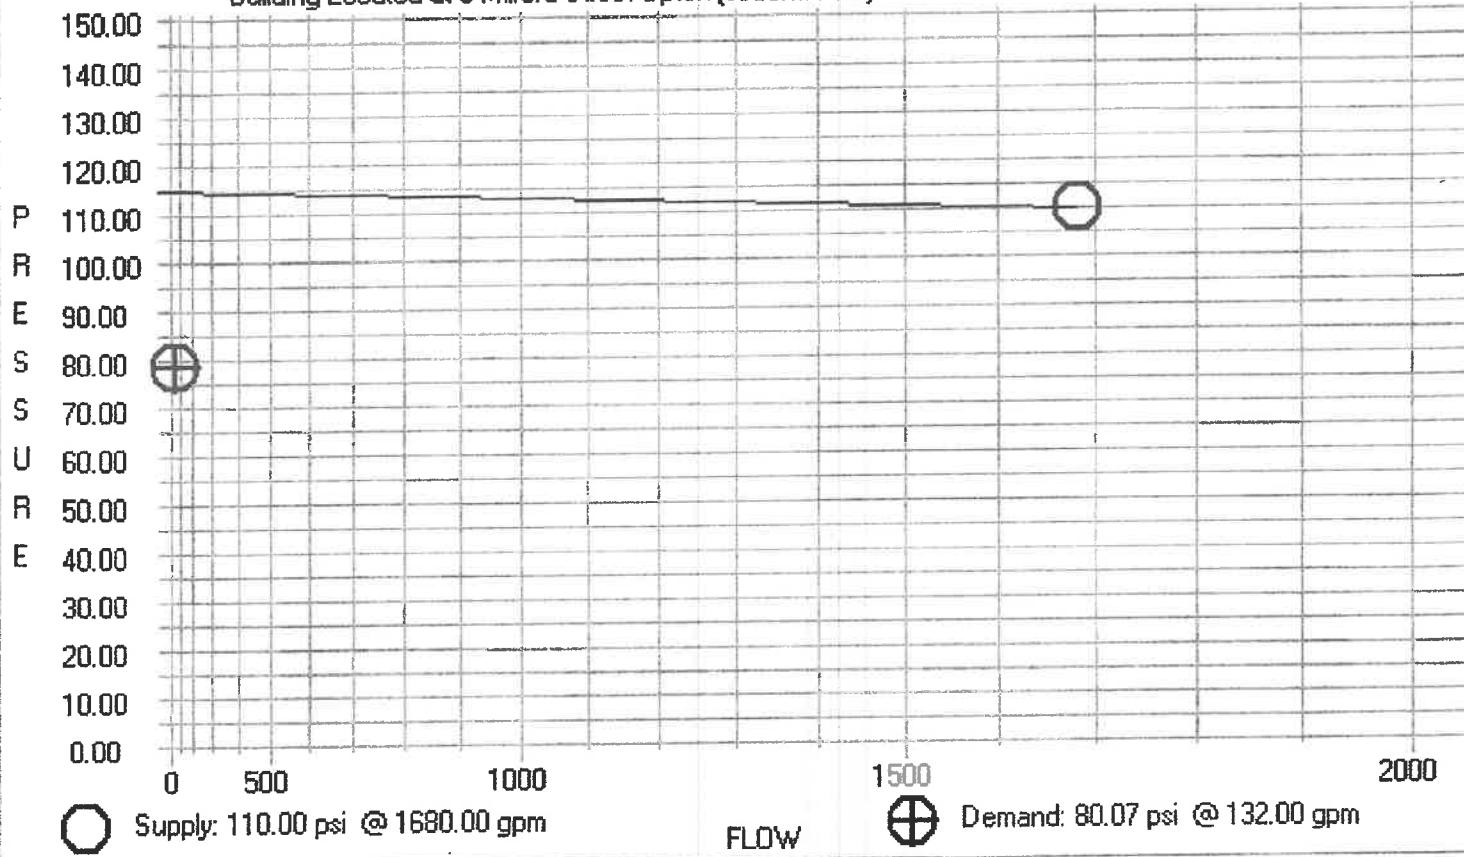
WATER SUPPLY/DEMAND GRAPH

Building Located at 3 Milford Street Upton (second floor)
