Upton, MA

Post Construction Stormwater Management

BMP RETROFIT SITE INVESTIGATIONS

Prepared by: **BETA GROUP, INC.**

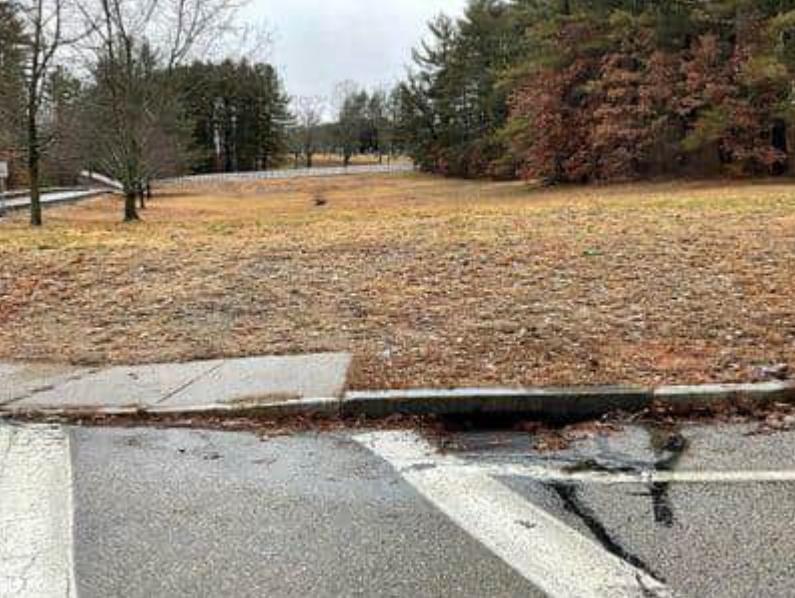
<p>Catch basin 93-14, facing north along Maple Ave.</p>

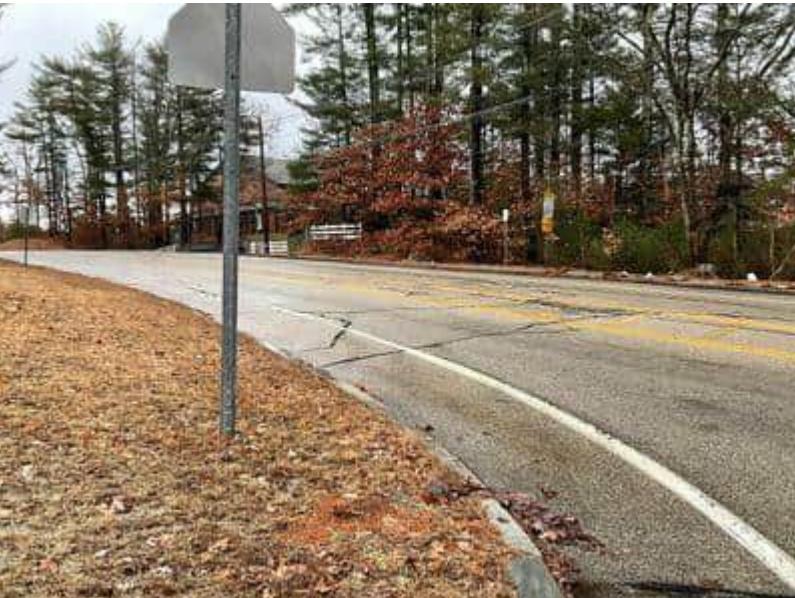
<p>Impervious catchment of catch basin 93-14, facing northeast along Pleasant Street.</p>

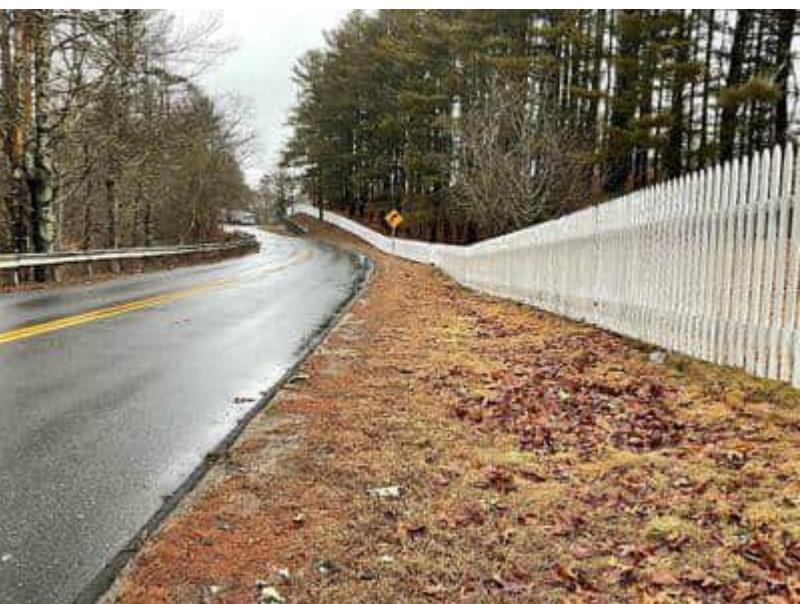
Facing north along Maple Ave from existing inlet structure.

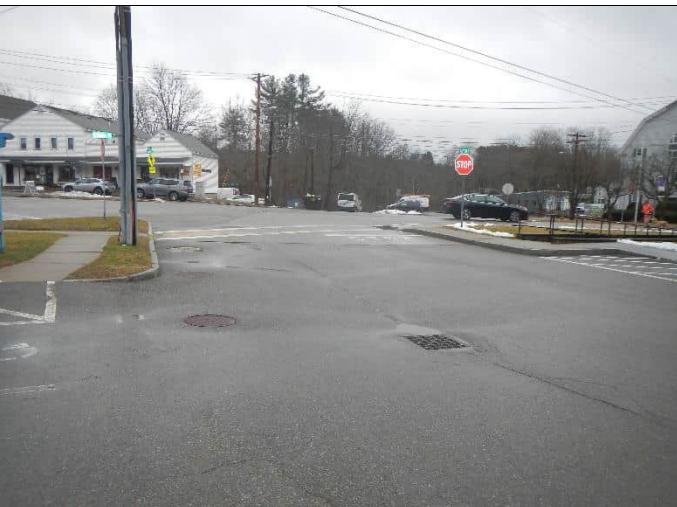
Existing catch basin at parking lot driveway, facing east.

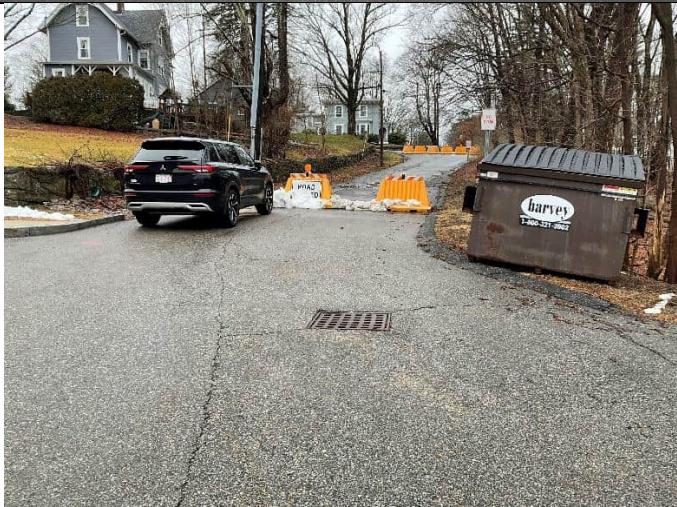
Existing catch basin 71-9, facing west.

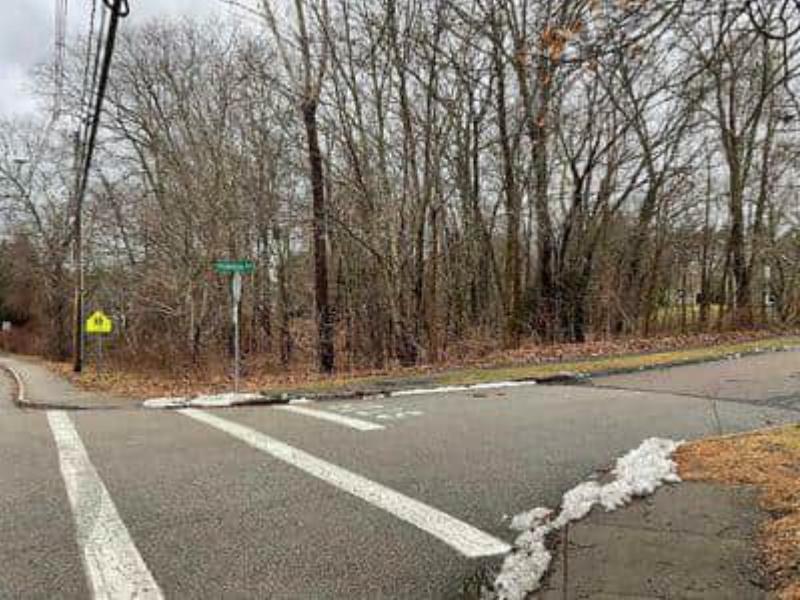
A photograph showing a paved road with white crosswalk lines. To the left is a utility pole with a green street sign. To the right is a grassy area with fallen leaves. Bare trees line the background.	View of site facing W at corner of Florence Circle and Pleasant Street.

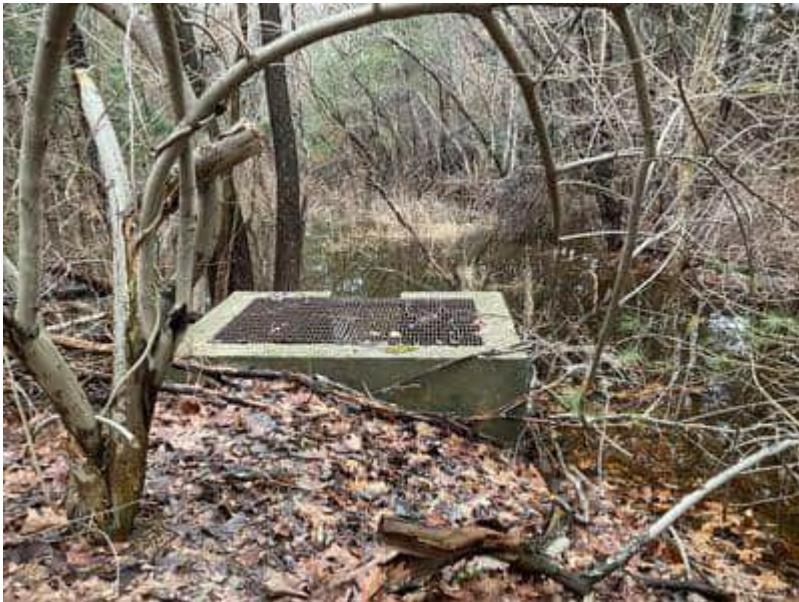
Inlet control structure at W corner of parcel, facing W.

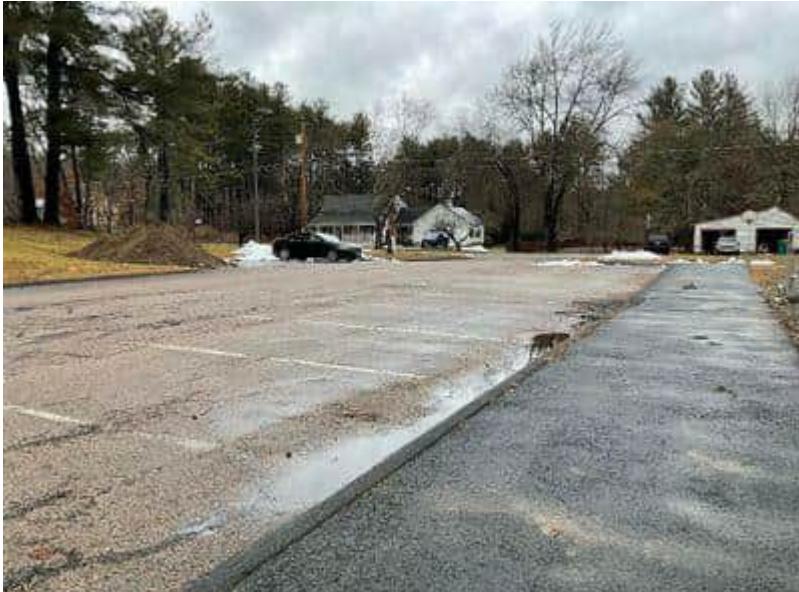
Fire department parking lot driveway facing north towards Church Street.

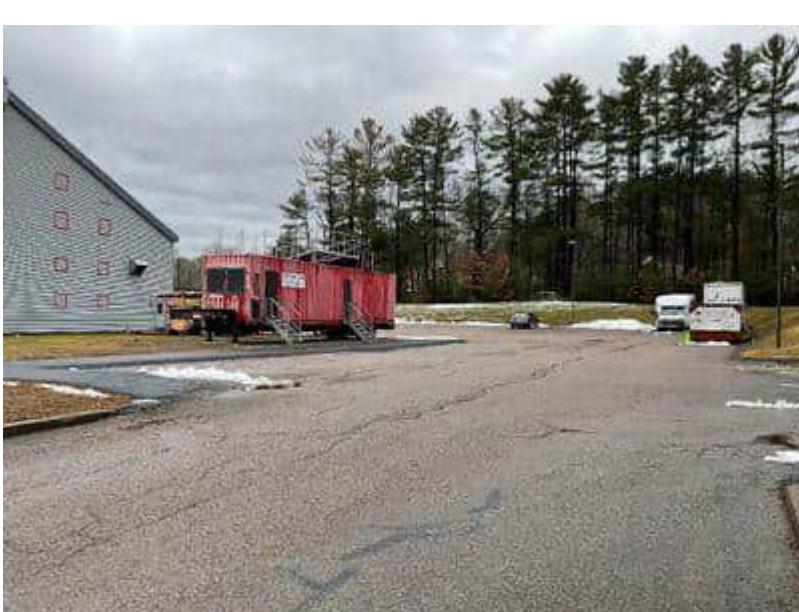
Fire department parking lot from Church Street, looking south.

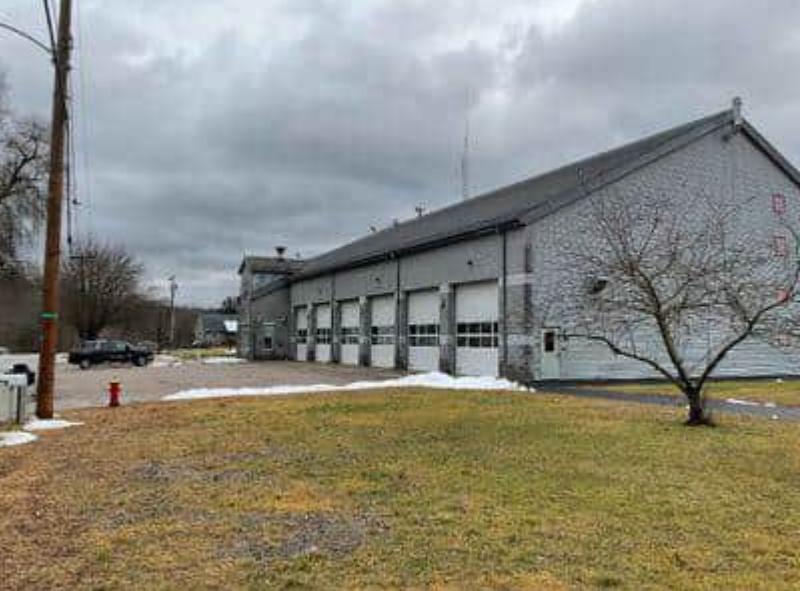
<p>Fire department building from Church Street, with view of downspouts.</p>

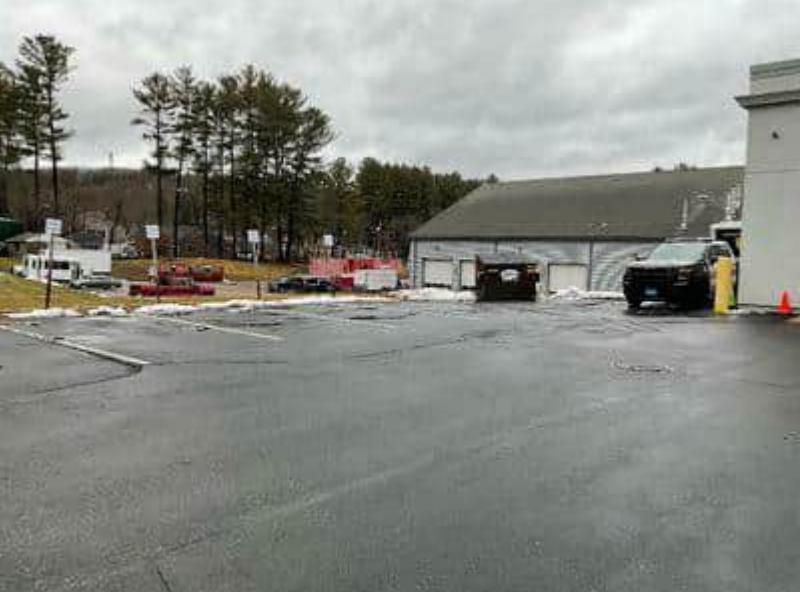
<p>Back parking lot of police department, looking northwest.</p>

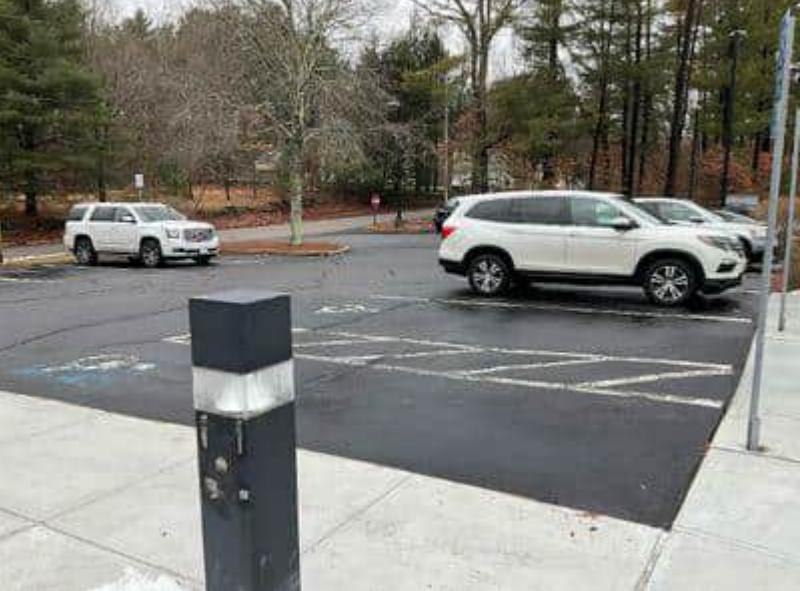
Front police department parking lot, looking southwest.

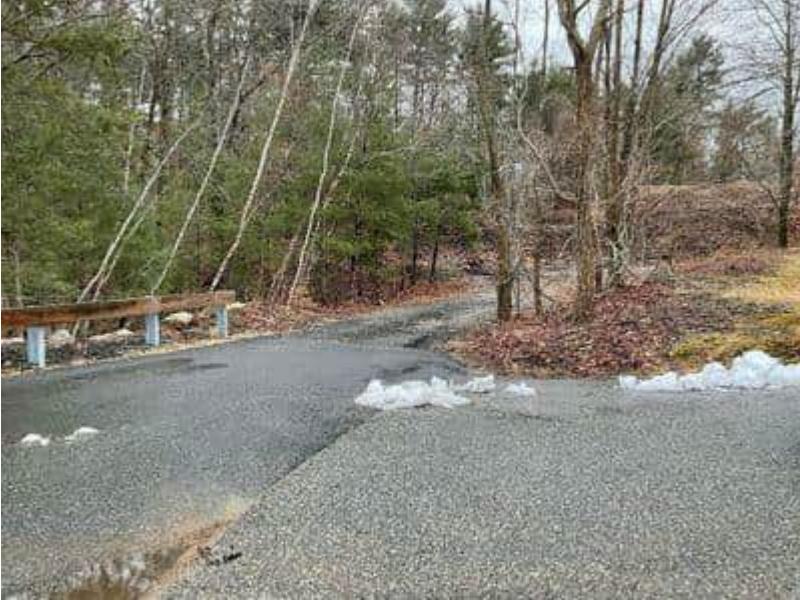
<p>View to south of existing brush dump area.</p>

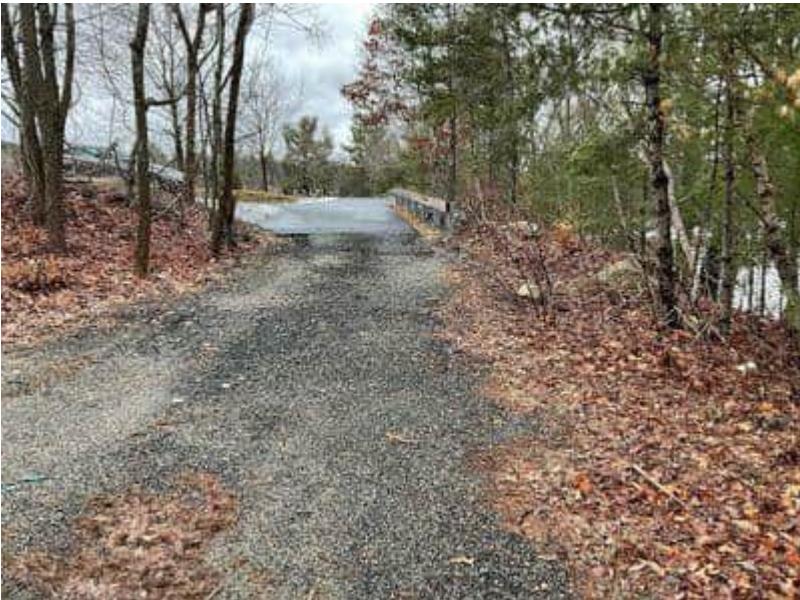
<p>View to north from existing brush dump area.</p>

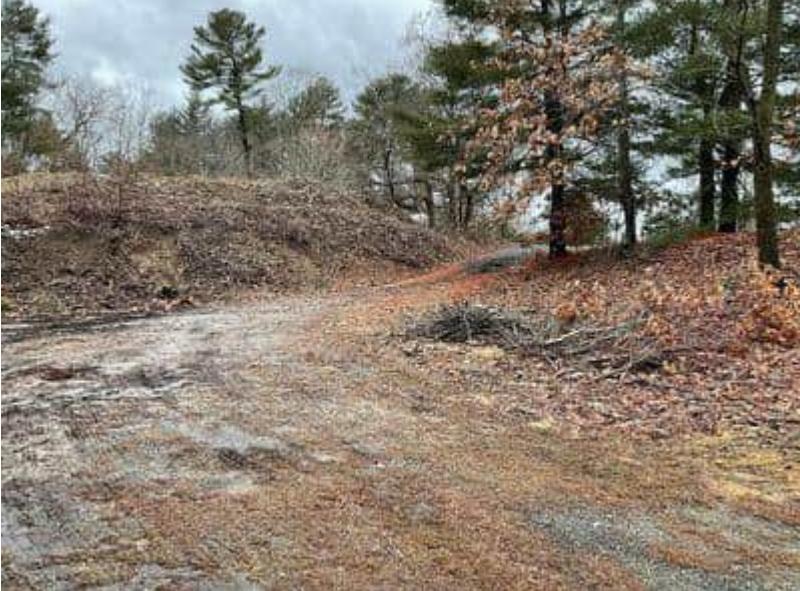
A photograph showing a brush dump area on a hillside. The ground is covered in fallen leaves and brush. Several evergreen trees are visible in the background.	View to west-southwest from existing brush dump area.

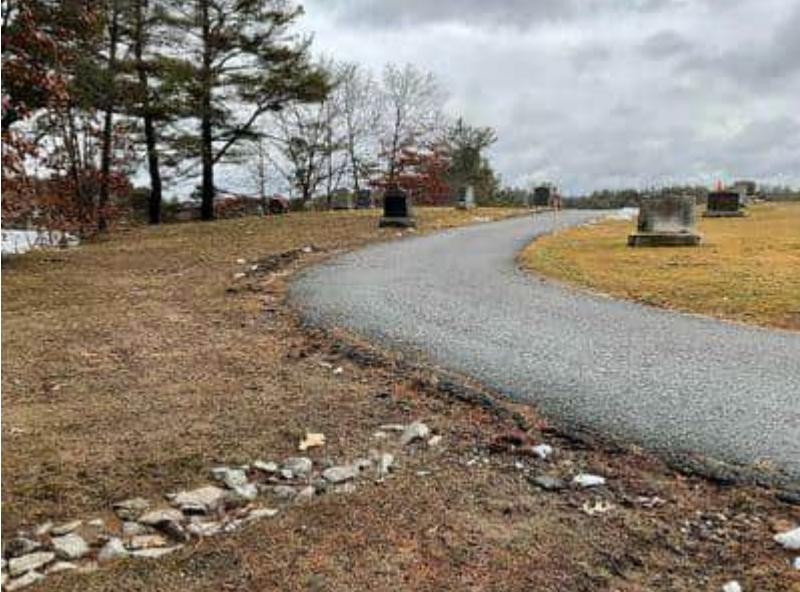
Existing riprap outlet protection, facing northeast.

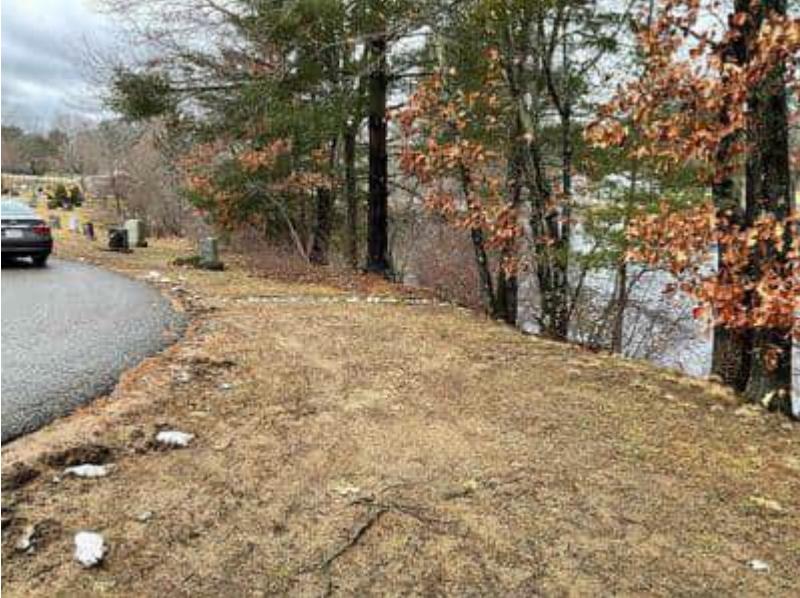
Existing riprap outlet protection, facing southwest.

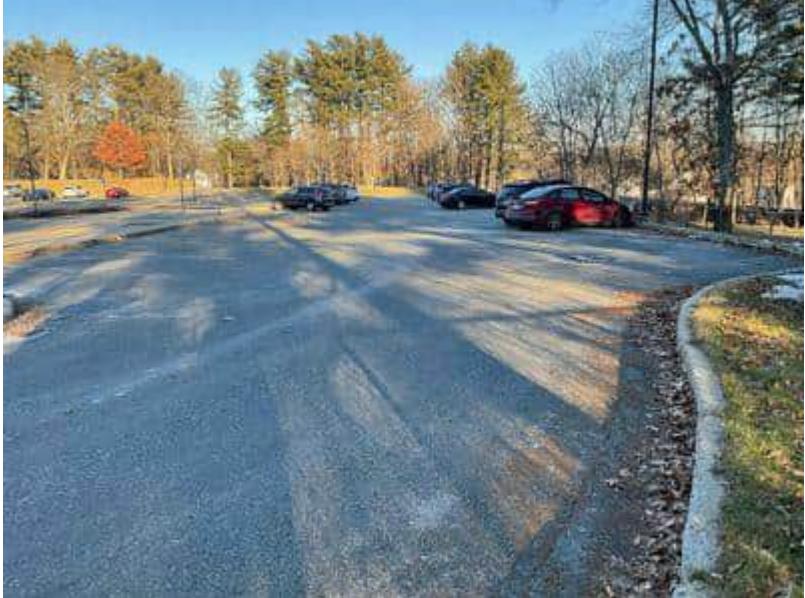
<p>South parking area, facing northeast.</p>

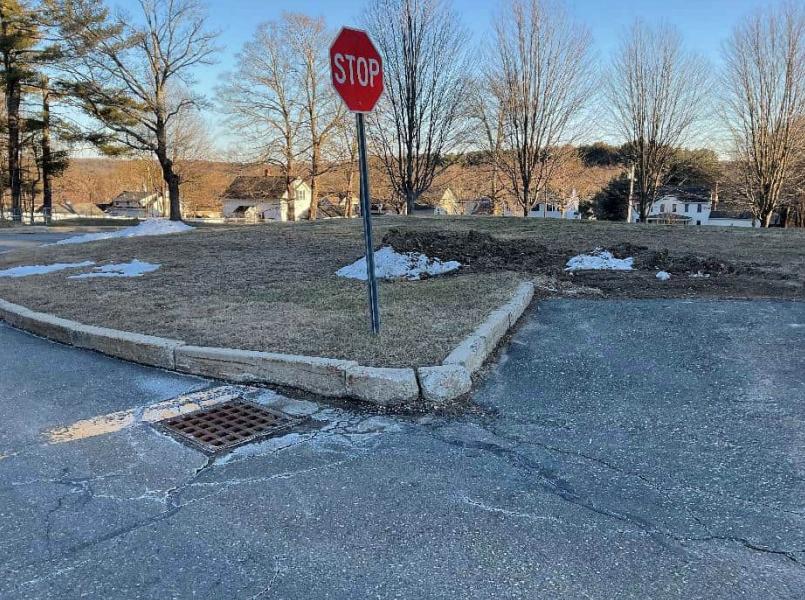
<p>Existing catch basin that captures stormwater from south parking lot, facing south.</p>

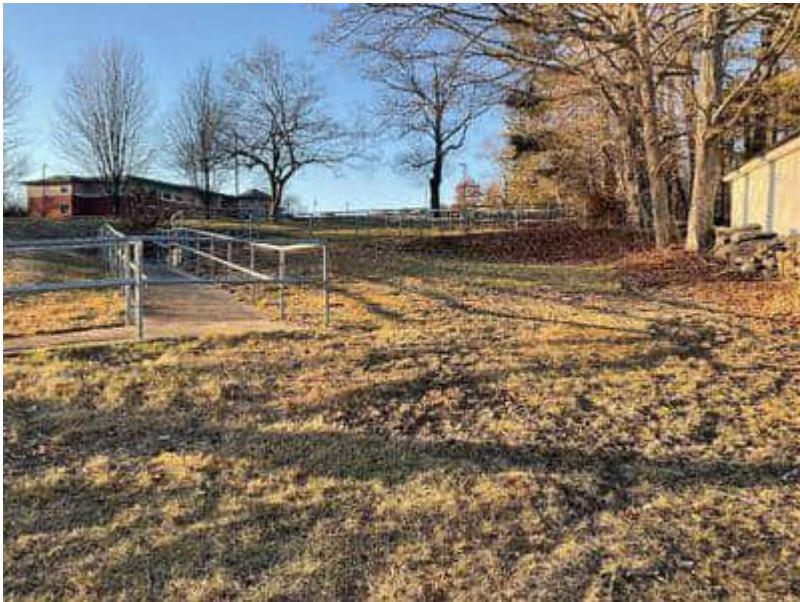
Accessible sidewalk to Main St, facing north.

5. The sidewalk leading from the school to Fiske Avenue has a slight pitch (0.5%) north and drains downhill towards the street. Existing vegetation along both edges of the sidewalk may be channeling stormwater along the sidewalk itself; there is an opportunity for installation of a water quality swale with check dams along the north edge of this sidewalk to reroute and infiltrate stormwater.

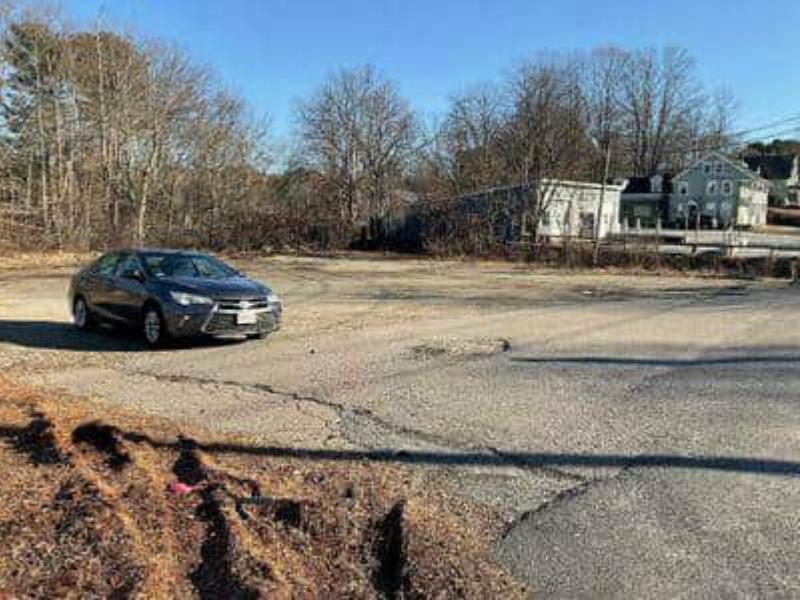
A photograph showing a paved area with a car parked on the left. In the background, there are houses and trees. The foreground shows some dry, brown vegetation and a paved surface with a crack.	View of site from northwest corner, facing southeast.

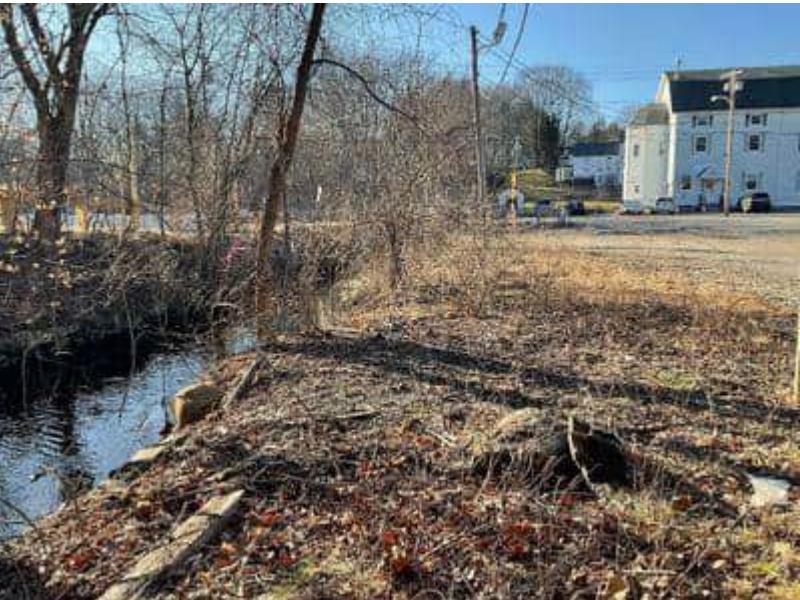
A photograph of a stream flowing through a grassy, somewhat overgrown area. In the background, there are buildings and utility poles. The foreground shows the edge of the stream and some fallen leaves.	Stream and adjacent area, facing east towards Grove St.

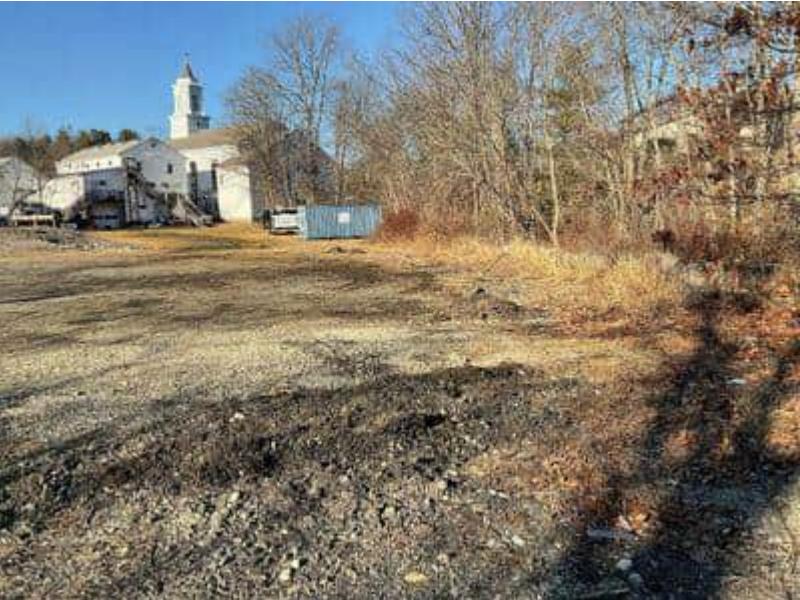
A photograph showing a dry, shallow depression in a grassy area, likely a stormwater management feature. In the background, there are buildings and trees under a clear blue sky.	Shallow area in rear of parking lot, facing northwest.

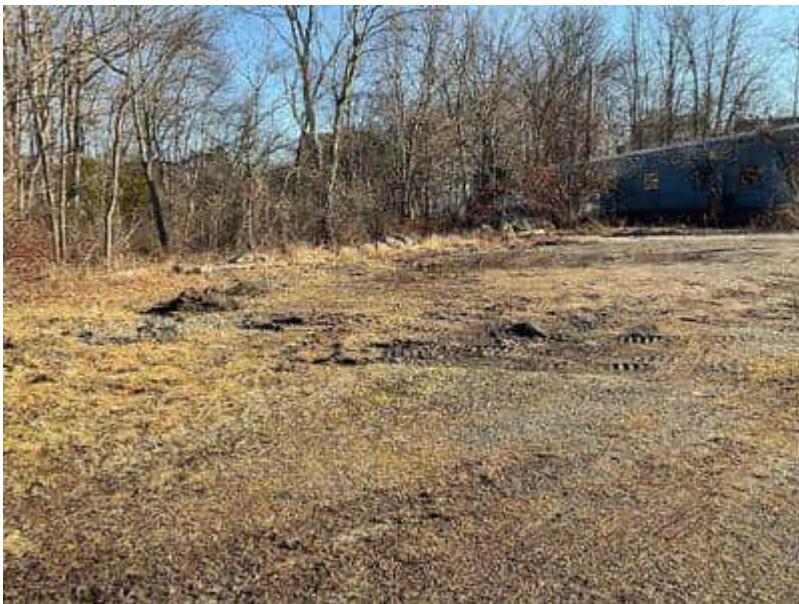
Shallow area in rear of parking lot, facing southeast.
