STRUCTURAL EVALUATION

Holy Angels Church
3 Milford Street
Upton, MA

April 26, 2019

Project Number: 19-0104-MA
Date of Inspection: April 4, 2019
Engineers: H. Alan Mooney, P.E.
Nate Powelson, P.E.

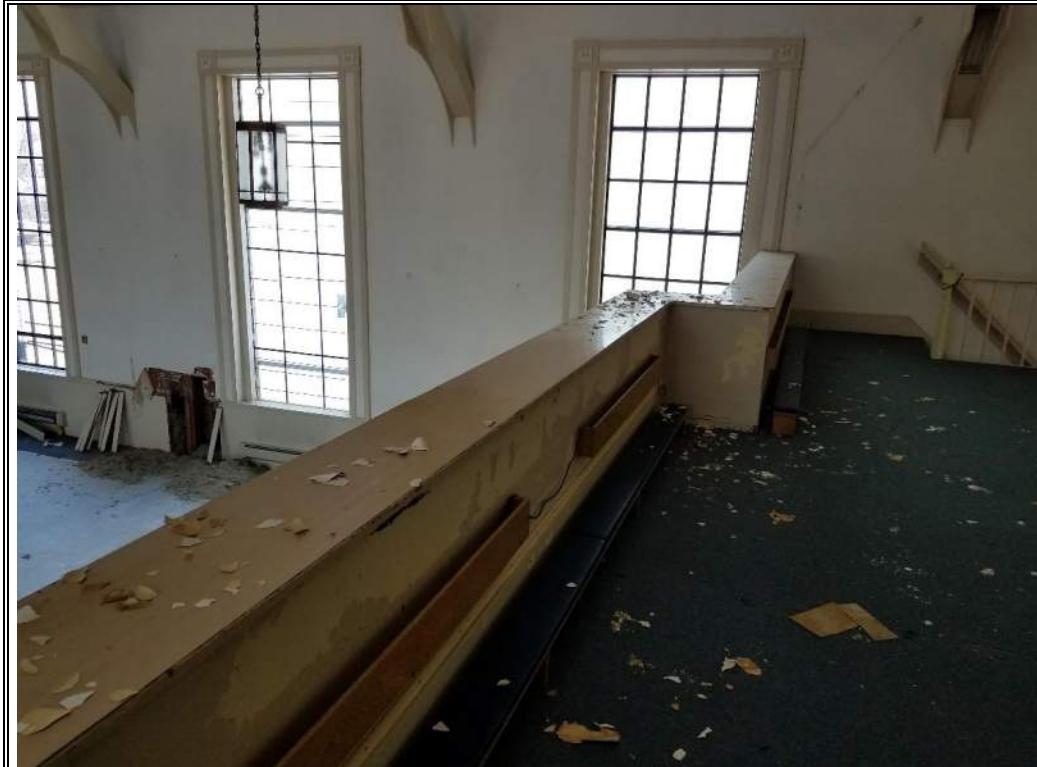
Photo Number
21

The most significant area of water intrusion is around the bell tower. There are water stains on the ceiling of the balcony, most likely the result of wind-driven rain entering the bell tower. That structure is not weather tight. It would be necessary, if the building is to be renovated, to enclose that bell tower in some way to assure weather-tightness.

Upper level -
balcony

At this point, if the building is to remain unused for the foreseeable future, some effort to make the bell tower weather tight, at least temporarily, is recommended. Given the accessibility (height, steep roof, attic access), we suggest an allowance of \$7,000 to do that, and that would only provide a temporary solution, not a permanent one.

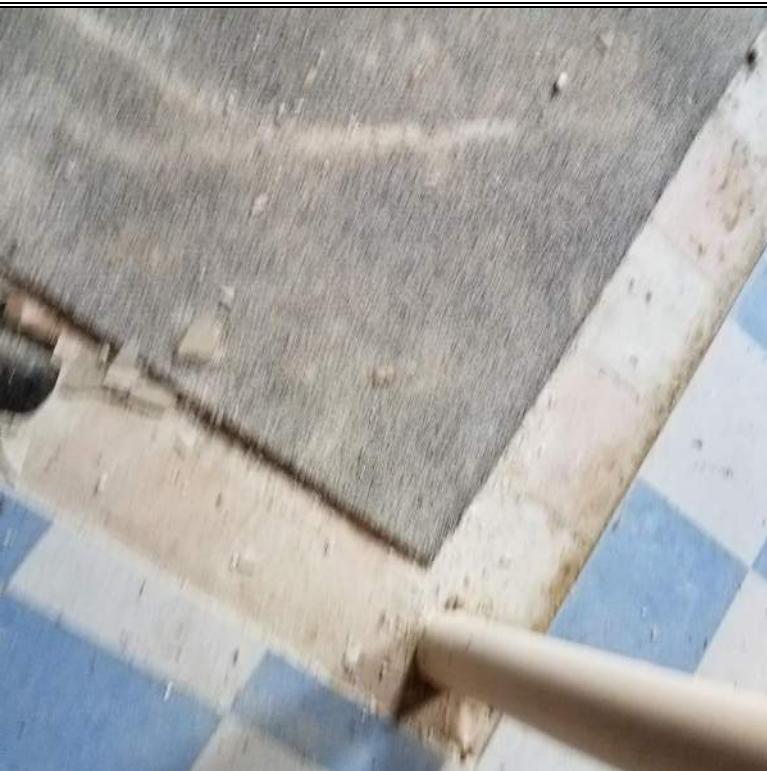
The first involves hazardous materials. There is evidence of widespread presence of asbestos-containing materials (ACM) in this building. This includes the smaller floor tiles (9" square) and some of the loose insulation. Some other materials such as wall finishes may also contain asbestos. Asbestos in building materials was quite common in the 19th century as well as the early 20th century.

Lower level –
floor tile, possible
ACM

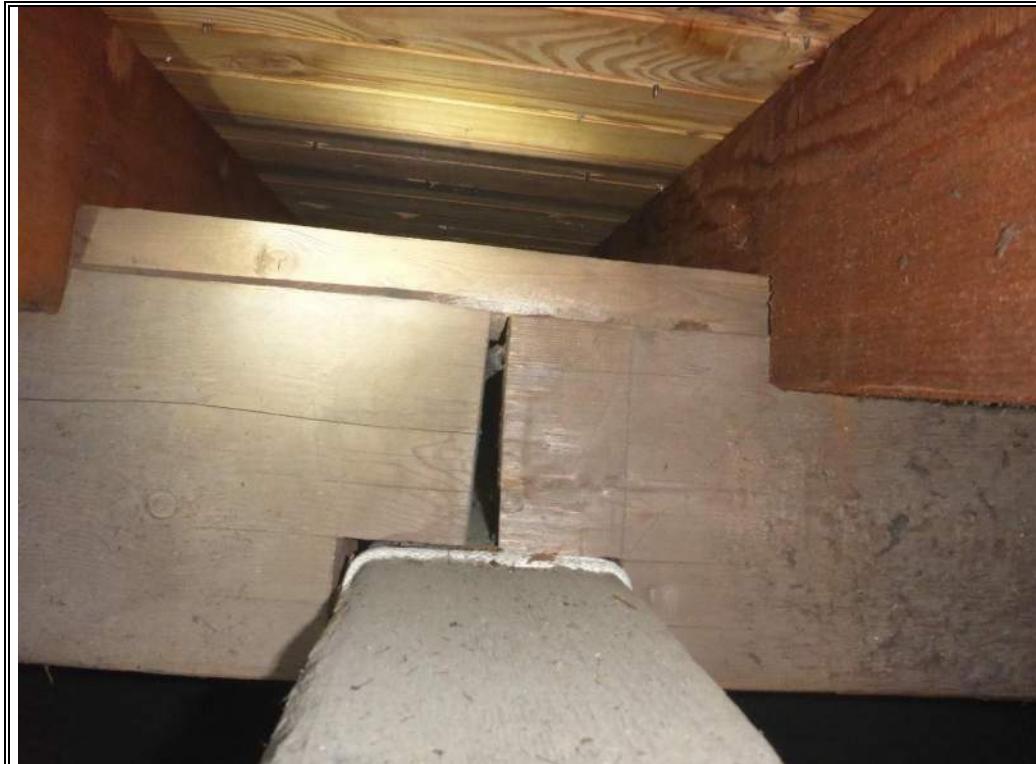
Framing details –
notched joists at
beams (see report)

This, along with some other upgrading or refreshing of the general capacity of the main floor framing, would be a recommendation of the building at this time regardless of its future use.

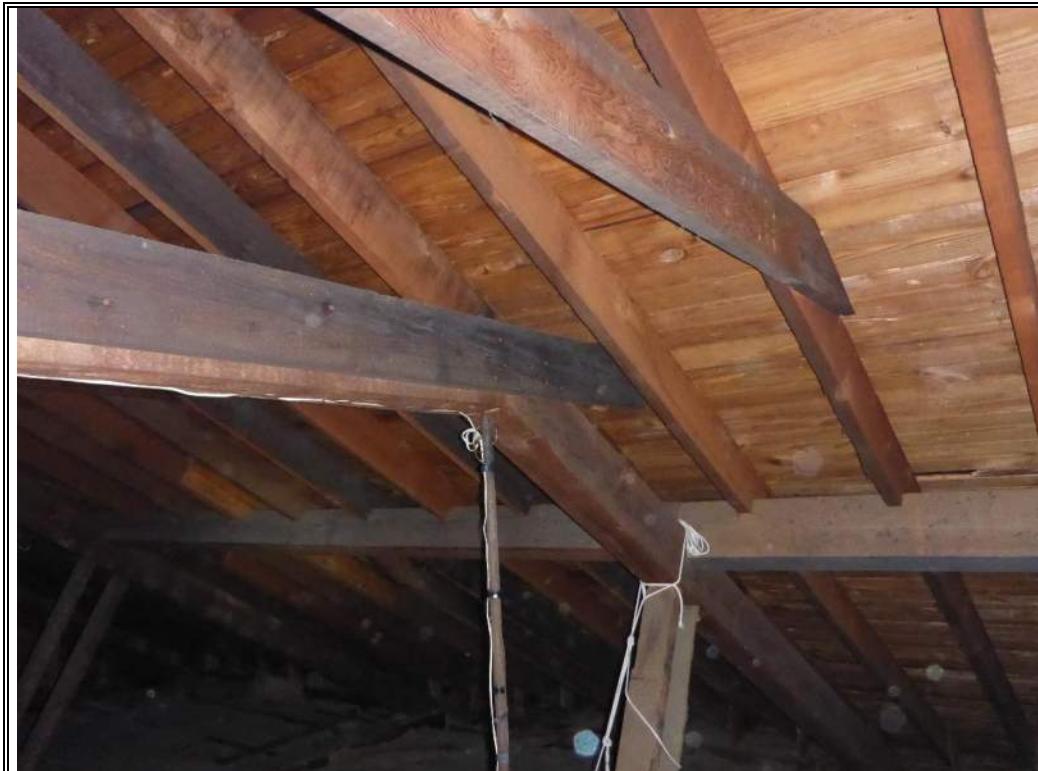
Photo Number
48

Description:
Attic/roof –
typical framing

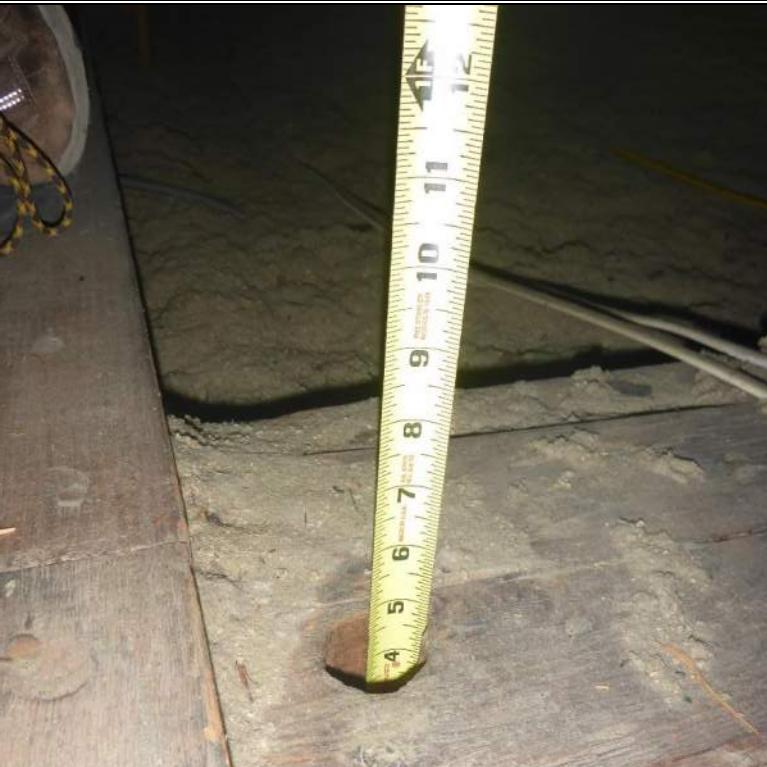
Photo Number

Attic/roof –
apparent insulation
depth

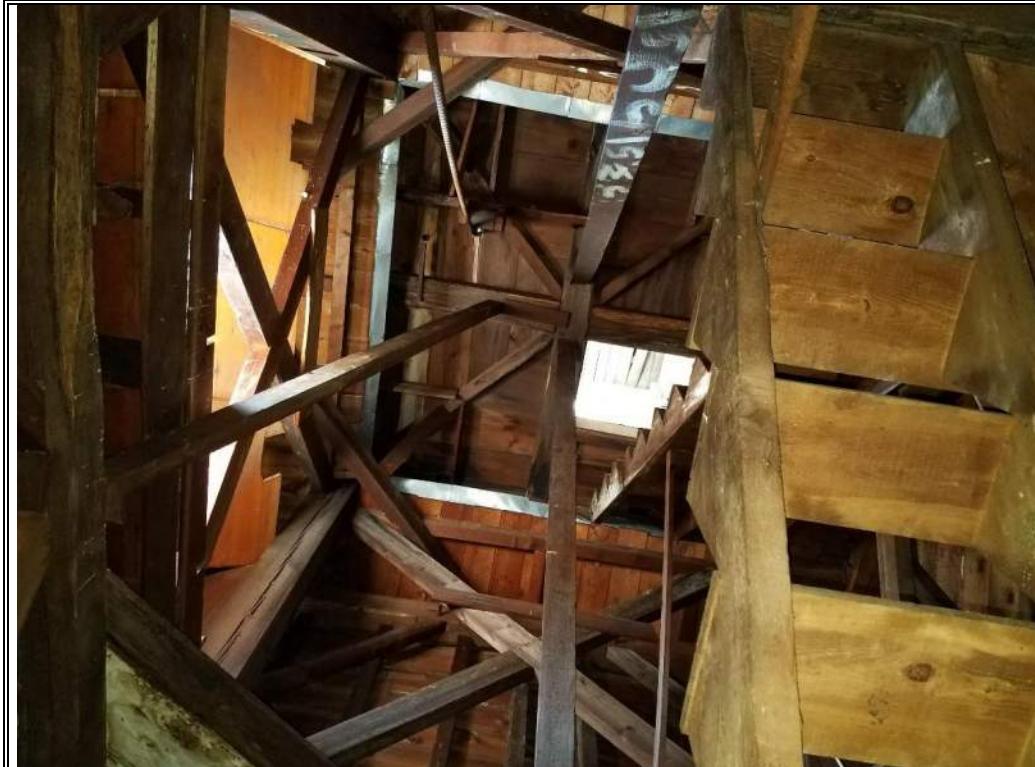
Photo Number

Attic/roof - bell
tower framing

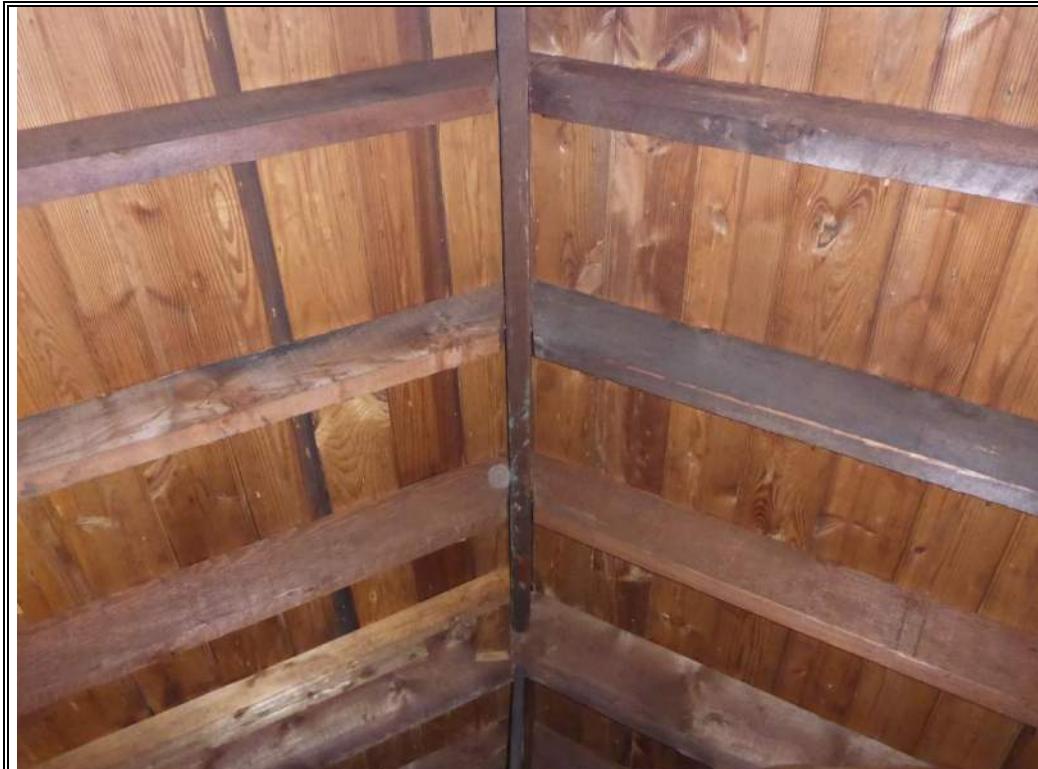
Photo Number
55

Attic/roof –
typical framing

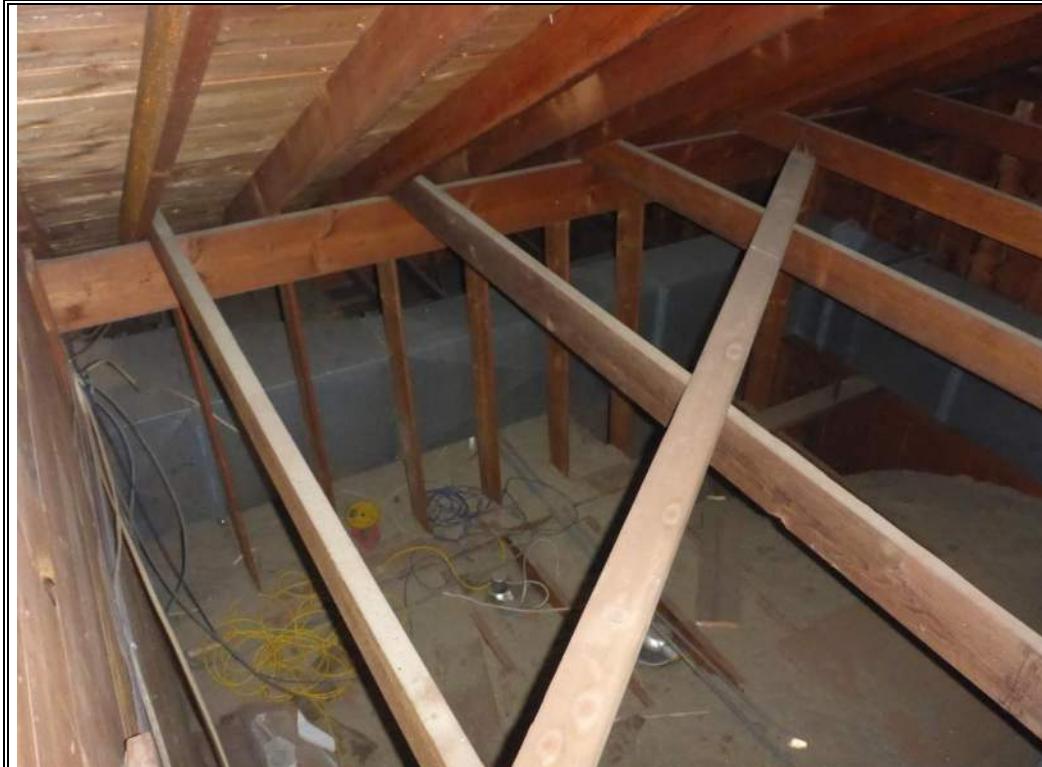
Photo Number
57

Attic/roof –
typical framing

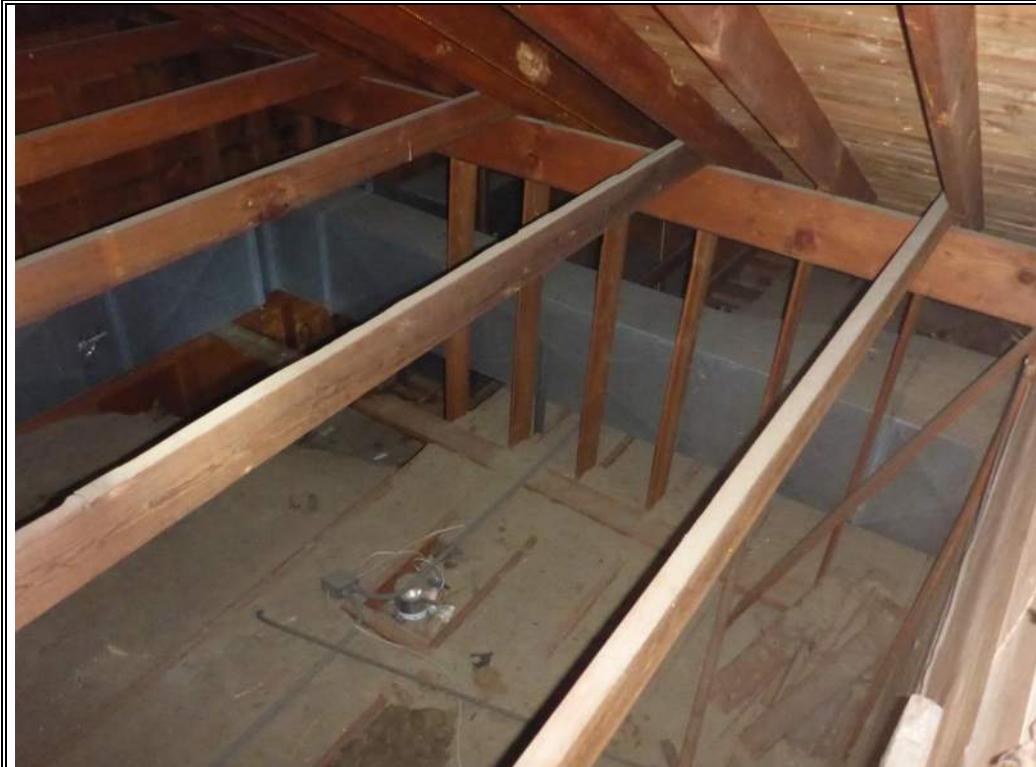
Photo Number
59

Attic/roof –
typical framing

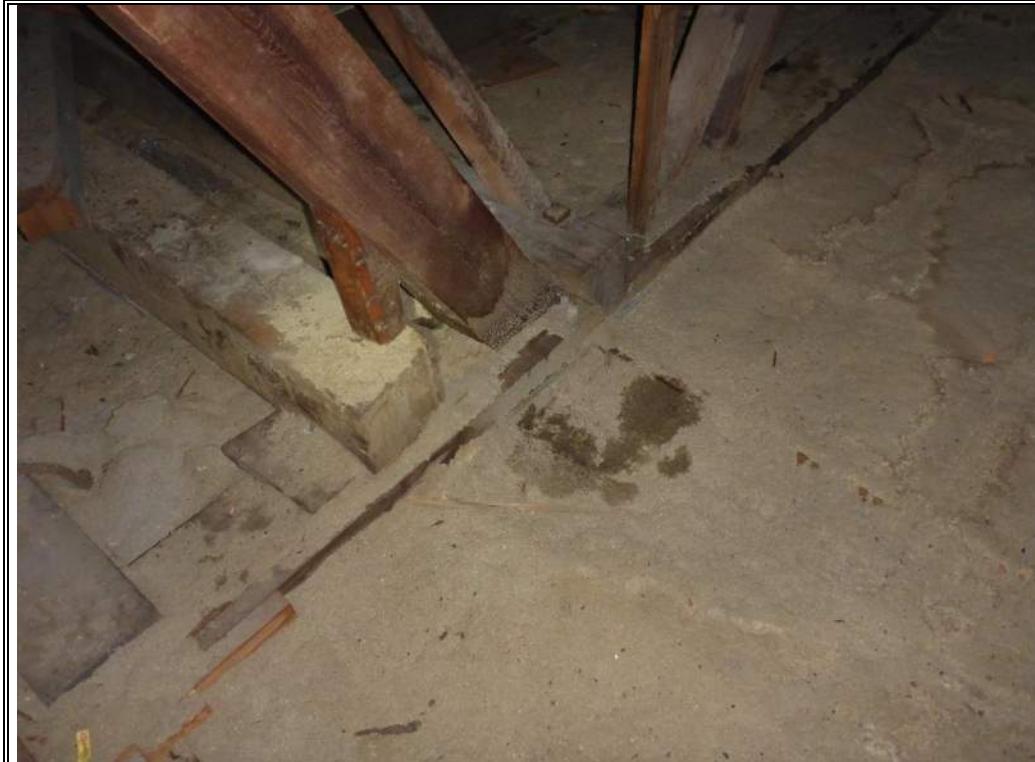
Photo Number
61

Attic/roof –
showing insulation
above ceiling

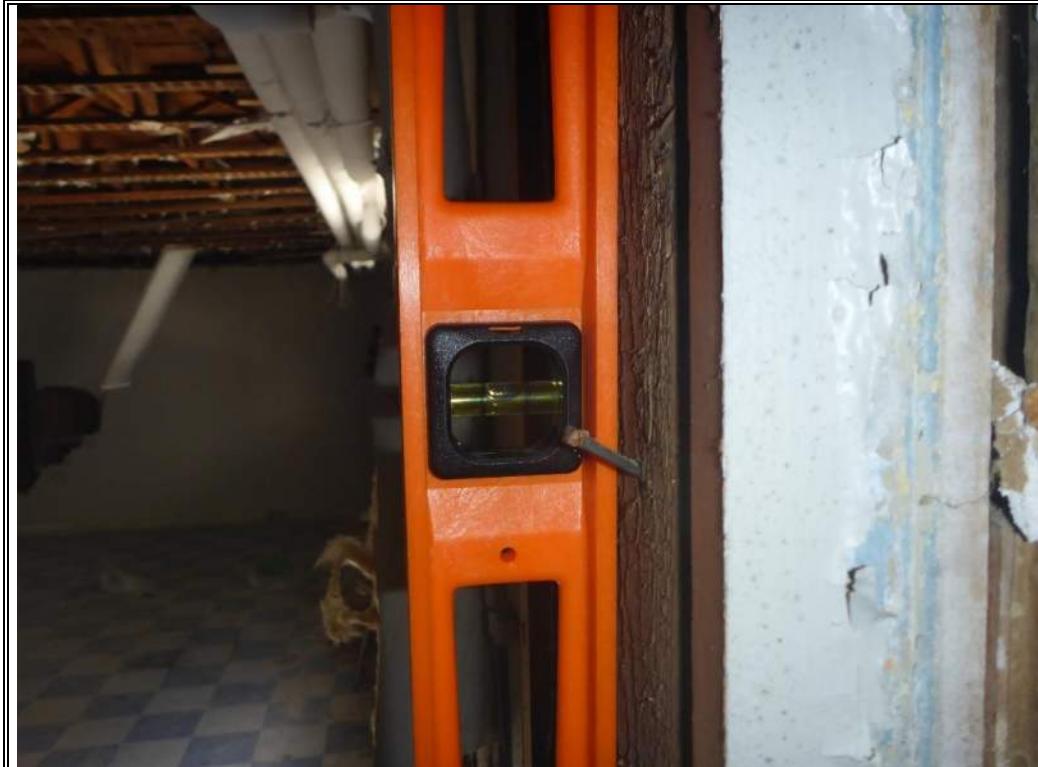
Photo Number

Plumbness sampling – well within reasonable tolerances

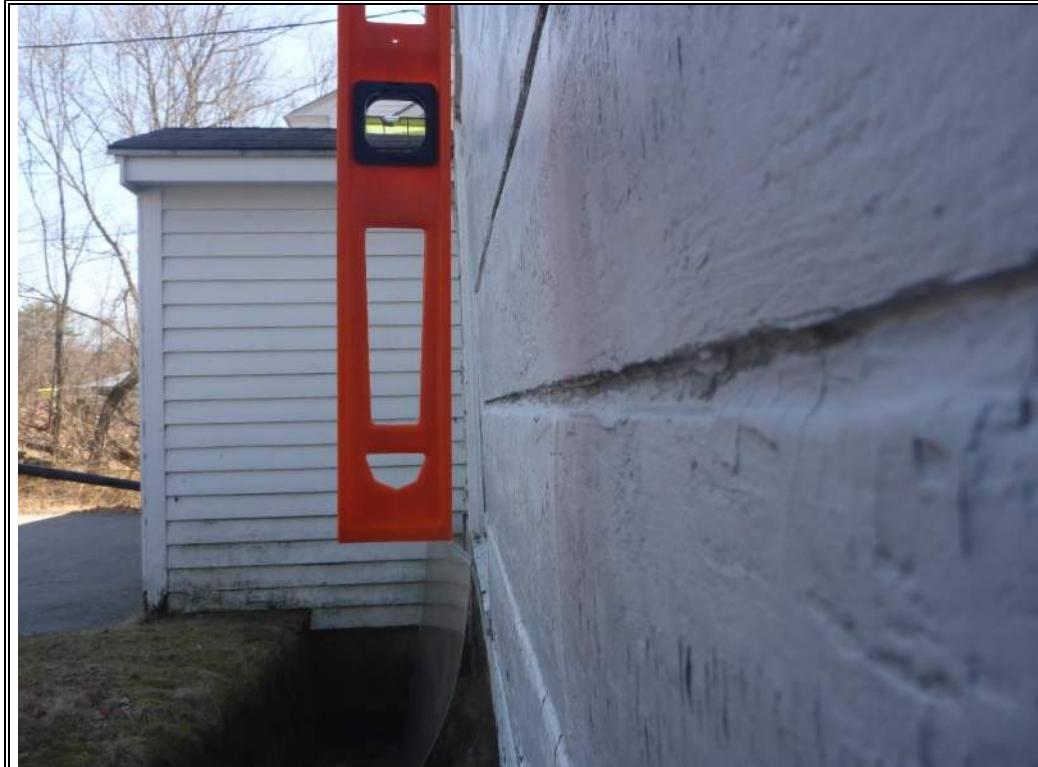
Photo Number
65

Plumbness sampling – well within reasonable tolerances

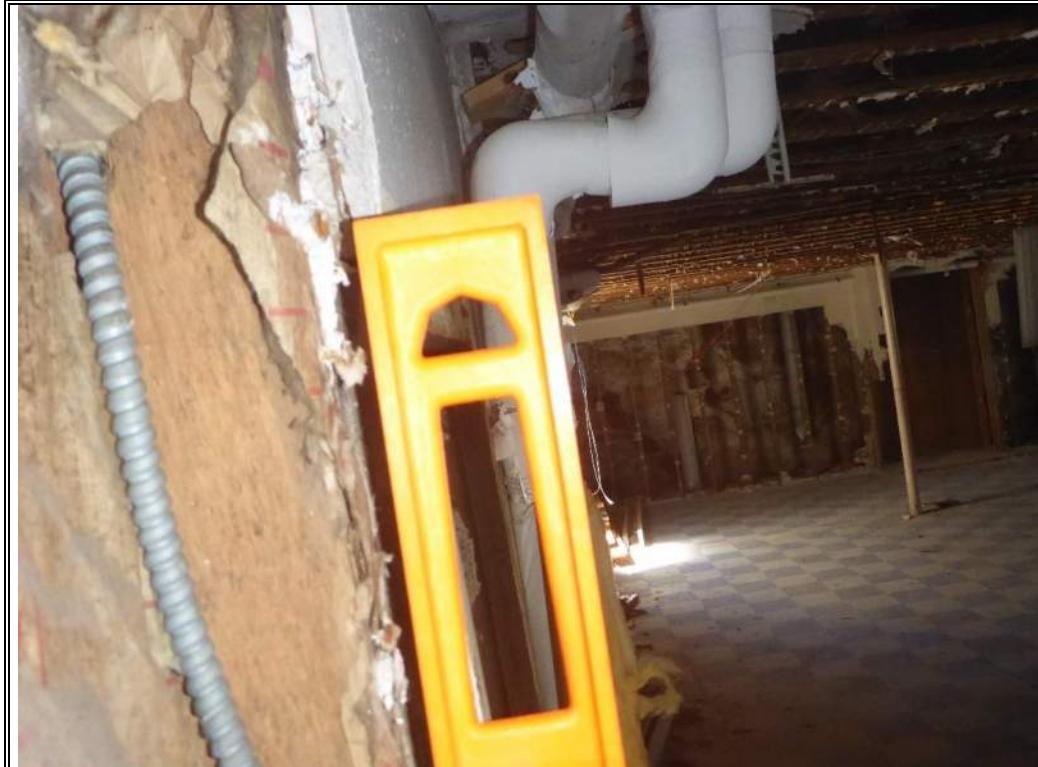
Photo Number
67

Plumbness sampling – well within reasonable tolerances

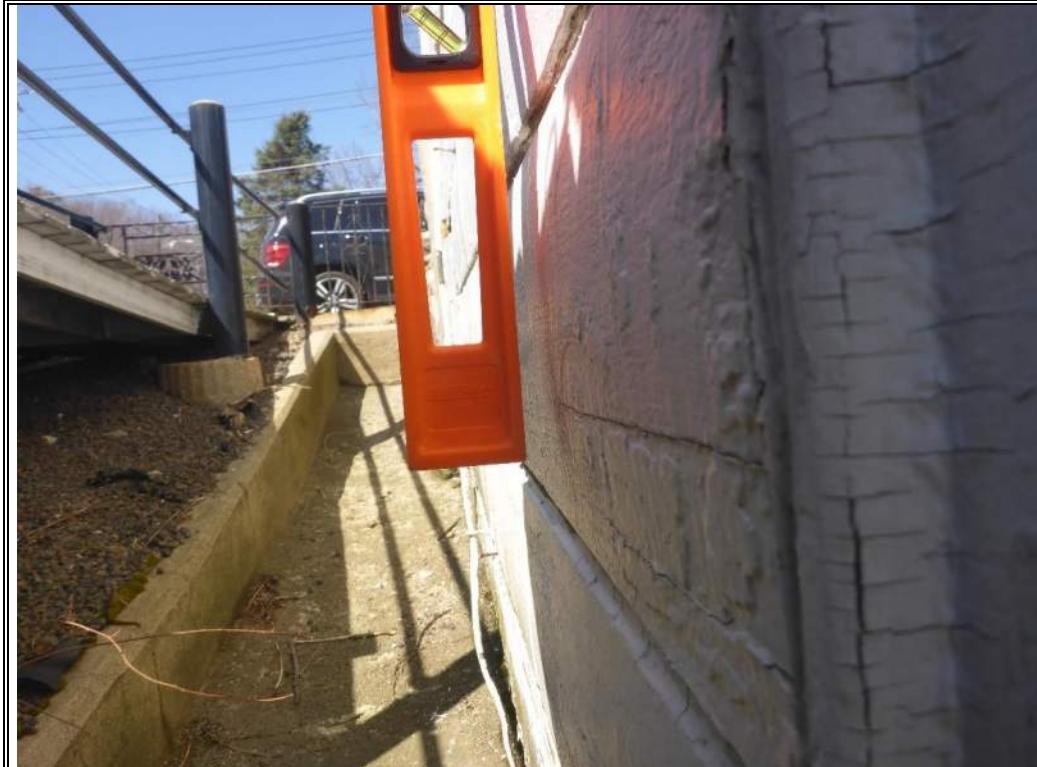
Photo Number
69

Plumbness sampling – well within reasonable tolerances

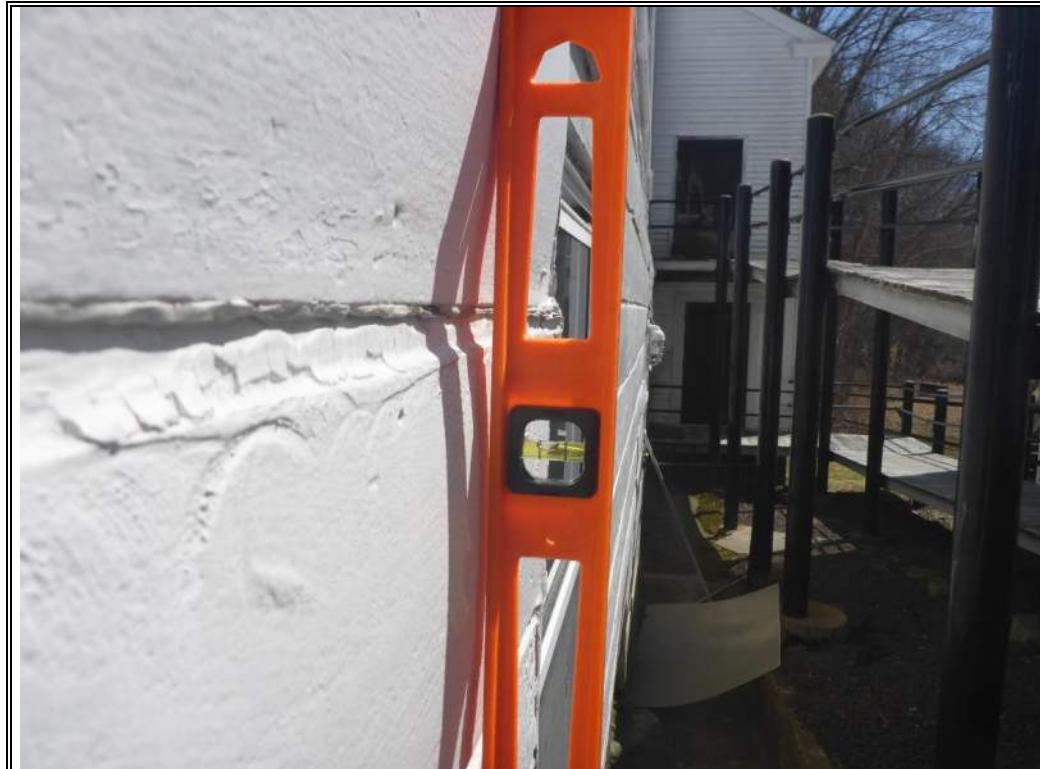
Photo Number
71

Plumbness sampling – well within reasonable tolerances

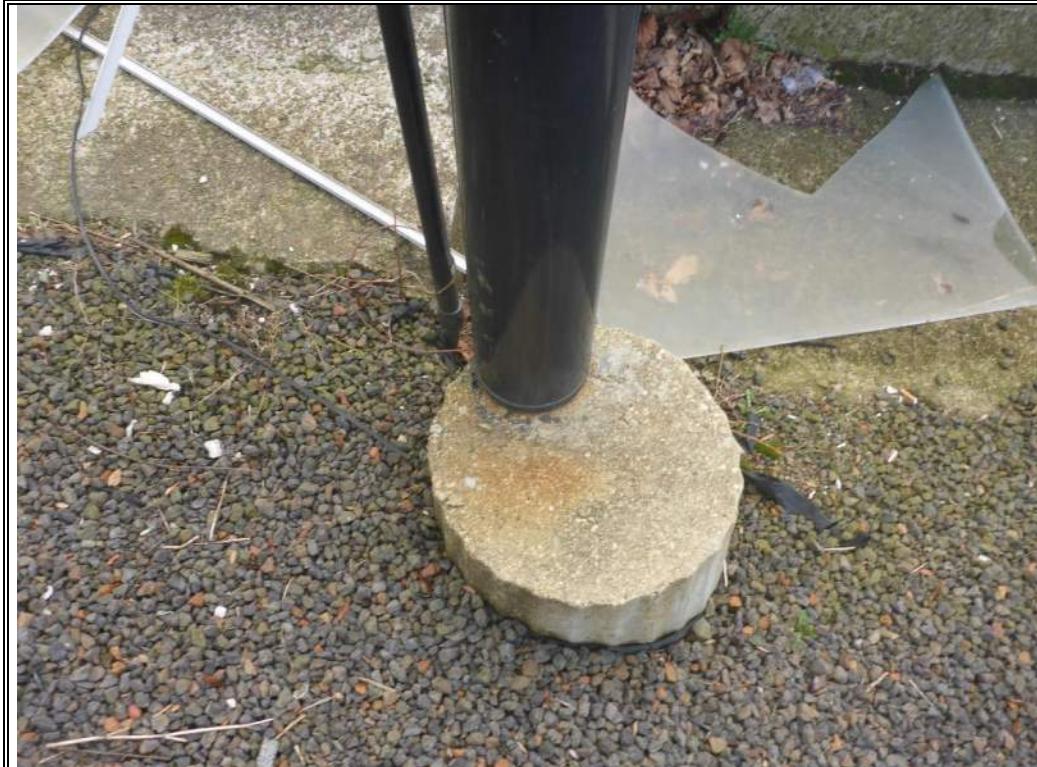
Deck/ramp – post off center

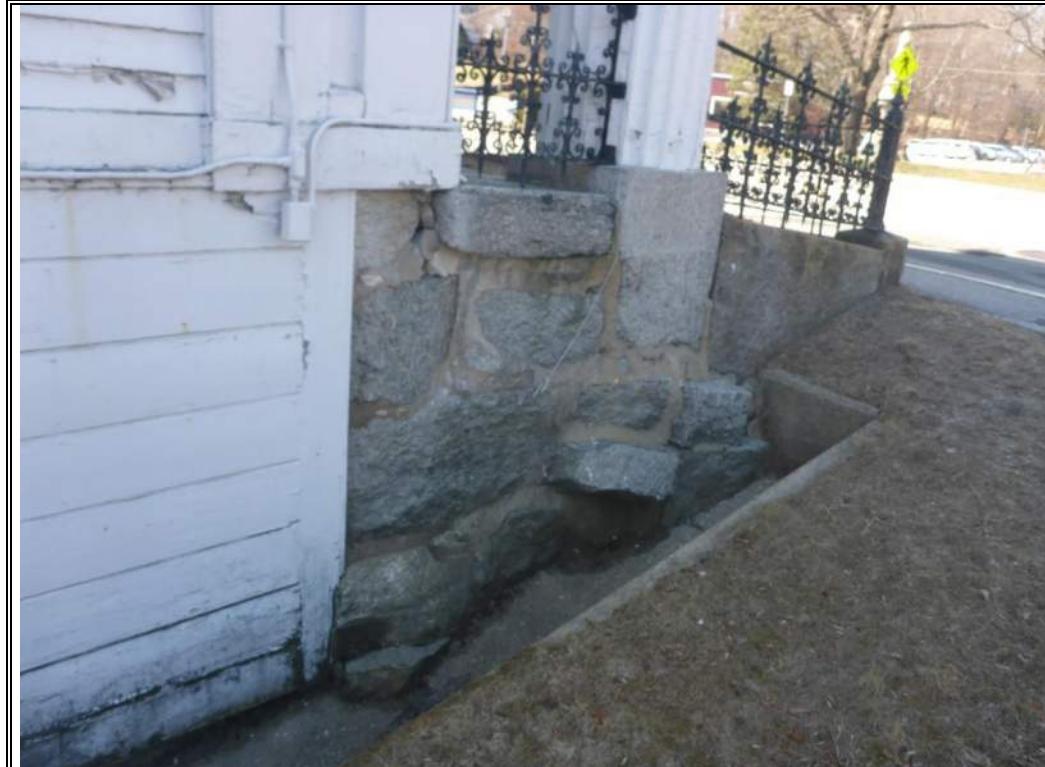
Exterior/details –
left side drainage
channel

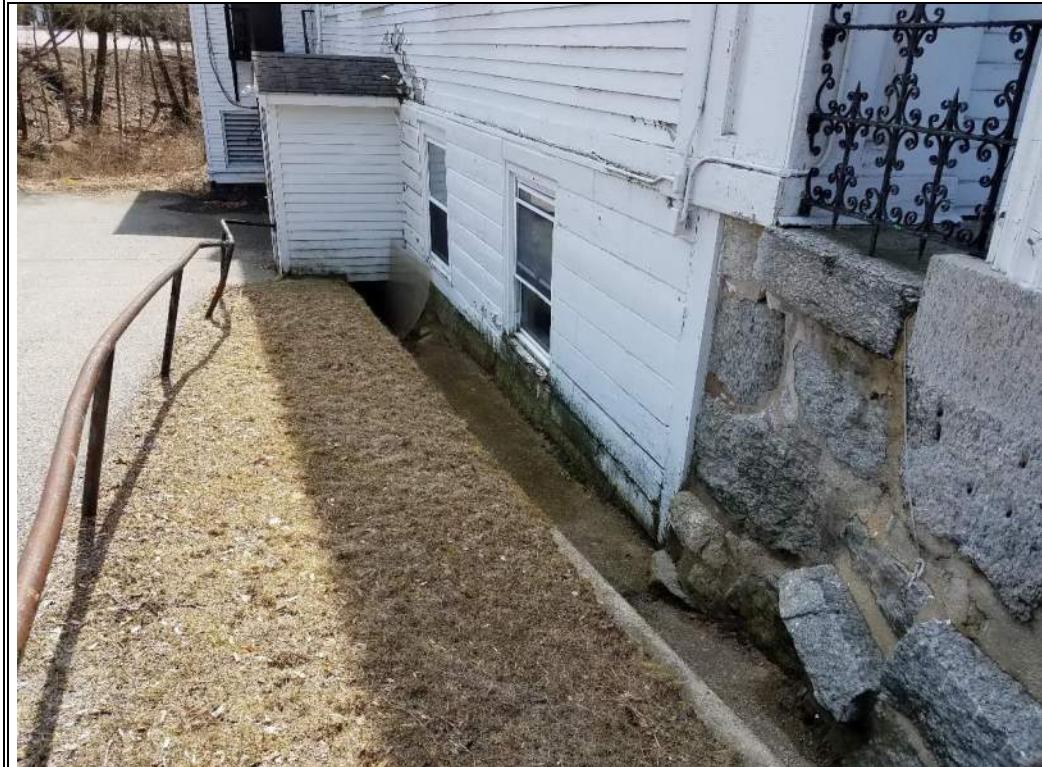
Photo Number
96

Exterior/details – keep channel clear, paint wood surfaces
